2023 OSIM Bridge Inspections Report

**Township of Amaranth
374028 6th Line
Amaranth, ON L9W 0M6**

**November 2023
300057065.0000**

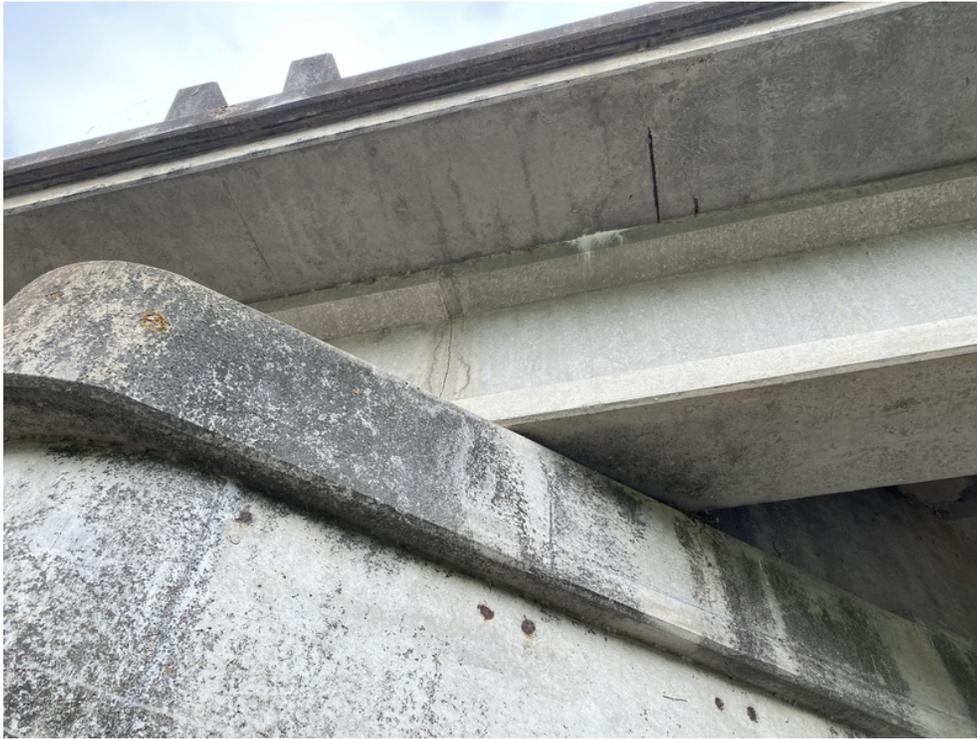
Comments | Exposed corroded rebar and efflorescence staining
