**2025 OSIM Bridge Inspections Report**

**Township of Amaranth  
374028 6<sup>th</sup> Line  
Amaranth, ON L9W 0M6**

**R.J. Burnside & Associates Limited  
15 Townline  
Orangeville ON L9W 3R4 CANADA**

**October 2025  
30057065.0000**

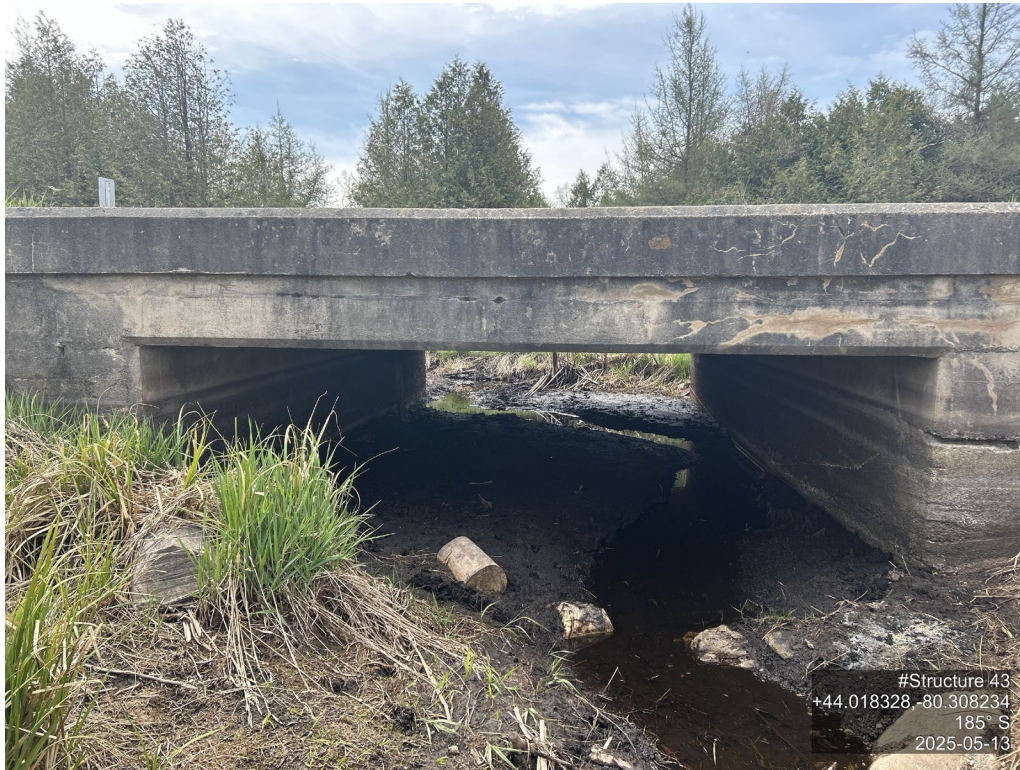
Structure 43 is generally in good condition with only minor defects noted.
