2023 OSIM Bridge Inspections Report

**Township of Amaranth
374028 6th Line
Amaranth, ON L9W 0M6**

**November 2023
300057065.0000**

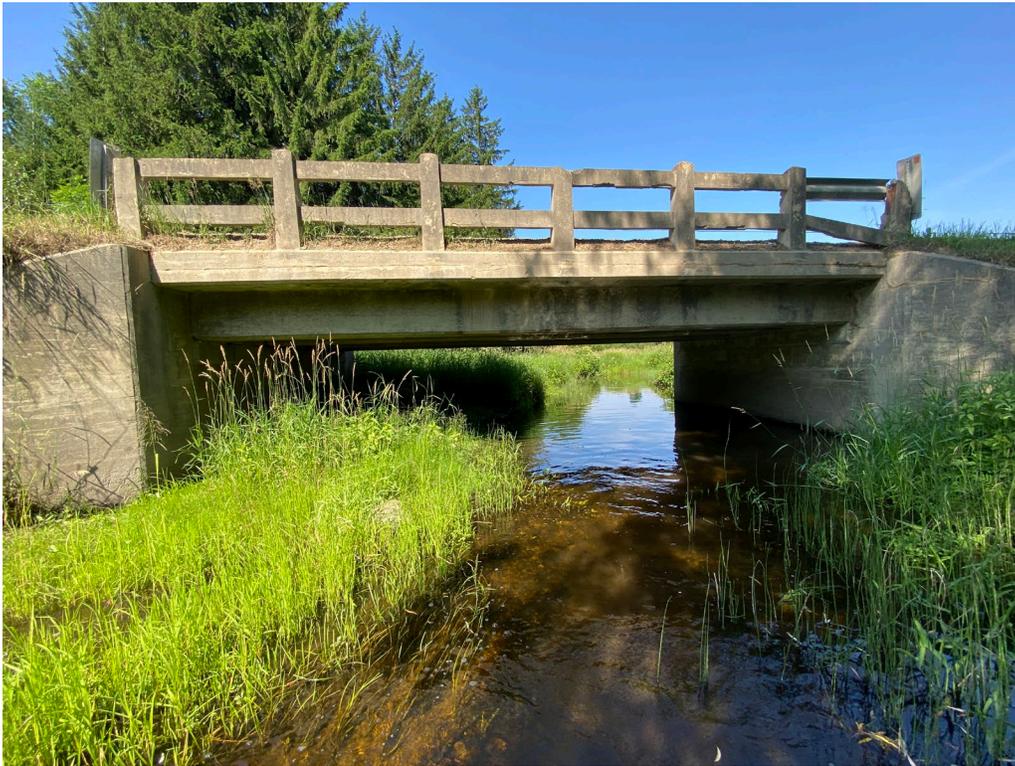
1.3 Structure No. 3

<u>Structure Name:</u>	Bridge 3	2023 BCI =63.16
<u>Road Name:</u>	8th Line	
<u>Location:</u>	Concessions 7 & 8, Lot 3	
<u>Structure Type:</u>	Cast-In-Place Concrete T-Beam	
<u>Number of Spans:</u>	1	<u>Span Lengths:</u> 9.25 m
<u>Overall Structure Width:</u>	7 m	<u>Roadway Width:</u> 6 m
<u>Year of Construction:</u>	1920 (Estimated)	<u>Current Load Limit:</u> N/A

Rehabilitation	Replacement
Estimated Capital Works Timelines (Years):	3.2	13.2

Recommendation: Major Rehabilitation is recommended within 3 years.

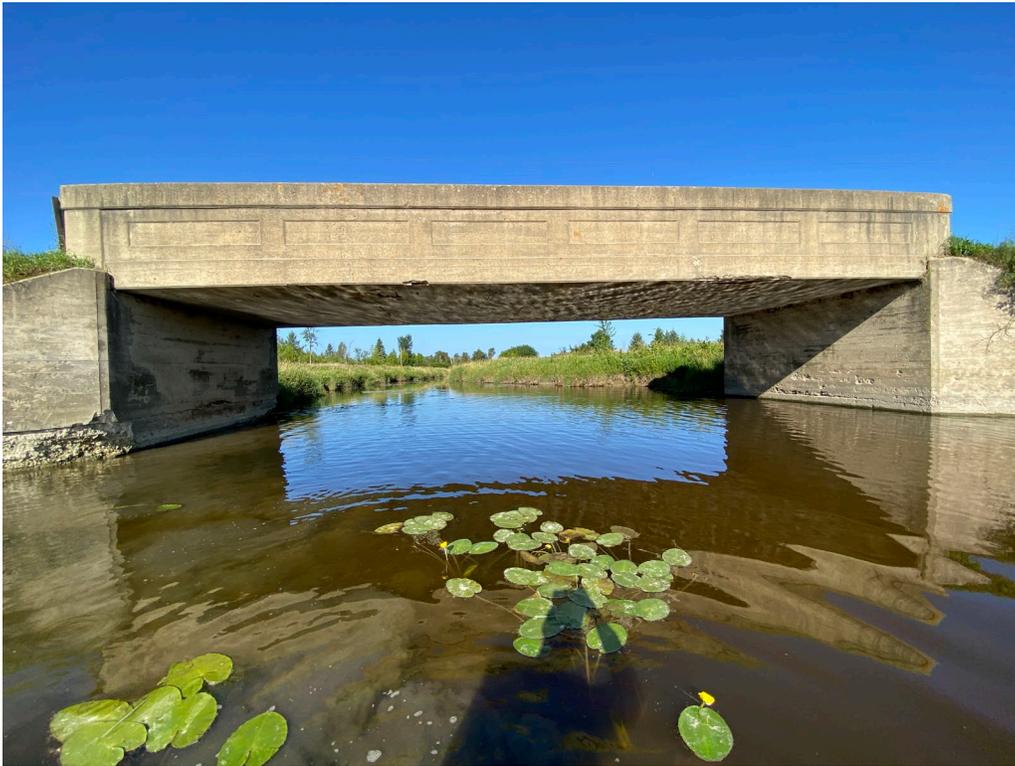
1.10 Structure No. 10

<u>Structure Name:</u>	Bridge 10	2023 BCI =35.23
<u>Road Name:</u>	7th Line	
<u>Location:</u>	Concessions 6 & 7, Lot 14	
<u>Structure Type:</u>	Through Girder (Concrete)	
<u>Number of Spans:</u>	1	<u>Span Lengths:</u> 15.2 m
<u>Overall Structure Width:</u>	6.4 m	<u>Roadway Width:</u> 6 m
<u>Year of Construction:</u>	1900 (Estimated)	<u>Current Load Limit:</u> 16 tonnes

Rehabilitation	Replacement
Estimated Capital Works Timelines (Years):	0.0	0.0

Recommendation:	Structure replacement is recommended as soon as possible.
------------------------	--

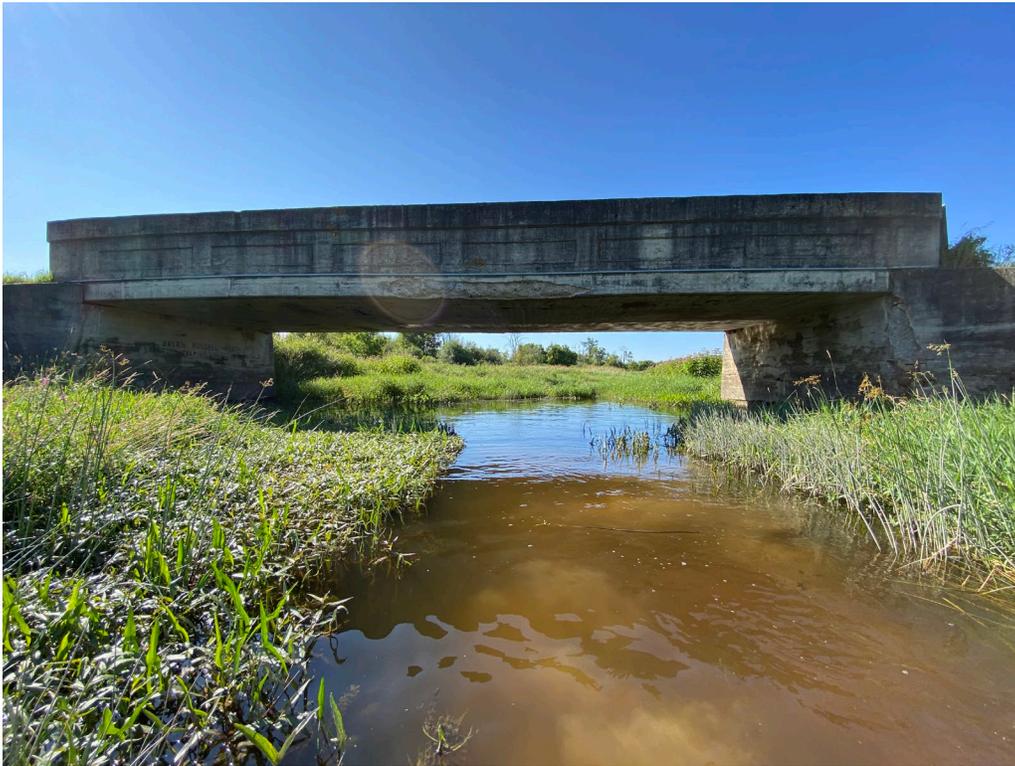
1.11 Structure No. 11

<u>Structure Name:</u>	Bridge 11	2023 BCI =56.95
<u>Road Name:</u>	15th Sideroad	
<u>Location:</u>	Concession 6, Lot 15	
<u>Structure Type:</u>	Through Girder (Concrete)	
<u>Number of Spans:</u>	1	<u>Span Lengths:</u> 15.2 m
<u>Overall Structure Width:</u>	6.2 m	<u>Roadway Width:</u> 4.6 m
<u>Year of Construction:</u>	1900 (Estimated)	<u>Current Load Limit:</u> 12 tonnes

Rehabilitation	Replacement
Estimated Capital Works Timelines (Years):	0.0	0.0

Recommendation:	Structure replacement is recommended as soon as possible.
------------------------	--

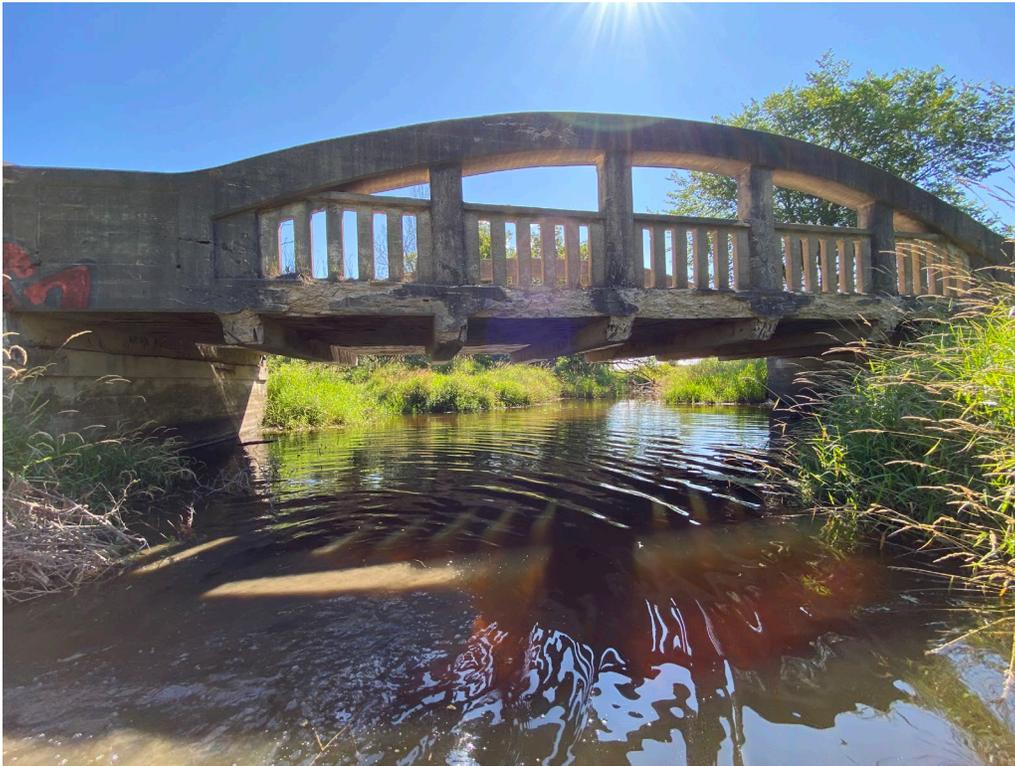
1.12 Structure No. 12

<u>Structure Name:</u>	Bridge 12	2023 BCI =65.75
<u>Road Name:</u>	6th Line	
<u>Location:</u>	Concessions 5 & 6, Lot 15	
<u>Structure Type:</u>	Arch (Concrete)	
<u>Number of Spans:</u>	1	<u>Span Lengths:</u> 15.2 m
<u>Overall Structure Width:</u>	6.63 m	<u>Roadway Width:</u> 5.5 m
<u>Year of Construction:</u>	1910 (Estimated)	<u>Current Load Limit:</u> 12 tonnes

Rehabilitation	Replacement
Estimated Capital Works Timelines (Years):	4.8	15.7

Recommendation:	Major Rehabilitation is recommended within 5 years.
------------------------	--

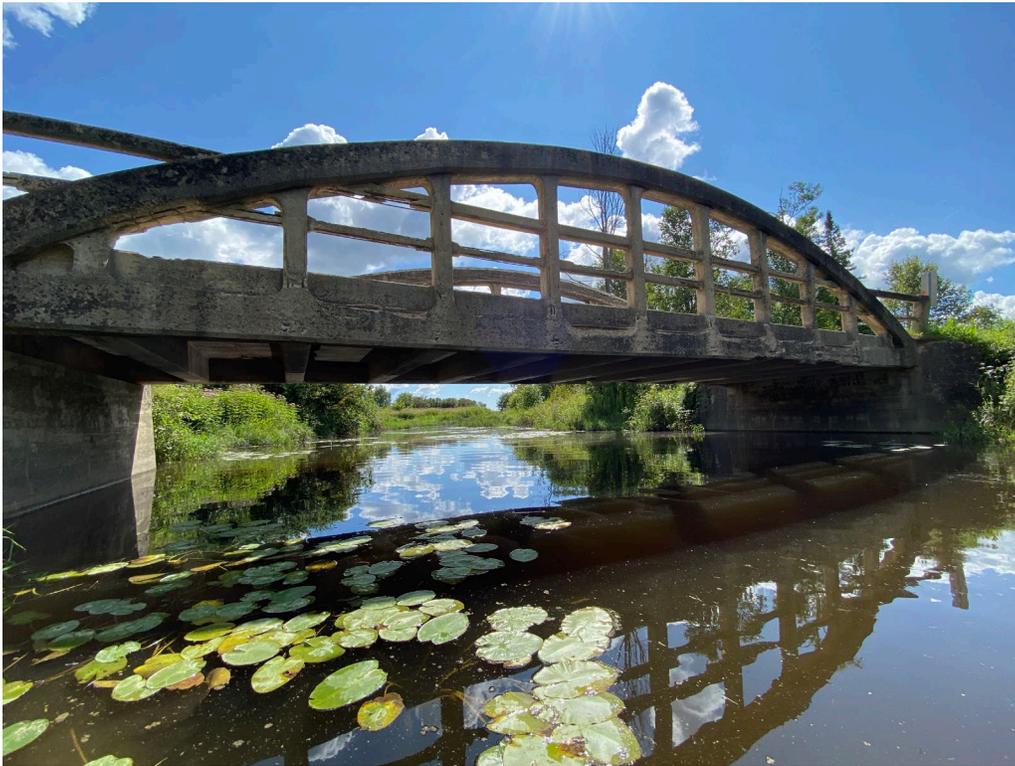
1.13 Structure No. 13

<u>Structure Name:</u>	Bridge 13	2023 BCI =58.93
<u>Road Name:</u>	6th Line	
<u>Location:</u>	Concession 5 & 6, Lot 16	
<u>Structure Type:</u>	Arch (Concrete)	
<u>Number of Spans:</u>	1	<u>Span Lengths:</u> 15.2 m
<u>Overall Structure Width:</u>	5.02 m	<u>Roadway Width:</u> 5 m
<u>Year of Construction:</u>	1910 (Estimated)	<u>Current Load Limit:</u> 14 tonnes

Rehabilitation	Replacement
Estimated Capital Works Timelines (Years):	0.0	9.5

Recommendation:	Forgo rehabilitation and replace structure within 9 years.
------------------------	---

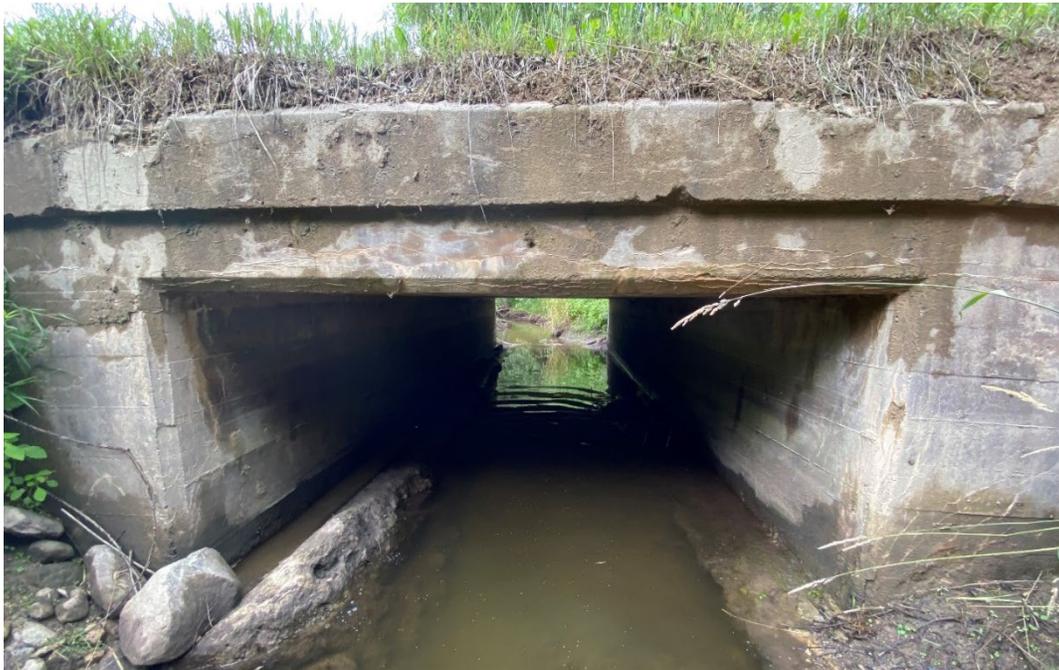
1.3 Structure No. 23

The north footing is fully separated from the structure limiting its ability to properly transfer loads to the founding soils. The footing also appears to be rotating up/into the culvert. Consideration could be given to investigating the feasibility of installing struts as a temporary repair measure if replacement is not an option in the near future.

Recommendation: Structure replacement is recommended in 1-5 years.

Maintenance Need	Comments	Estimated Cost
Hazard Signs	Install 2 additional signs at leaving ends and raise existing signs	\$500
Erosion Control	Place rock protection in all quadrants	\$2,000
Maintenance Needs Total		\$2,500

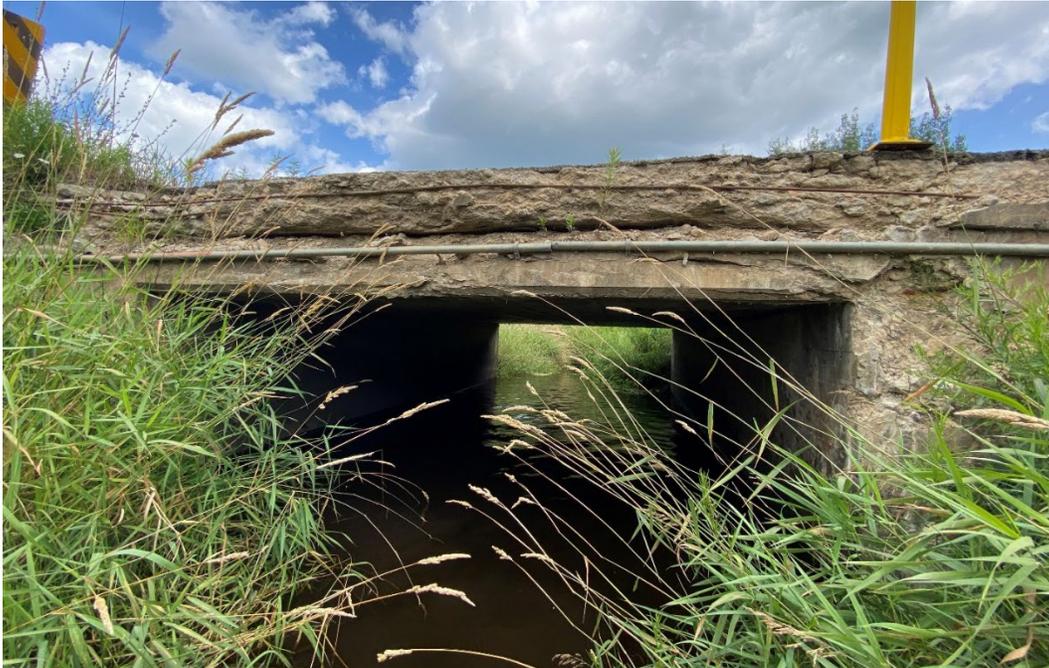
1.4 Structure No. 24

Structure 24 is generally in fair condition with some severe defects noted. There are wide cracks all corners of the abutments. Delaminations and spalls with exposed corroded rebar are present in the soffit. The west wingwalls and exterior soffit are severely disintegrated and delaminated. Alternatives such as constructing a structural slab could be considered as a cost-effective option.

Recommendation:	Structure replacement is recommended in 6-10 years.
------------------------	--

Maintenance Need	Comments	Estimated Cost
Hazard Signs	Raise existing signs	\$250
Erosion Control	Place rock protection in SW and NE quadrants	\$1,000
Maintenance Needs Total		\$1,250

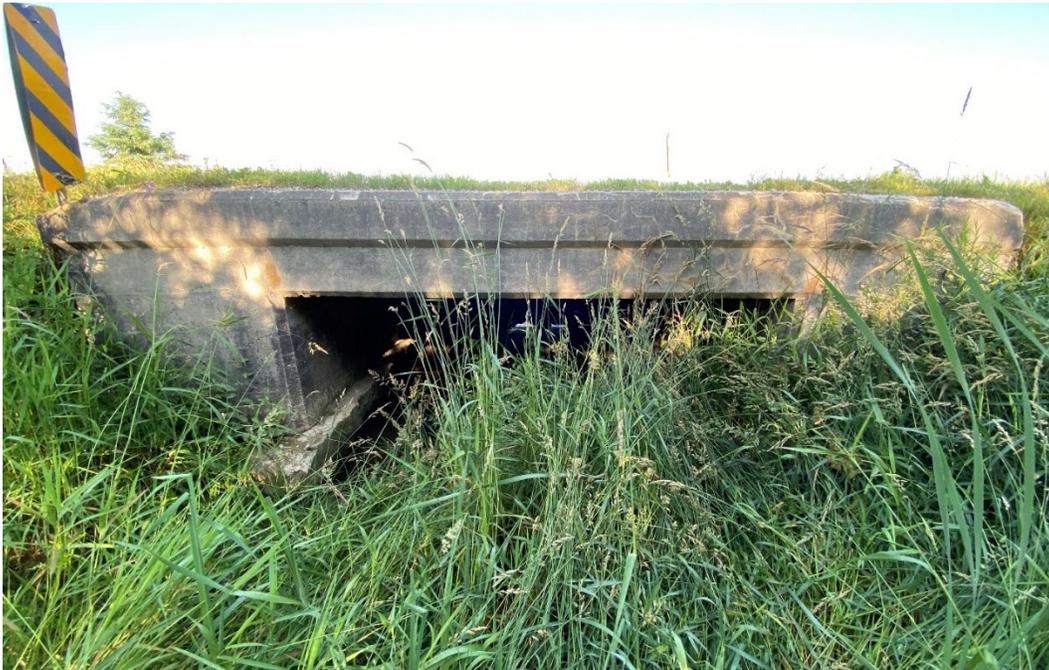
1.5 Structure No. 25

Structure 25 is generally in good condition with only minor defects noted. The exposed footings are severely eroded.

Recommendation: No Capital Work estimated to be required within 10 years.

Maintenance Need	Comments	Estimated Cost
Hazard Signs	Install 2 additional signs at leaving ends and raise east sign	\$500
Erosion Protection	Place rock protection in SW and SE quadrants	\$1,000
Maintenance Needs Total		\$1,500
Estimated Construction Cost		\$450,000

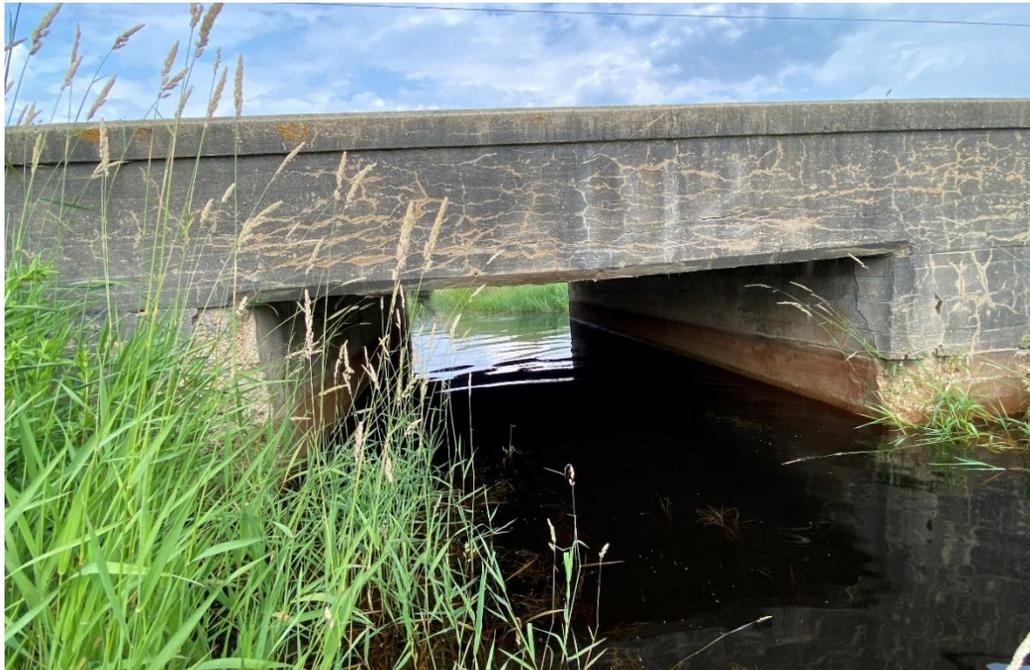
1.6 Structure No. 26

Structure 26 is generally in fair condition with some severe defects noted. There are wide cracks at all corners of the abutments (except NE). Delaminations and spalls with exposed corroded rebar are present in the soffit. The west wingwalls are severely disintegrated and delaminated.

Recommendation:	Structure replacement is recommended in 6-10 years.
------------------------	--

Maintenance Need	Comments	Estimated Cost
Hazard Signs	Install 2 additional signs at leaving ends and raise existing signs	\$500
Erosion Control	Place rock protection in all quadrants	\$2,000
Maintenance Needs Total		\$2,500
Estimated Construction Cost		\$550,000

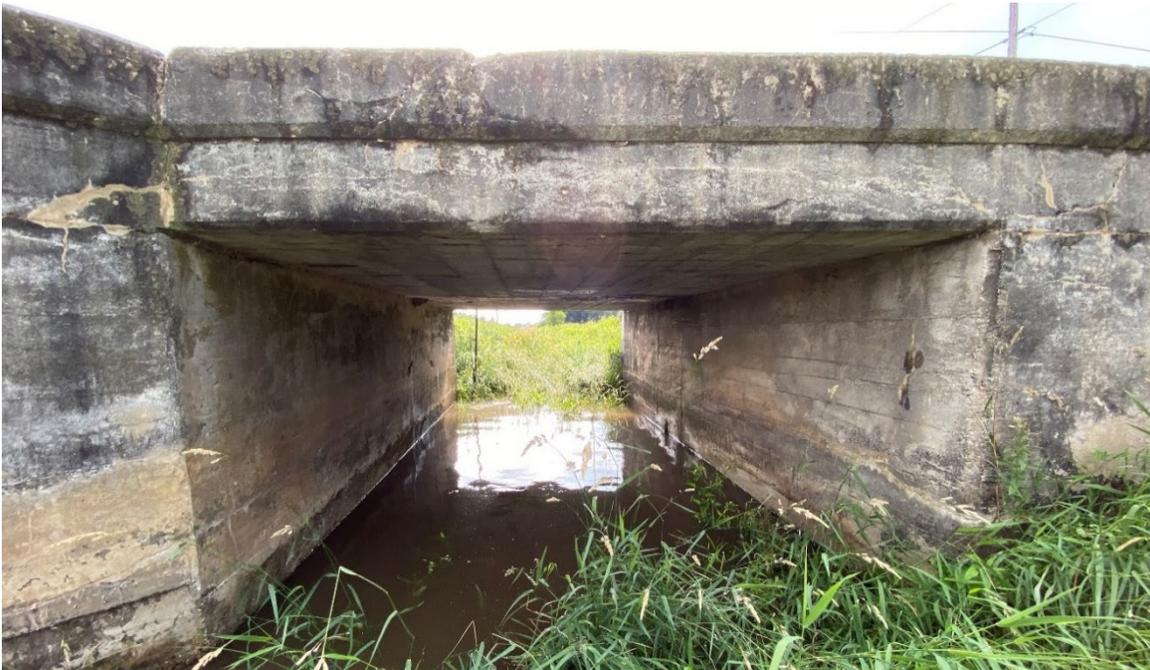
1.7 Structure No. 27

Structure 27 is generally in fair to good condition with some severe defects noted. Delaminations and spalls with exposed corroded rebar are present in the soffit, which are generally a result of low concrete cover. The north abutment has a full height wide crack.

Recommendation:	No Capital Work estimated to be required within 10 years.
------------------------	--

Maintenance Need	Comments	Estimated Cost
Hazard Signs	Install 2 additional signs at approach ends and raise east signs	\$500
Maintenance Needs Total		\$2,500
Estimated Construction Cost		\$450,000

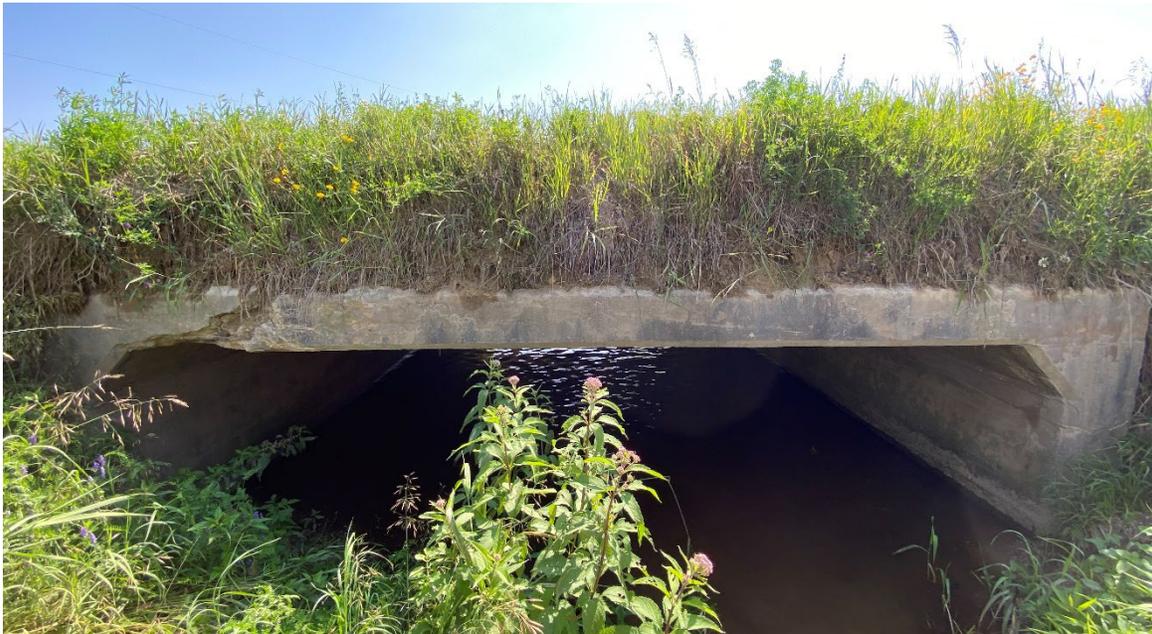
1.8 Structure No. 29

Structure 29 is generally in fair to good condition with some severe defects noted. Delaminations and spalls with exposed corroded rebar are present in the soffit, which are generally a result of low concrete cover.

Recommendation: No Capital Work estimated to be required within 10 years.

Maintenance Need	Comments	Estimated Cost
Hazard Signs	Install 2 additional signs at leaving ends and raise existing signs	\$500
Erosion Control	Place rock protection in all quadrants	\$2,000
Roadwork	Remove excessive fill if deemed necessary after Structure Evaluation	\$1,500
Maintenance Needs Total		\$4,000
Estimated Construction Cost		\$600,000

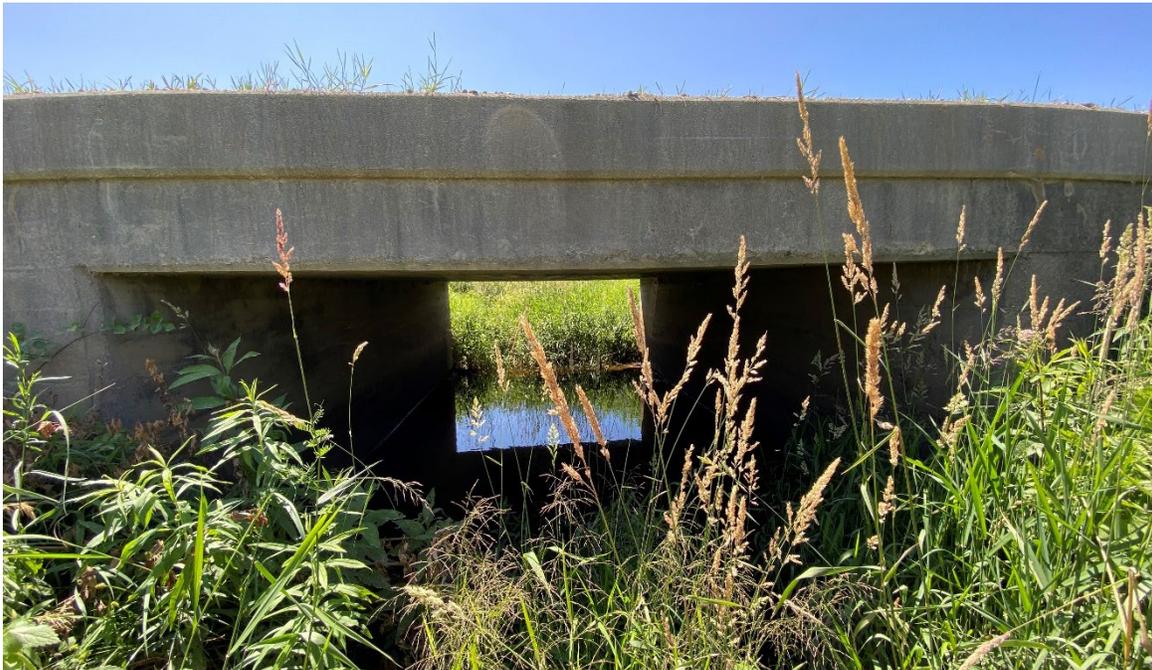
1.9 Structure No. 30

Structure 30 is generally in fair to good condition with some severe defects noted. Delaminations and spalls with exposed corroded rebar are present in the soffit. The exposed footings are severely eroded.

Recommendation:	No Capital Work estimated to be required within 10 years.
------------------------	--

Maintenance Need	Comments	Estimated Cost
Hazard Signs	Install 2 additional signs at leaving ends and raise existing signs	\$500
Erosion Control	Place rock protection in NE and NW quadrants	\$1,000
Maintenance Needs Total		\$1,500
Estimated Construction Cost		\$500,000

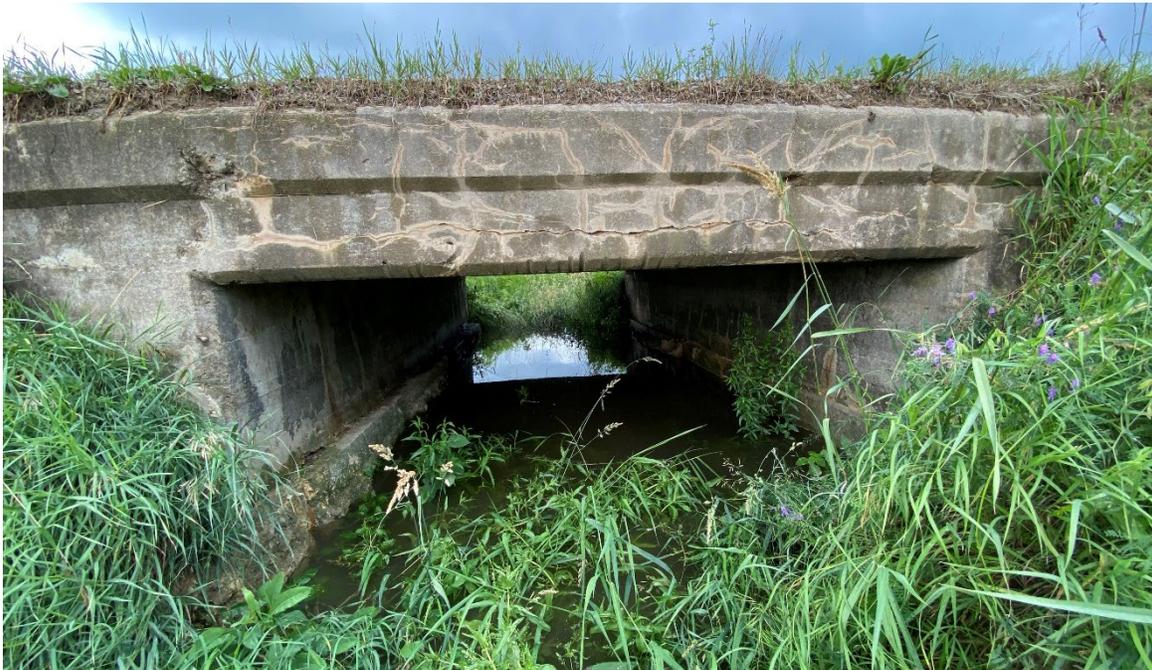
1.10 Structure No. 31

Structure 31 is generally in fair to good condition with some severe defects noted. Delaminations and spalls with exposed corroded rebar are present in the soffit. The west exterior soffit is severely disintegrated and delaminated. The exposed footings are severely eroded.

Recommendation:	No Capital Work estimated to be required within 10 years.
------------------------	--

Maintenance Need	Comments	Estimated Cost
Hazard Signs	Install 2 additional signs at leaving ends and raise existing signs	\$500
Erosion Control	Place rock protection in NE and SW quadrants	\$1,000
Maintenance Needs Total		\$1,500

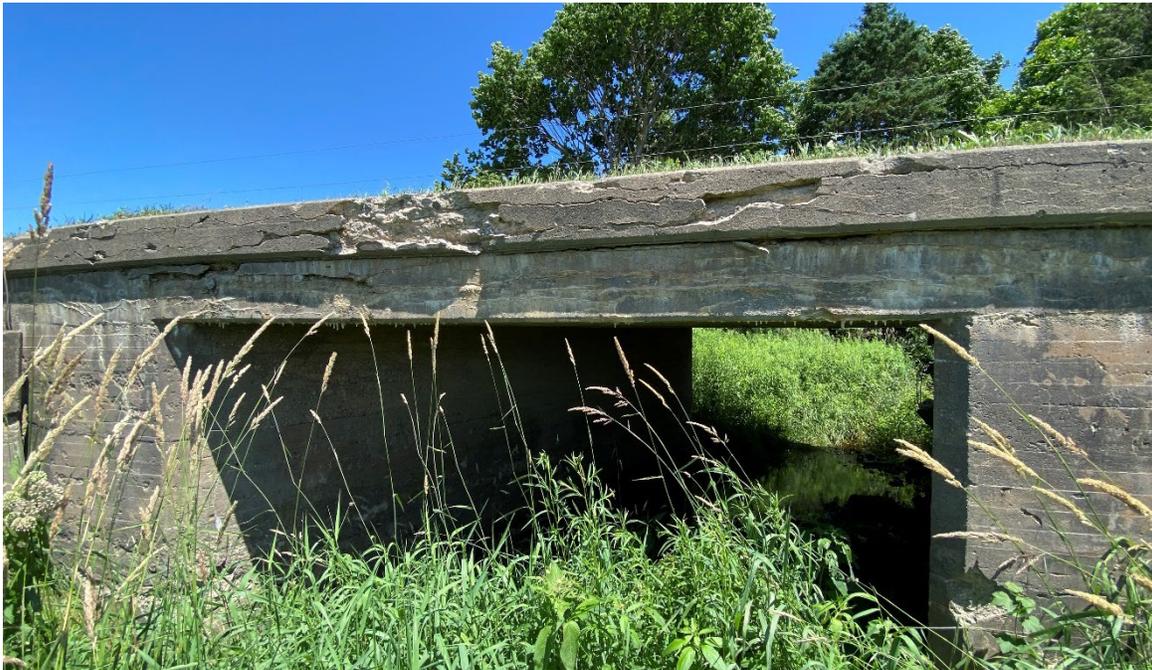
1.12 Structure No. 33

Structure 33 is generally in fair condition with some severe defects noted. Delaminations and spalls with exposed corroded rebar are present in the soffit. The curbs are severely disintegrated. The exposed footings are severely eroded.

Recommendation:	No Capital Work estimated to be required within 10 years.
------------------------	--

Maintenance Need	Comments	Estimated Cost
Hazard Signs	Install 2 additional signs at leaving ends and raise existing signs	\$500
Erosion Control	Place rock protection in NE and SW quadrants	\$1,000
Maintenance Needs Total		\$1,500
Estimated Construction Cost		\$550,000

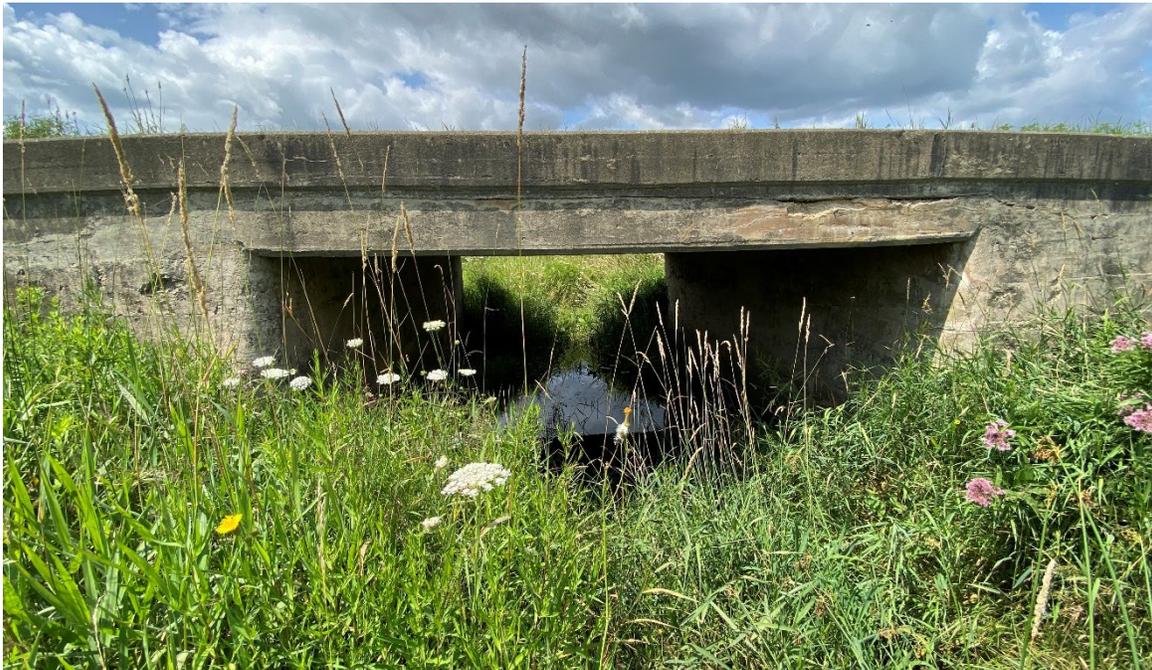
1.13 Structure No. 34

Structure 34 is generally in fair condition with some severe defects noted. Delaminations and spalls with exposed corroded rebar are present in the soffit. The west wingwalls and west end of the abutments are severely disintegrated and delaminated.

Recommendation: No Capital Work estimated to be required within 10 years.

Maintenance Need	Comments	Estimated Cost
Hazard Signs	Install 2 additional signs at leaving ends	\$500
Erosion Control	Place rock protection in all quadrants	\$2,000
Maintenance Needs Total		\$2,500
Estimated Construction Cost		\$550,000

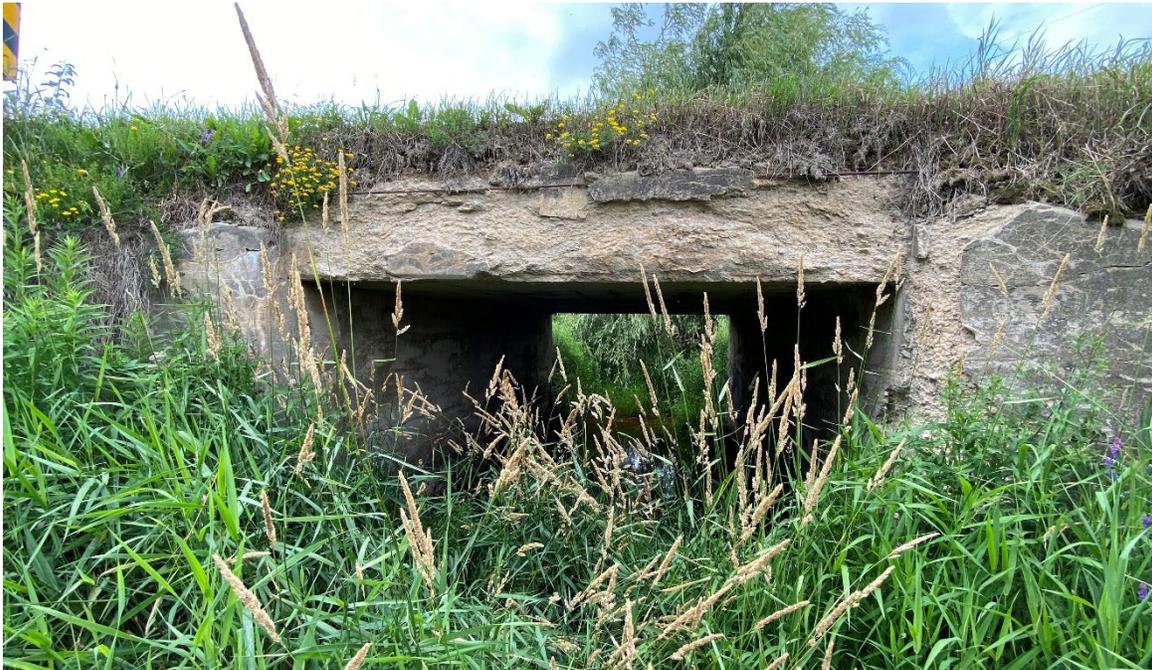
1.14 Structure No. 35

Structure 35 is generally in fair condition with some severe defects noted. Delaminations and spalls with exposed corroded rebar are present in the soffit. The south wingwalls and exterior soffit are severely disintegrated and delaminated. Severe erosion is present along the waterline.

Recommendation:	No Capital Work estimated to be required within 10 years.
------------------------	--

Maintenance Need	Comments	Estimated Cost
Hazard Signs	Install 2 additional signs at leaving ends and raise existing signs	\$500
Roadwork	Remove excessive fill	\$1,000
Maintenance Needs Total		\$1,500
Estimated Construction Cost		\$450,000

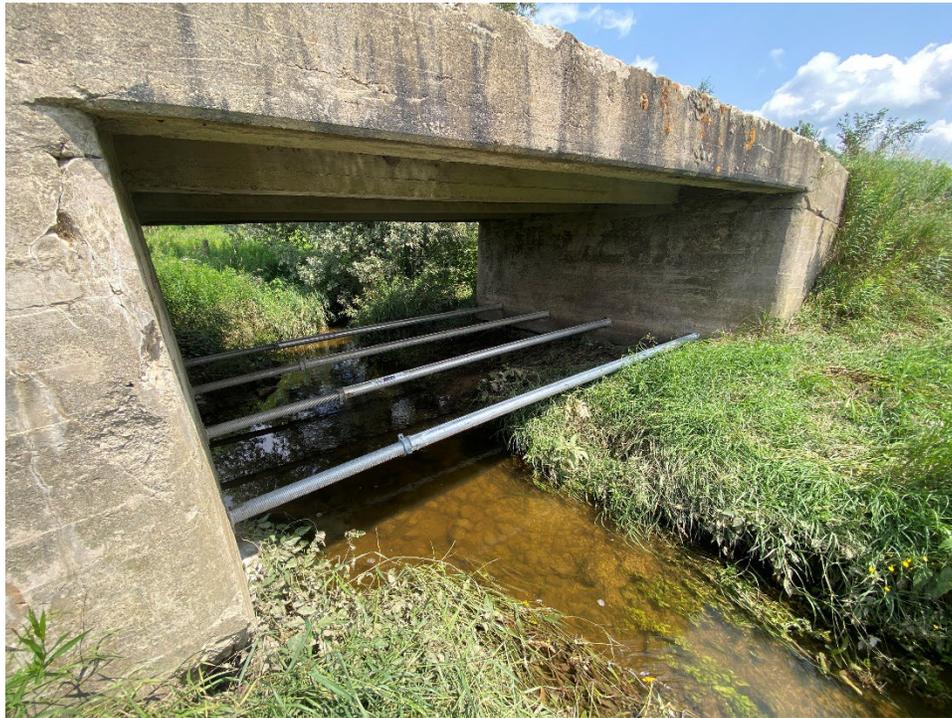
1.15 Structure No. 36

The east abutment is separating from the superstructure and rotating however struts were installed in 2023 installed to temporarily brace the structure. A restrictive 10 tonne load posting has also been placed on the structure to limit large vehicles from crossing the bridge. Closure of this structure should be considered if replacement cannot occur within one year.

Recommendation:	Structure replacement is recommended as soon as possible.
------------------------	--

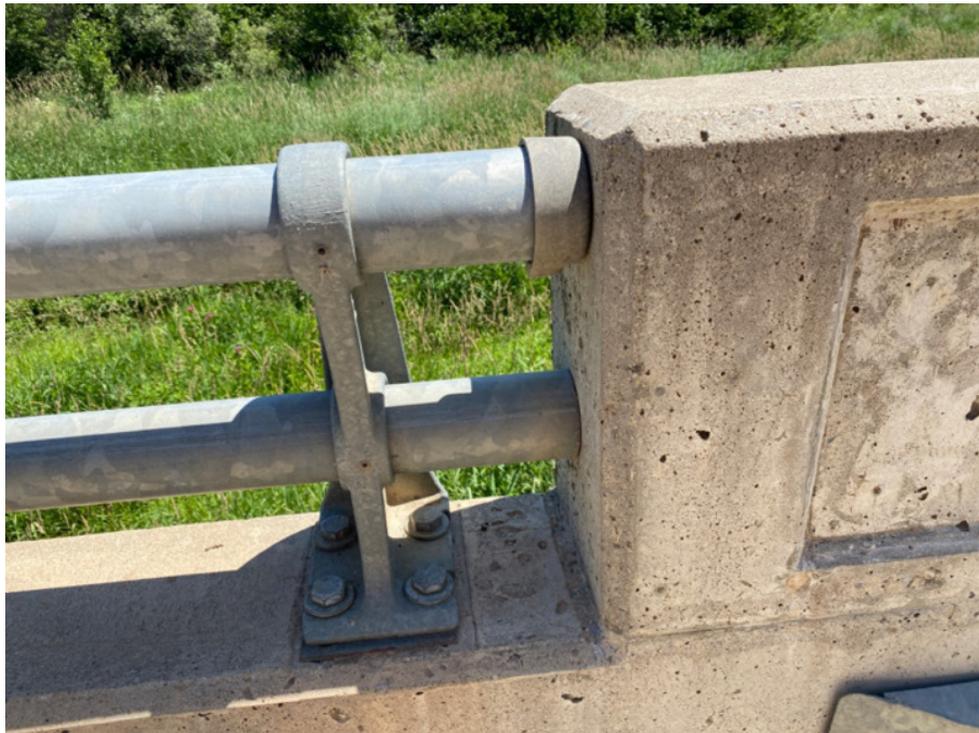
Hand Railings (South East)

| Missing end cap

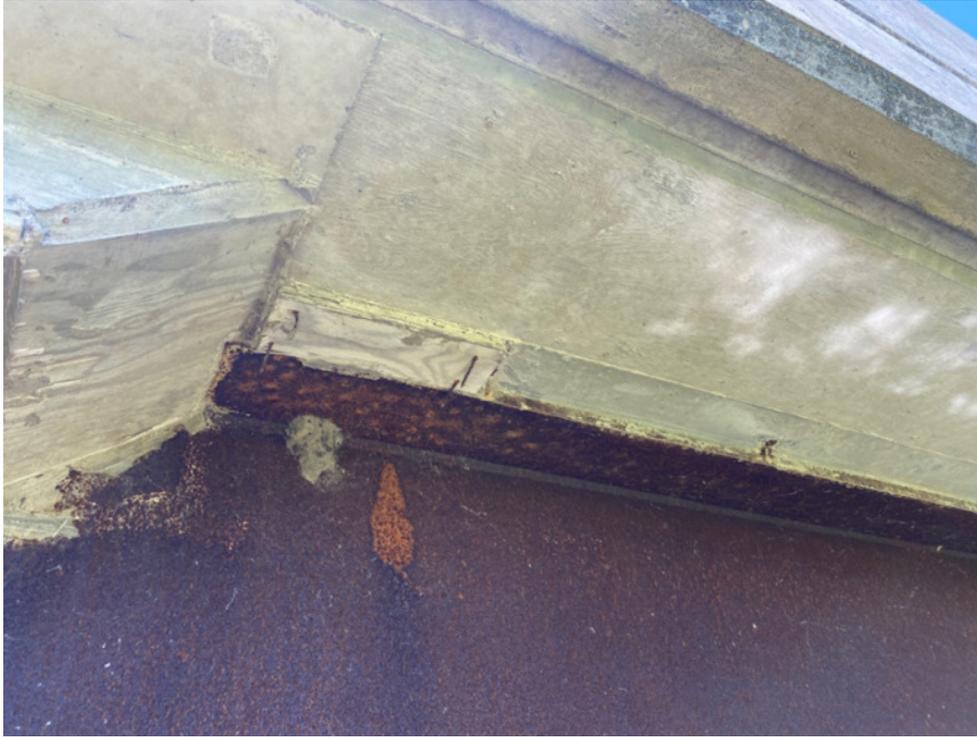
Soffit - Thin Slab - Ext (South East)

| Formwork left in place

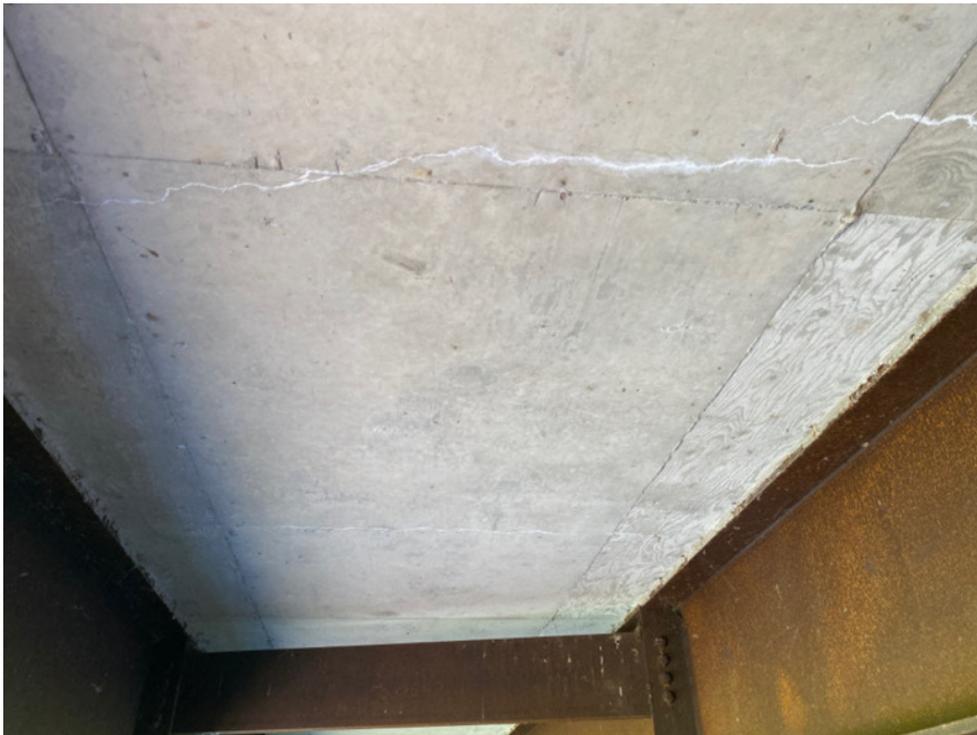
Soffit - Thin Slab - Int (East)

| Efflorescence staining

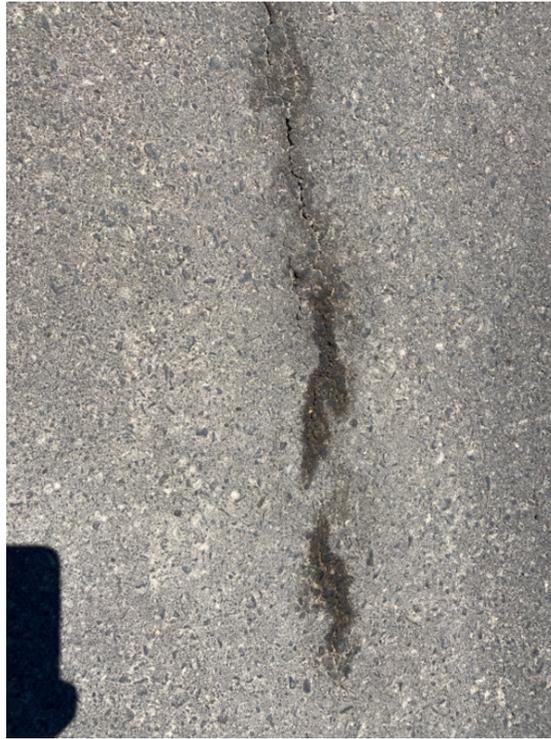
Deck Wearing Surface (North)

| Light cracking

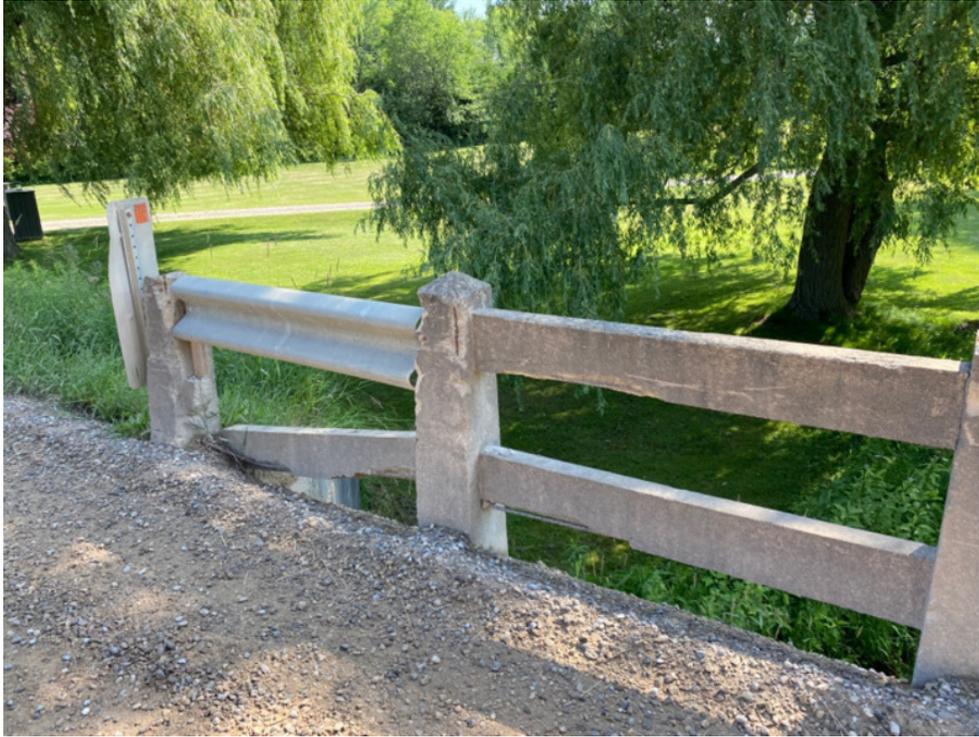
Railing System (East)

| Separation of railing from post

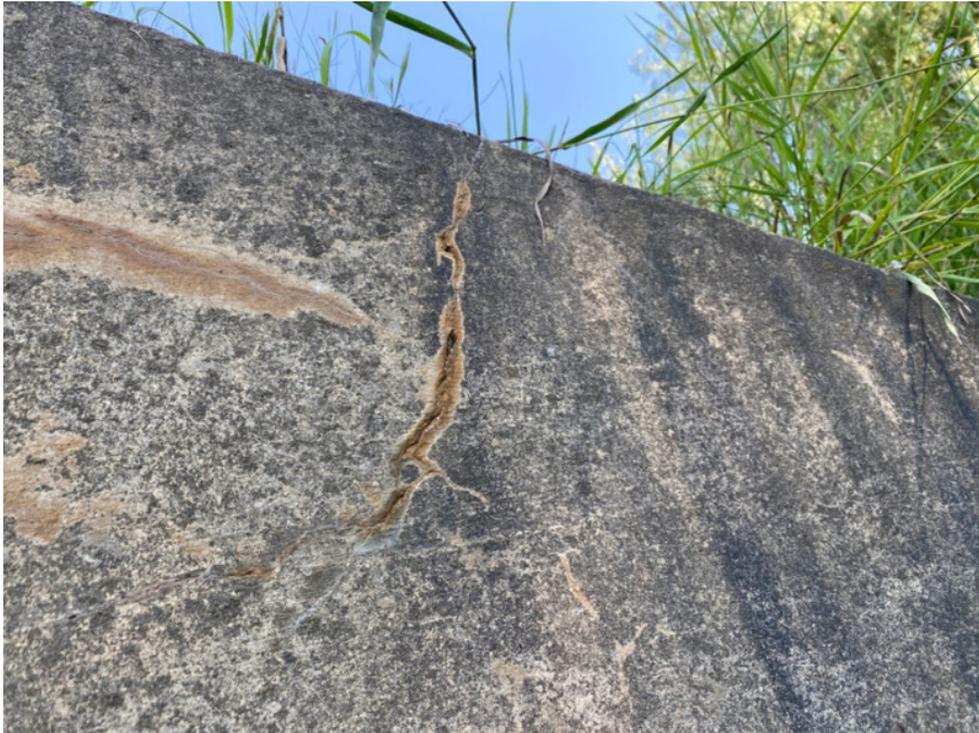
Wingwalls (North East)

| Wide crack

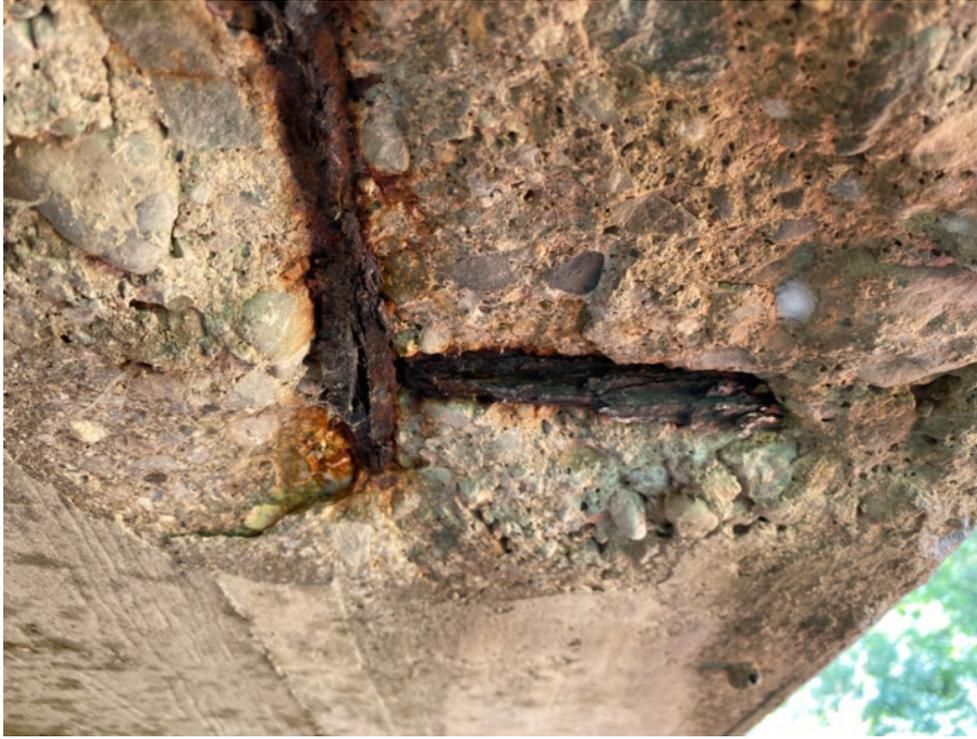
Soffit - Thin Slab - Ext (West)

| Section loss of exposed steel

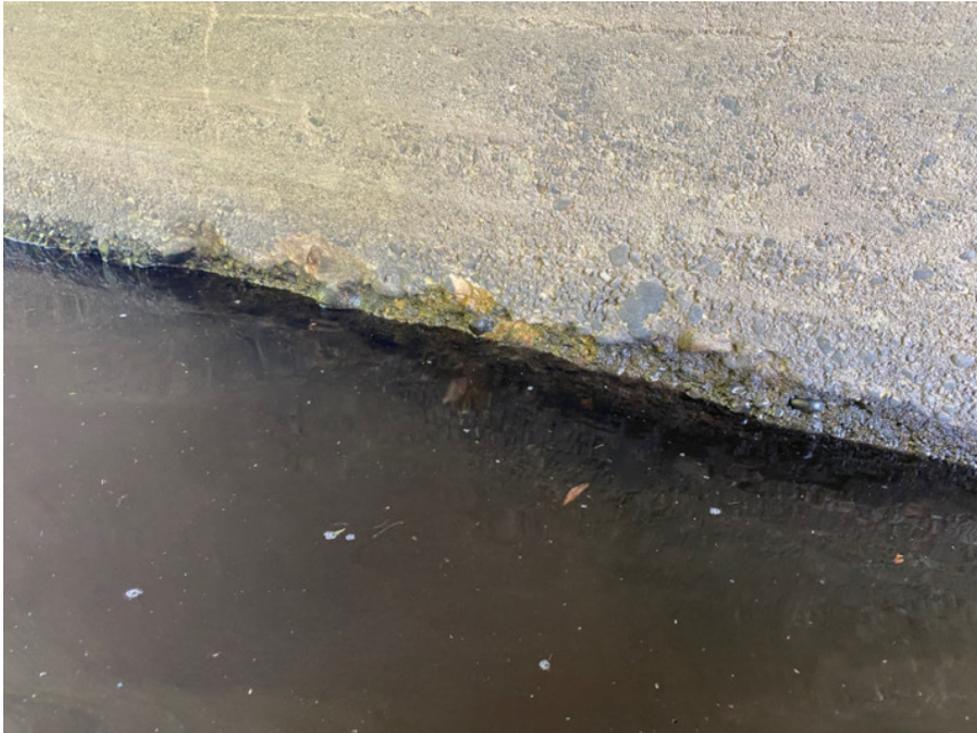
Abutment Walls (North)

| Severe erosion

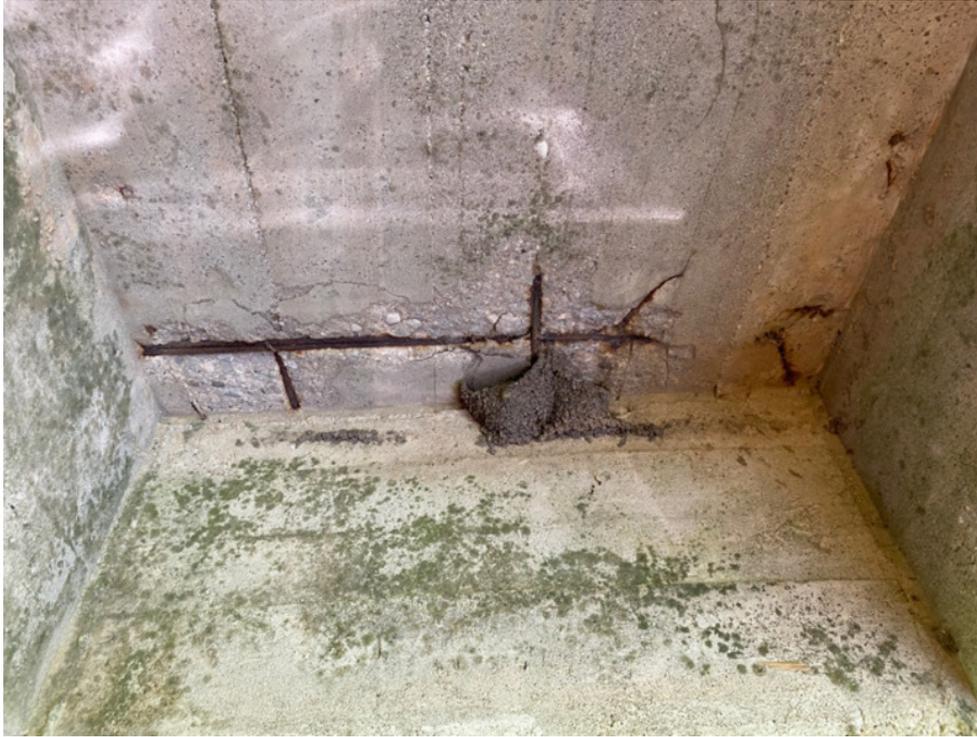
Soffit - Thin Slab - Int (North East)

| Spalls with exposed corroded rebar

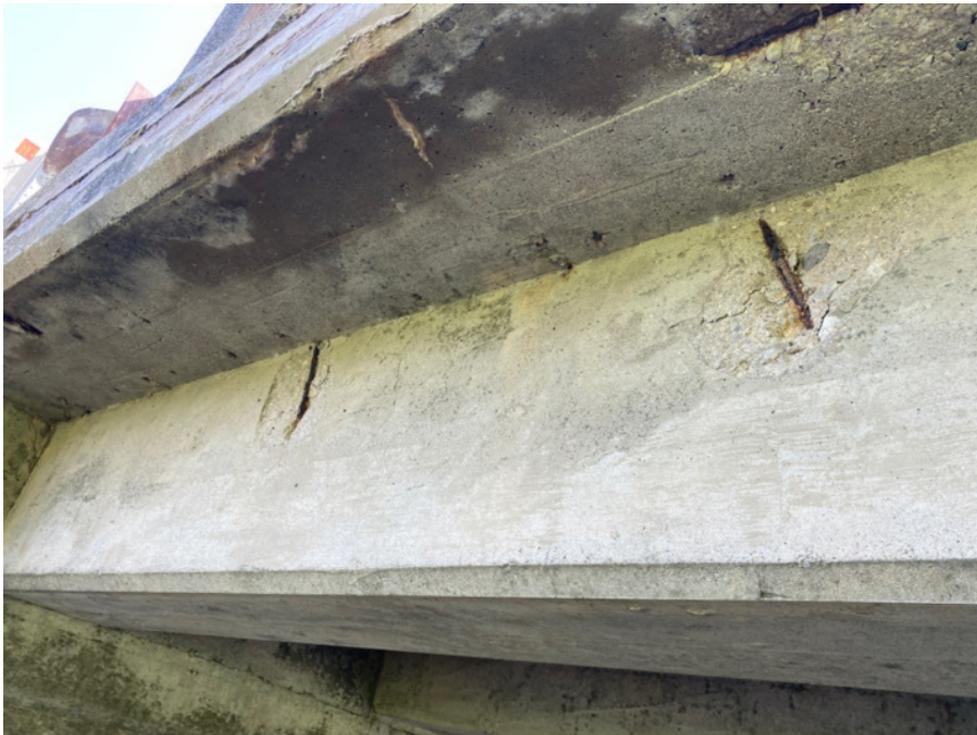
Girders - Middle (West)

| Spalls with exposed corroded rebar
