2023 OSIM Bridge Inspections Report

**Township of Amaranth
374028 6th Line
Amaranth, ON L9W 0M6**

**November 2023
300057065.0000**

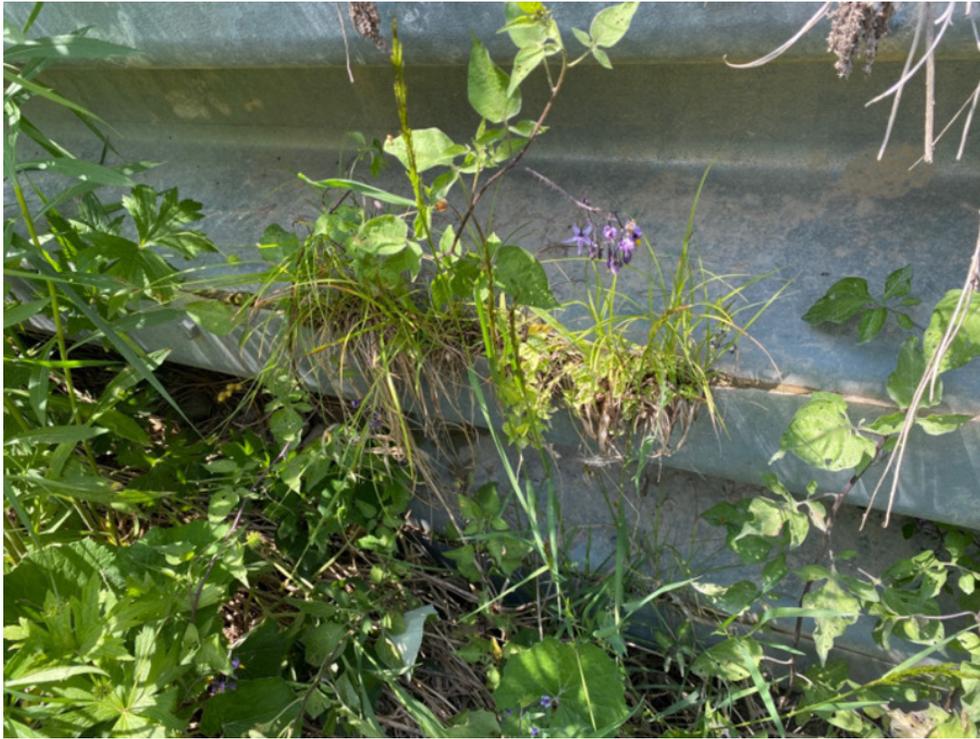
Wall (South East)

| Vegetation growing through wall

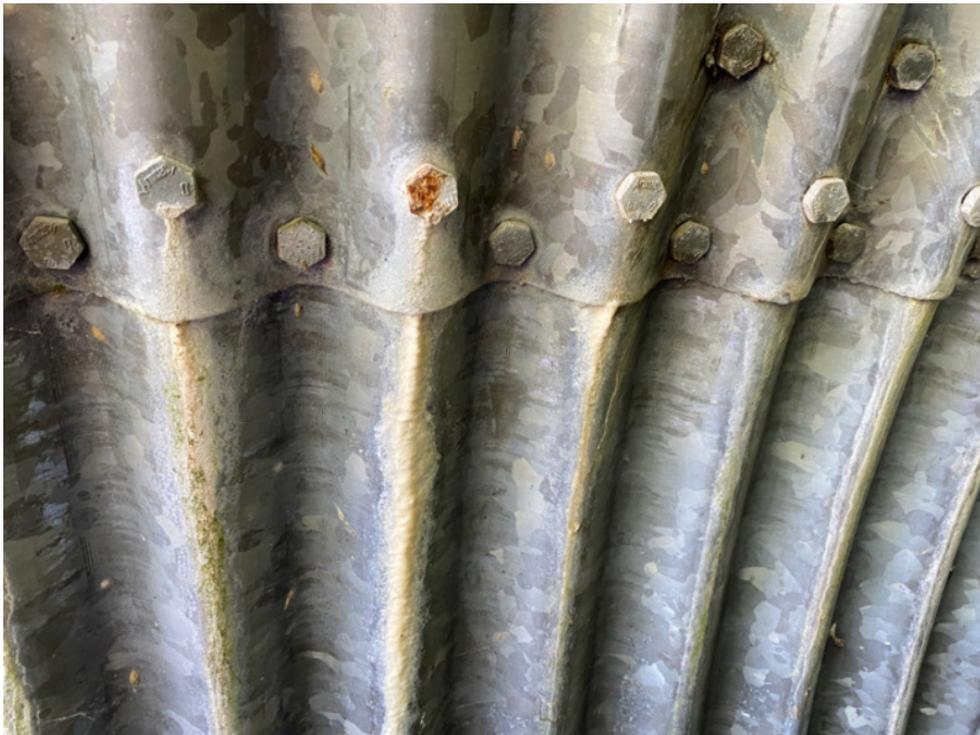
Barrels (South)

| Efflorescence

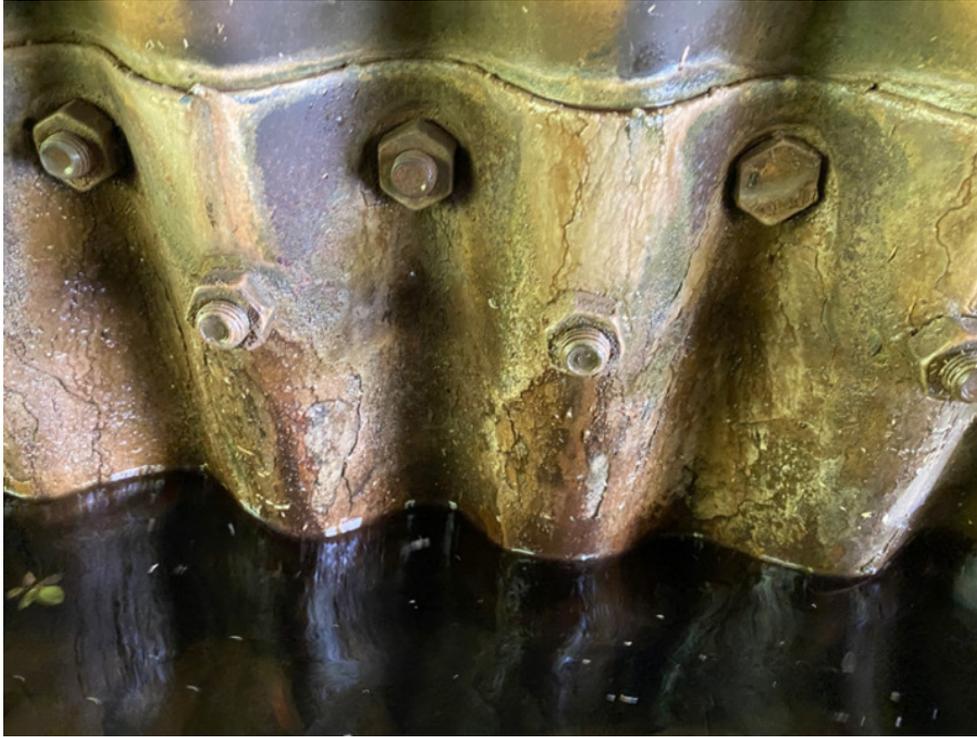
Barrels (North)

| Section loss

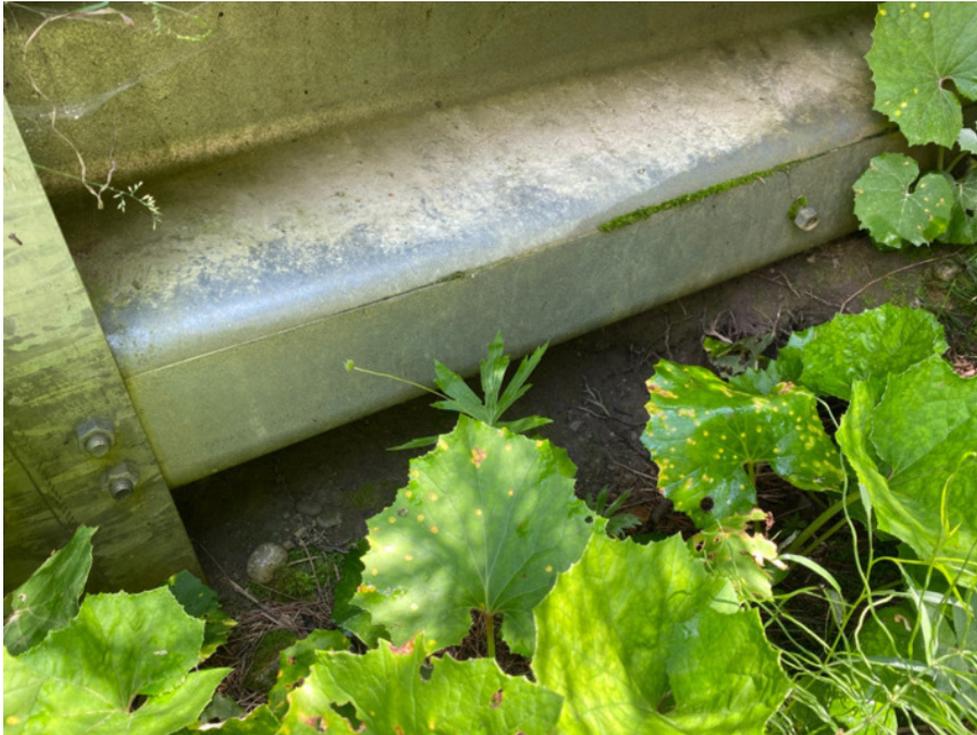
Wall (South West)

| Void under wall

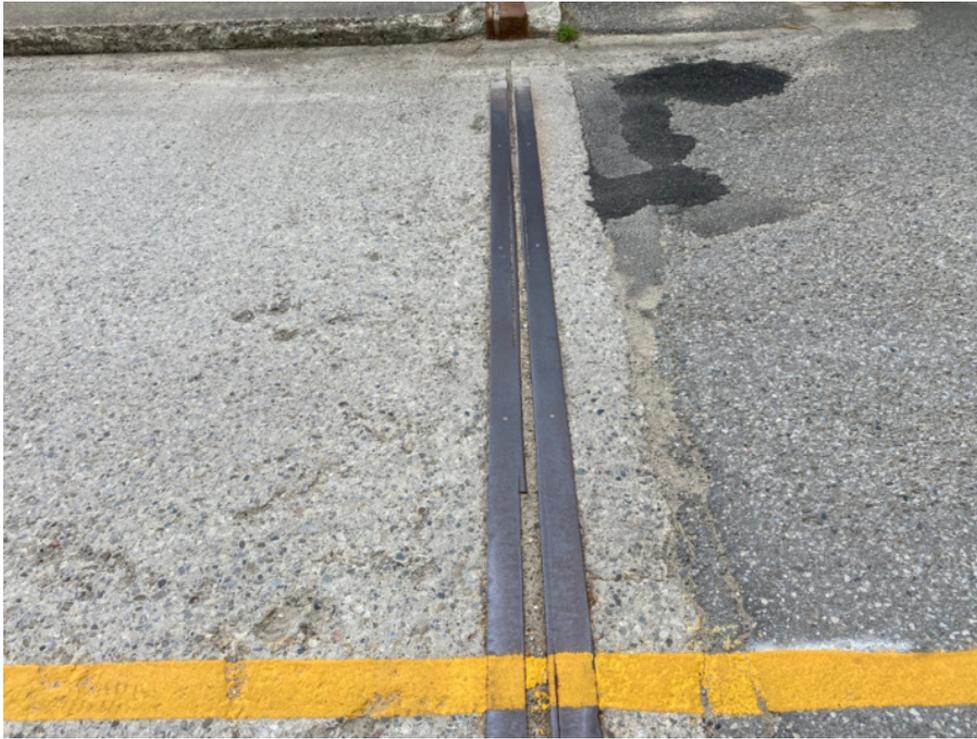
Armouring/Retaining Device (West)

| Missing and separated sections

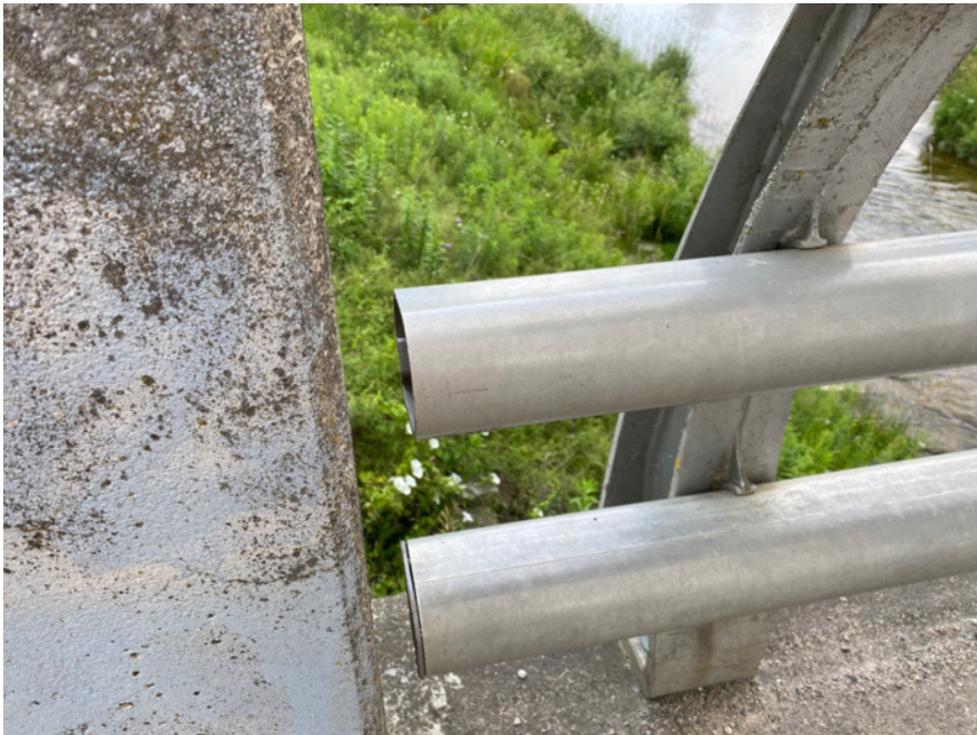
Hand Railings (North West)

| Missing end cap

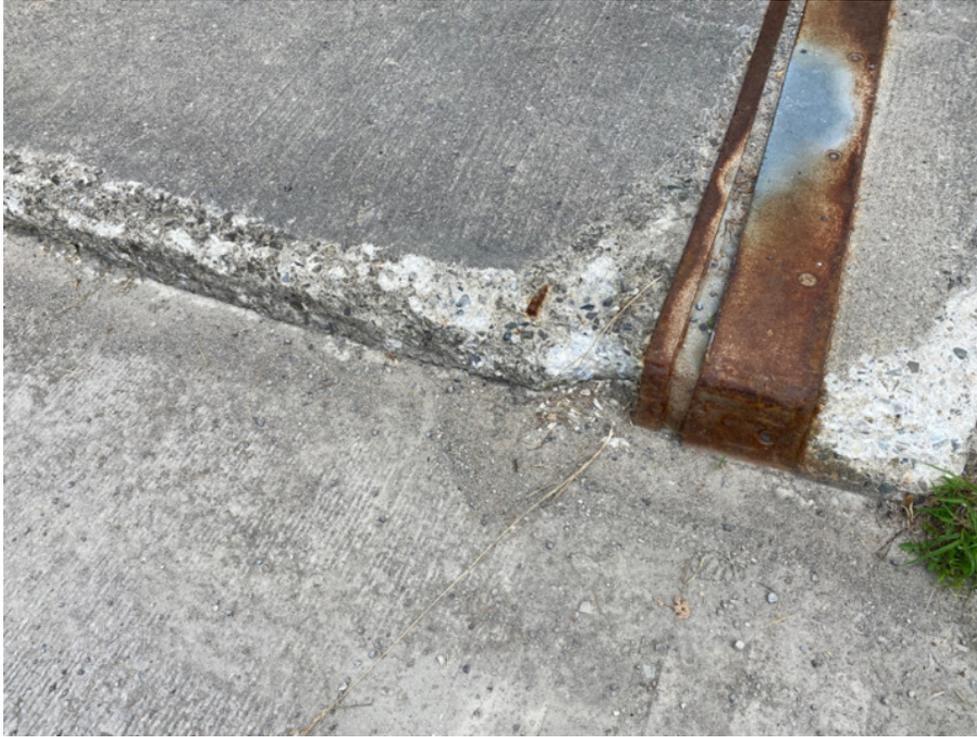
Sidewalk (South West)

| Spall with exposed corroded rebar

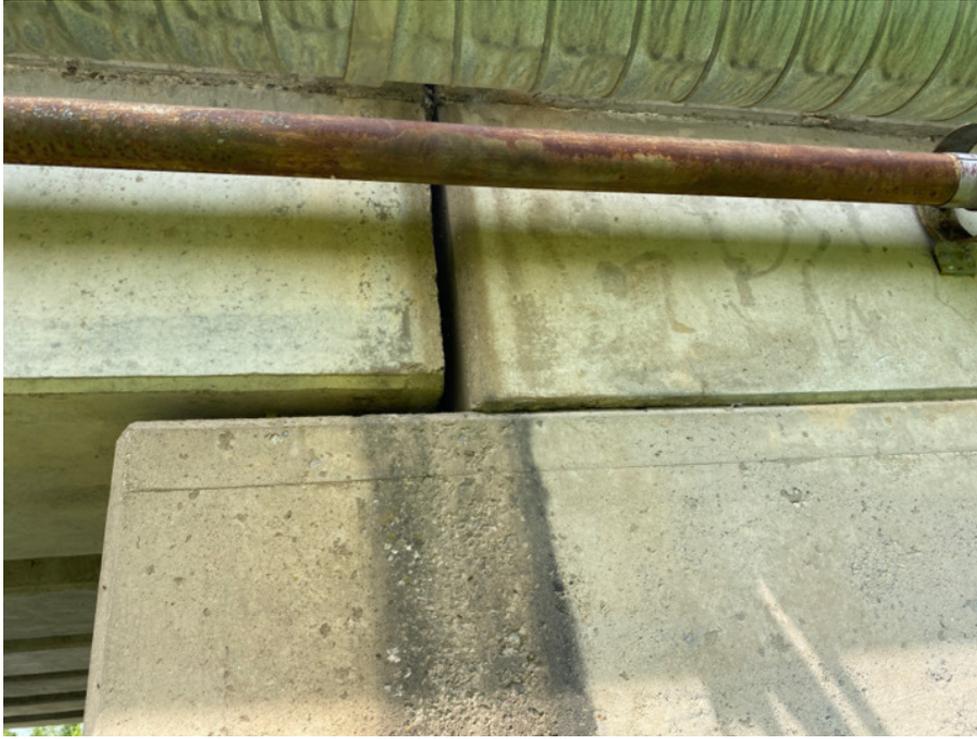
Wingwalls (South East)

| Moisture leakage from joint

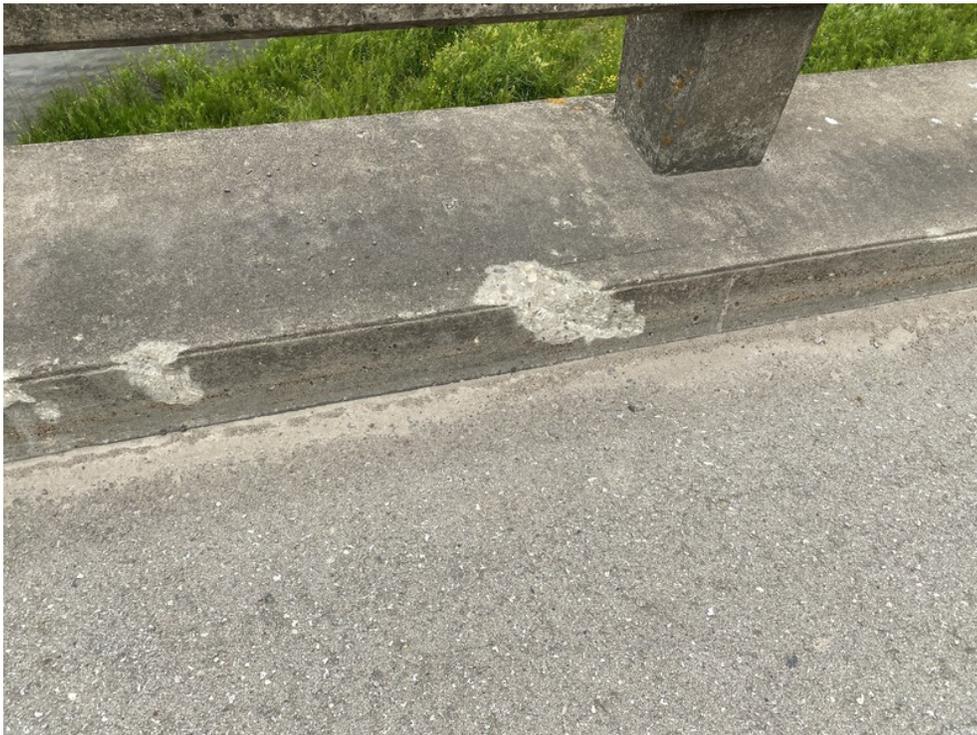
Curbs (North East)

| Small spall

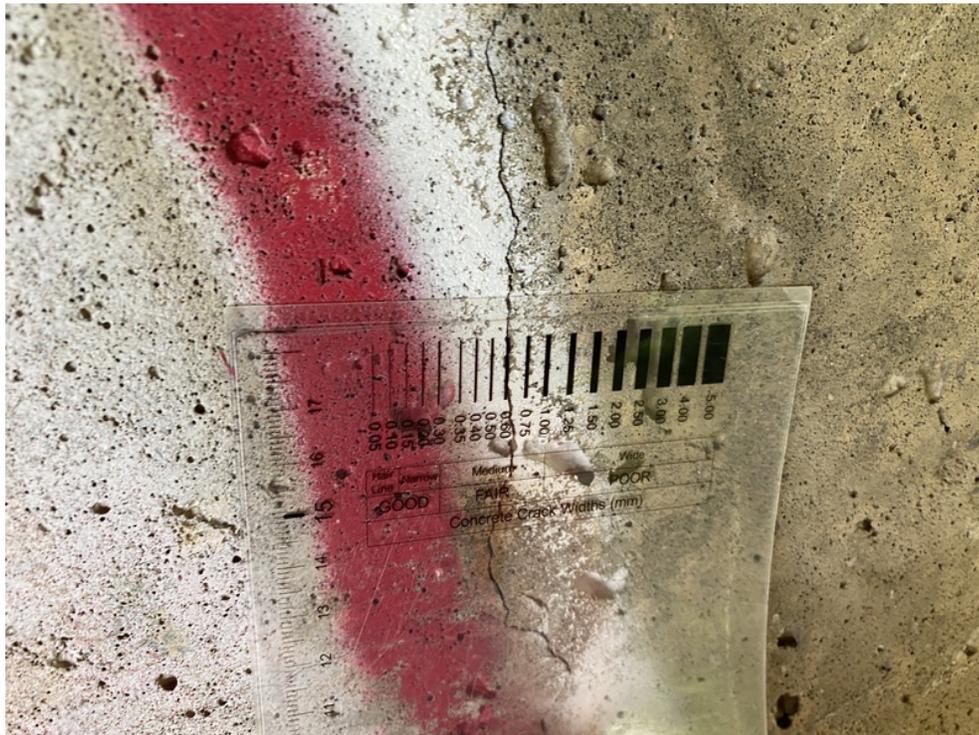
Abutment Walls (West)

| Medium crack

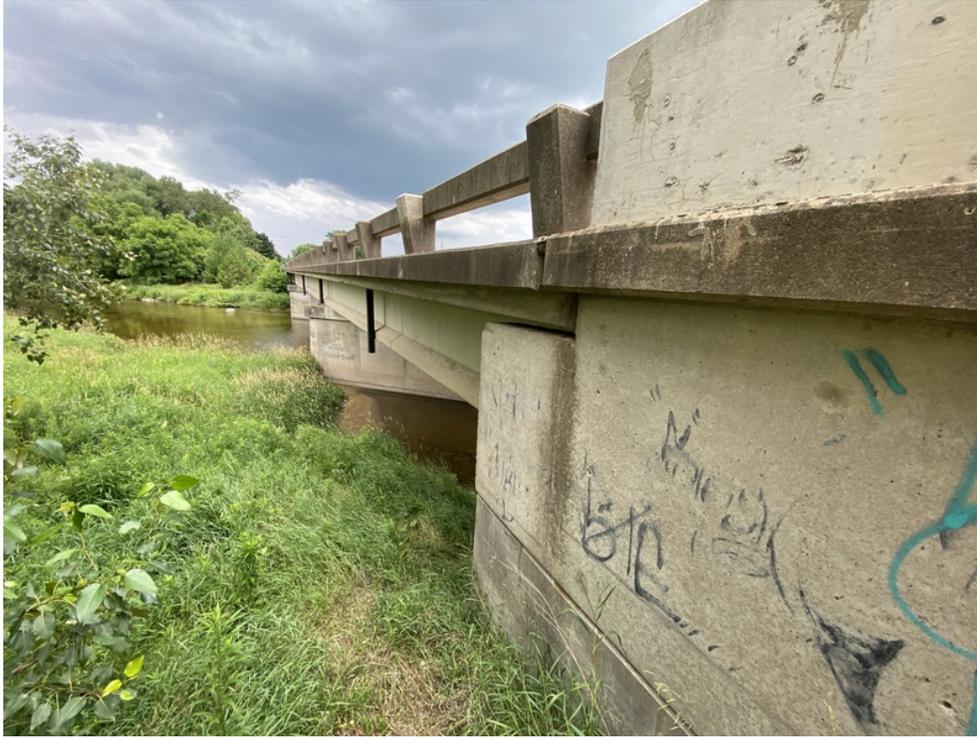
Seals / Sealants (South West)

| Evidence of water leakage

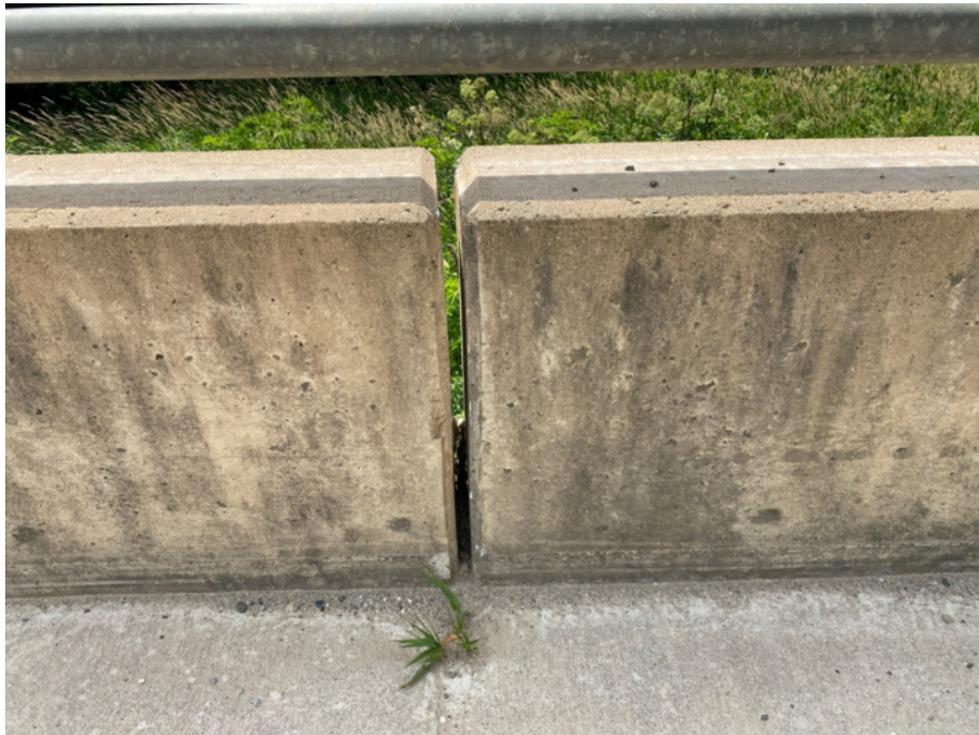
Barrier/Parapet Walls Interior (All Quadrants)

| Missing sealant

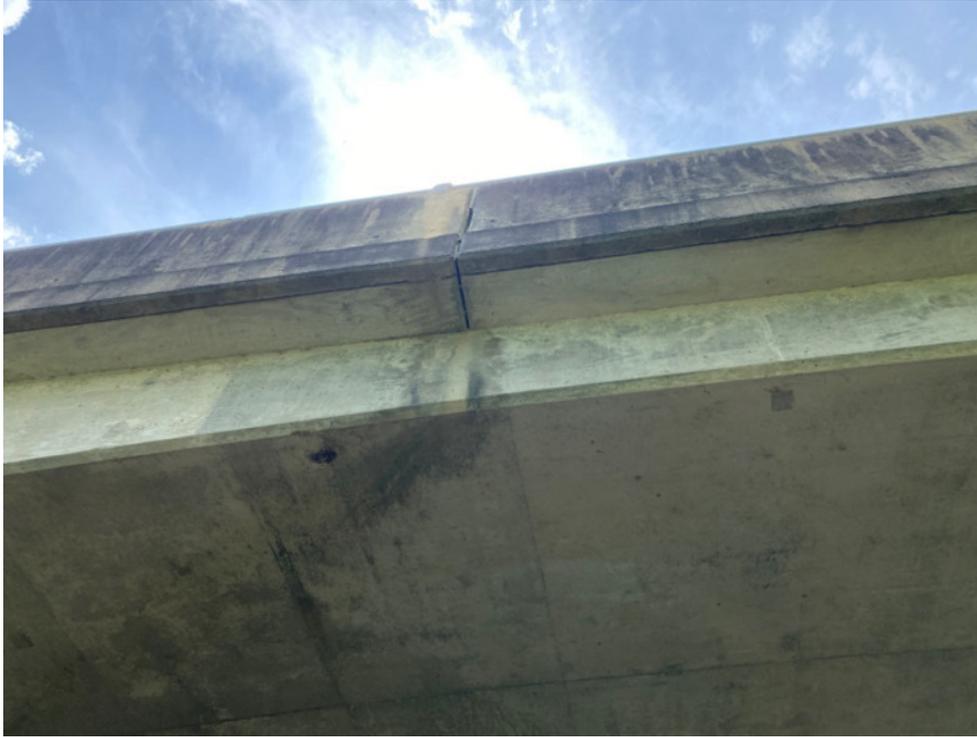
Soffit - Thin Slab - Ext (North)

| Water staining around parapet joints

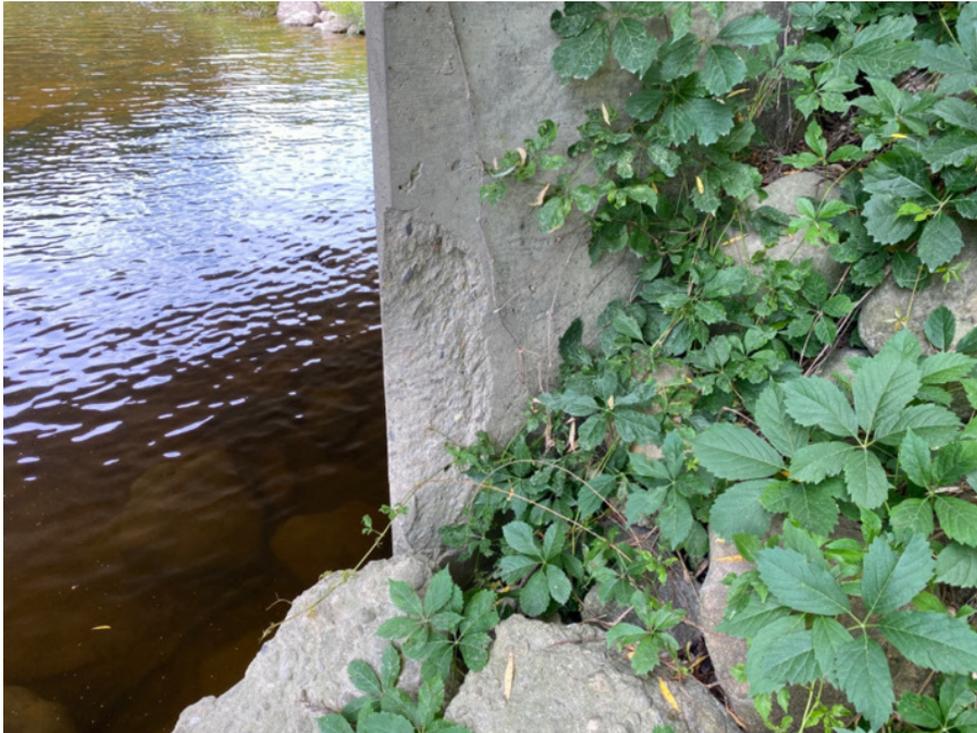
Wingwalls (North West)

| Spall

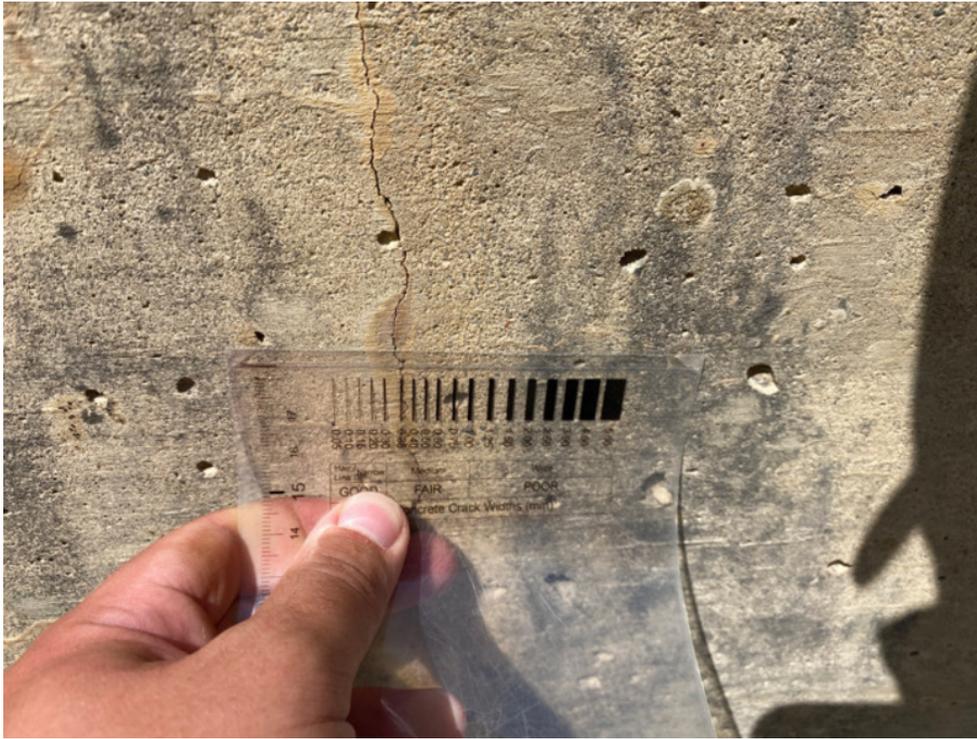
Barrier/Parapet Walls Interior (West)

Medium crack

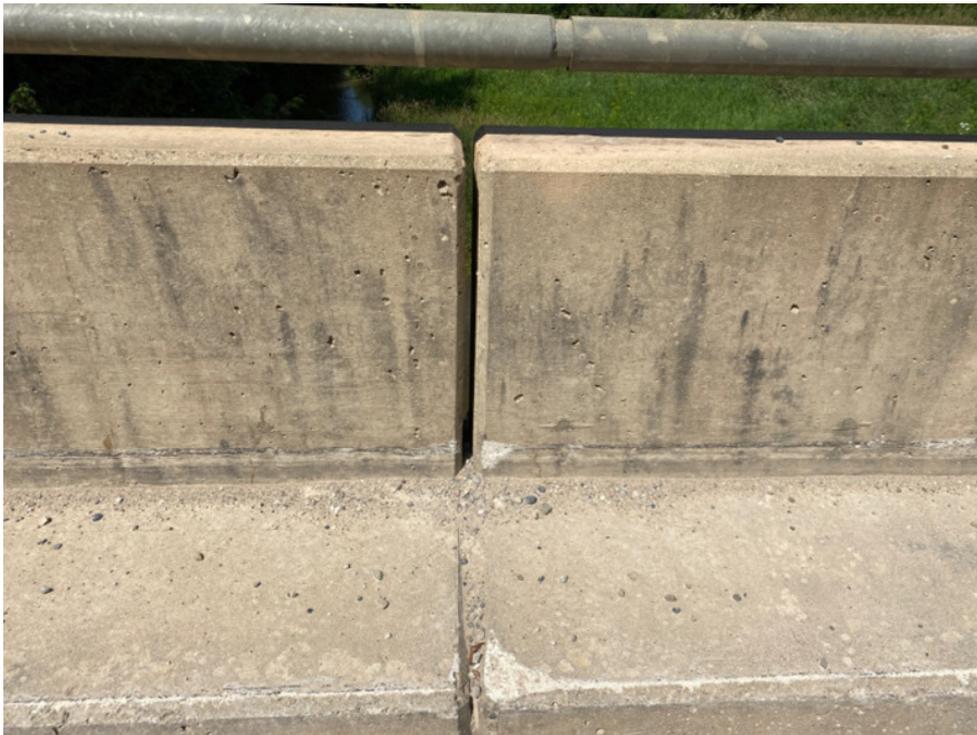
Barrier/Parapet Walls Interior (All Quadrants)

Missing sealant

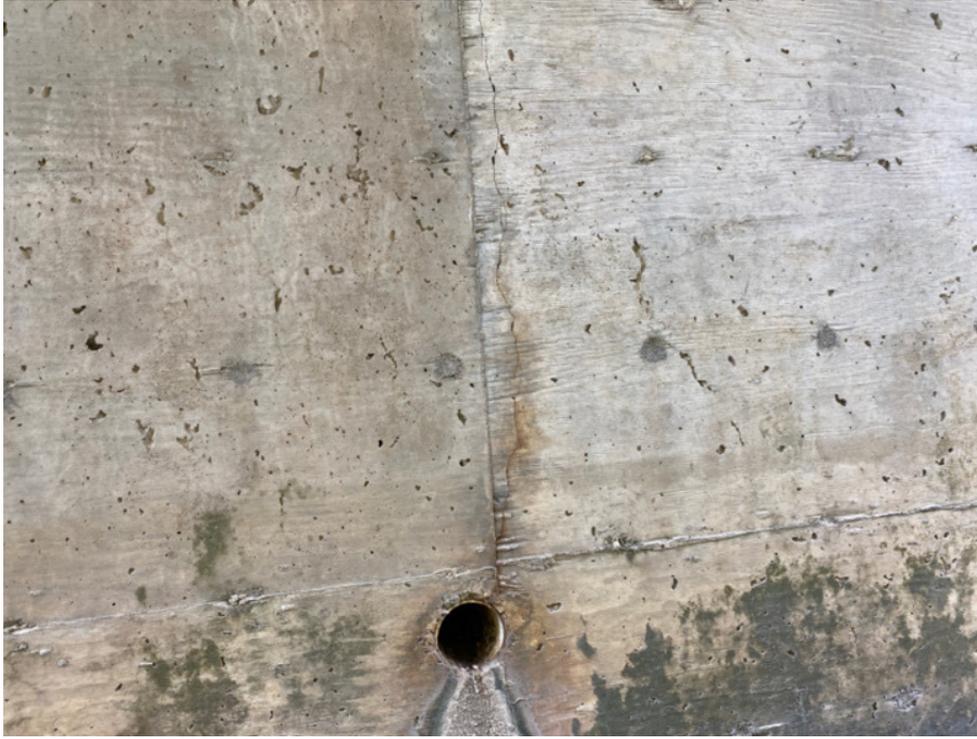
Abutment Walls (North)

| Wide crack

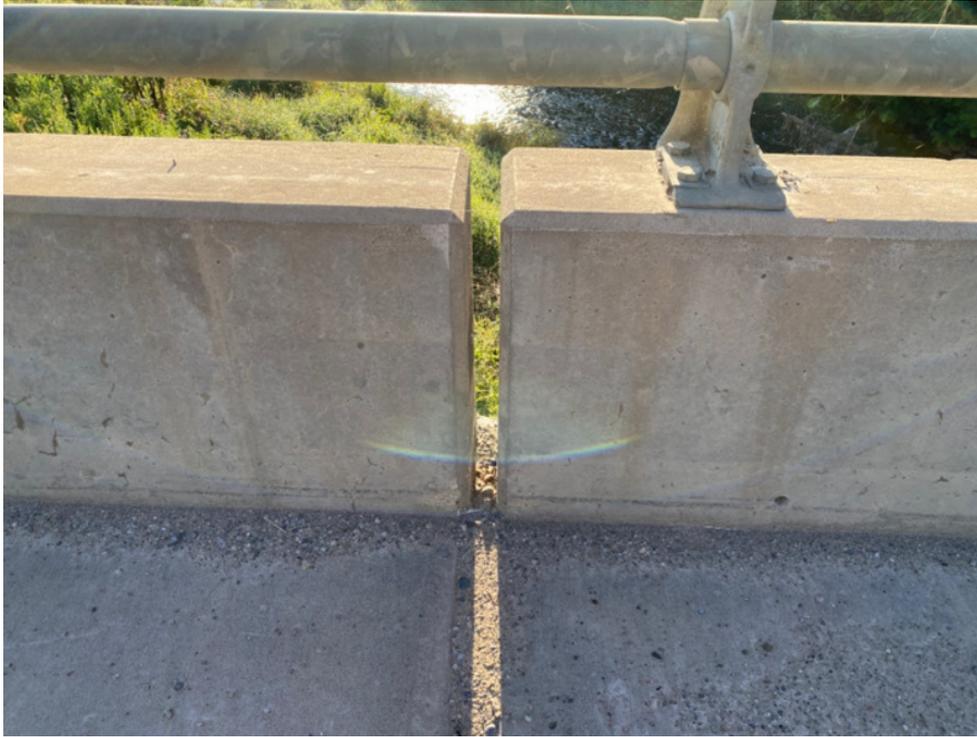
Barrier/Parapet Walls Interior (All Quadrants)

| Missing sealant

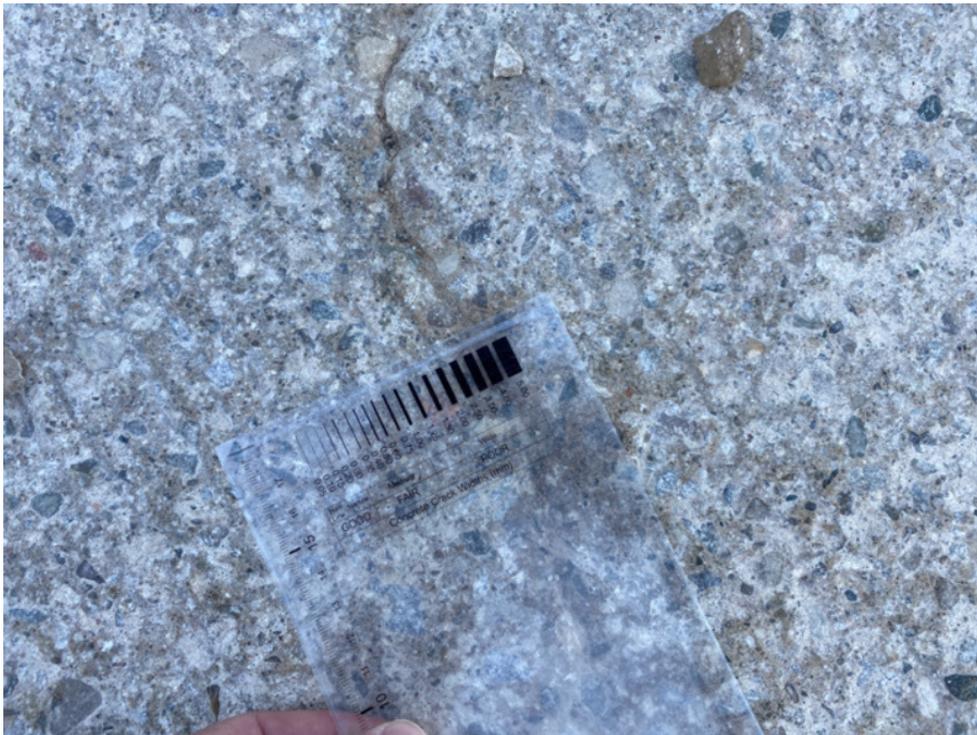
Approach Slabs (South West)

| Wide crack

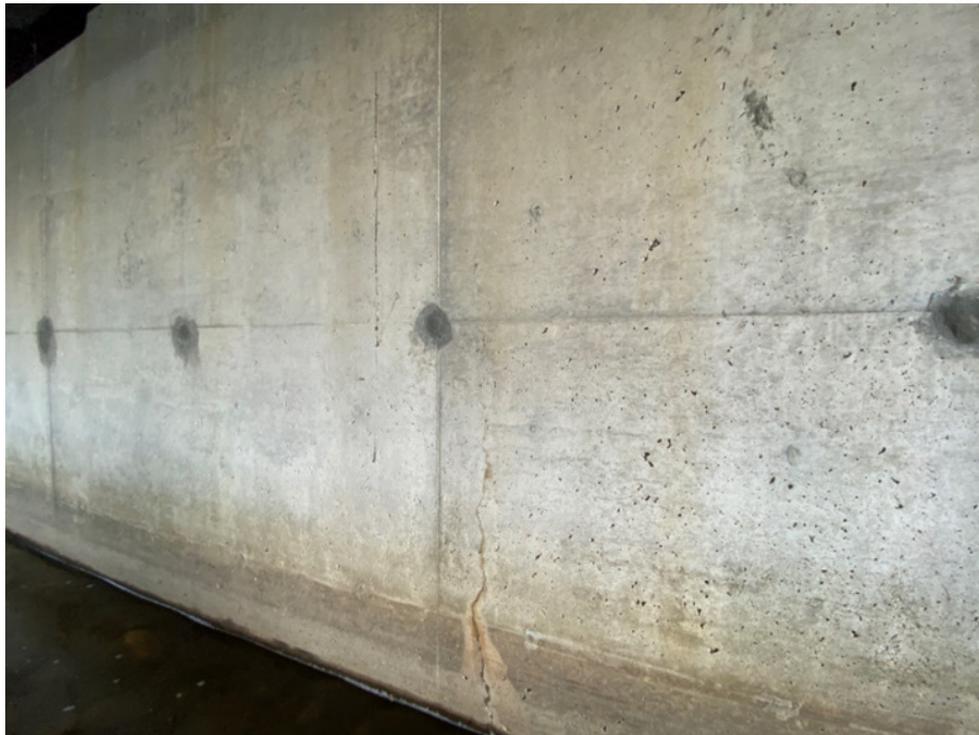
Abutment Walls (North)

| Wide crack

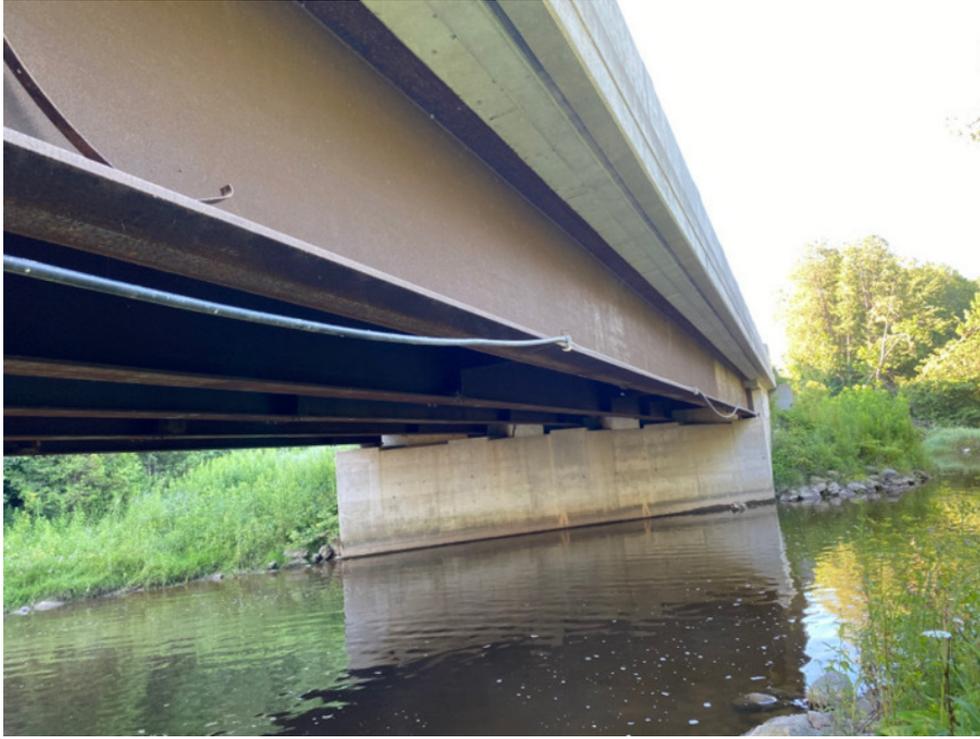
Utilities (West)

| Detached

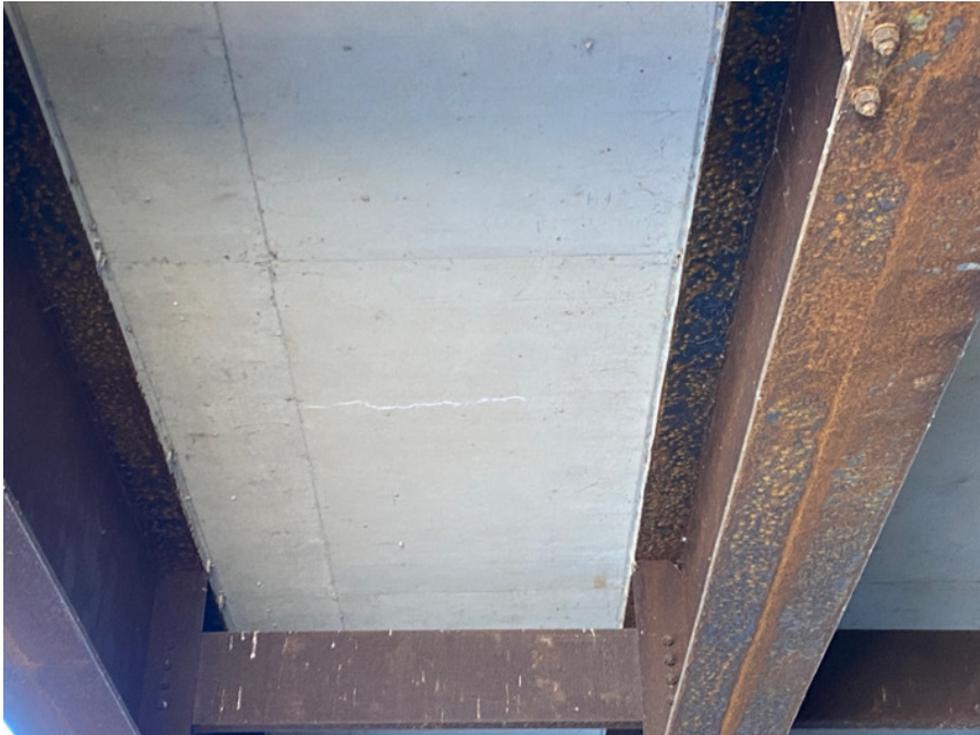
Soffit - Thin Slab - Int (East)

| Efflorescence

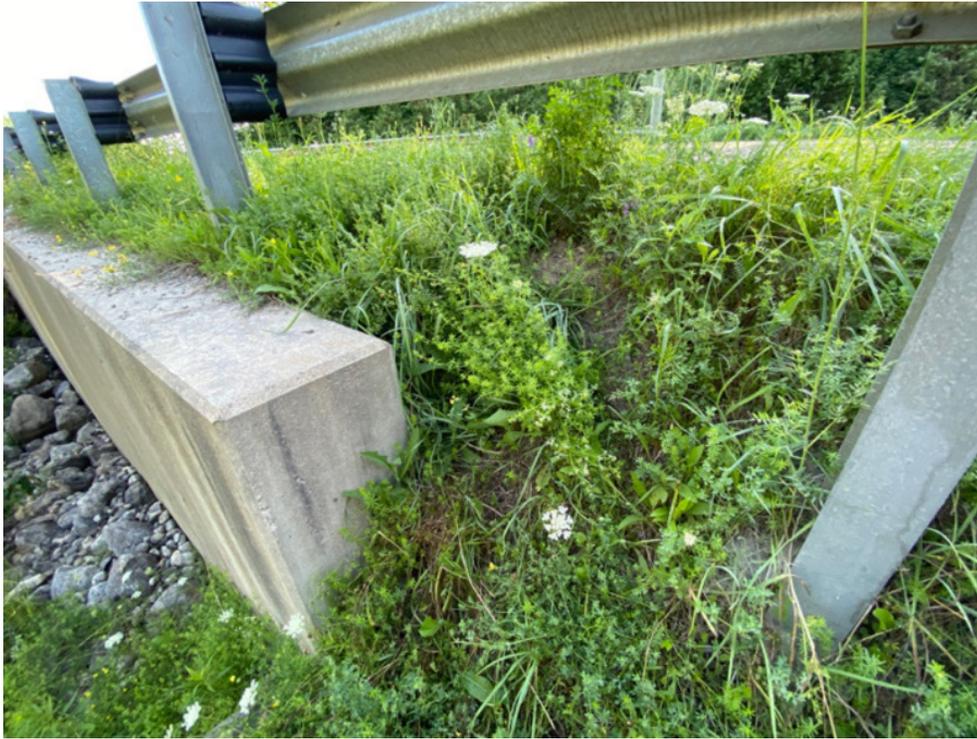
Wall (South West)

Moderate washout

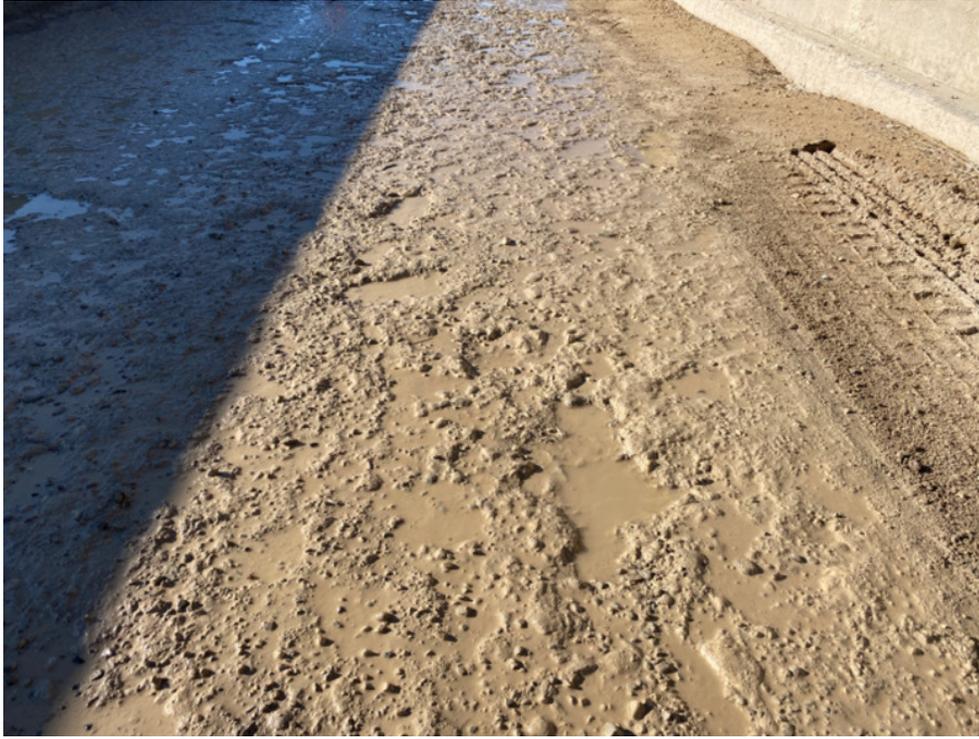
Deck Top (Throughout)

| Large spalls

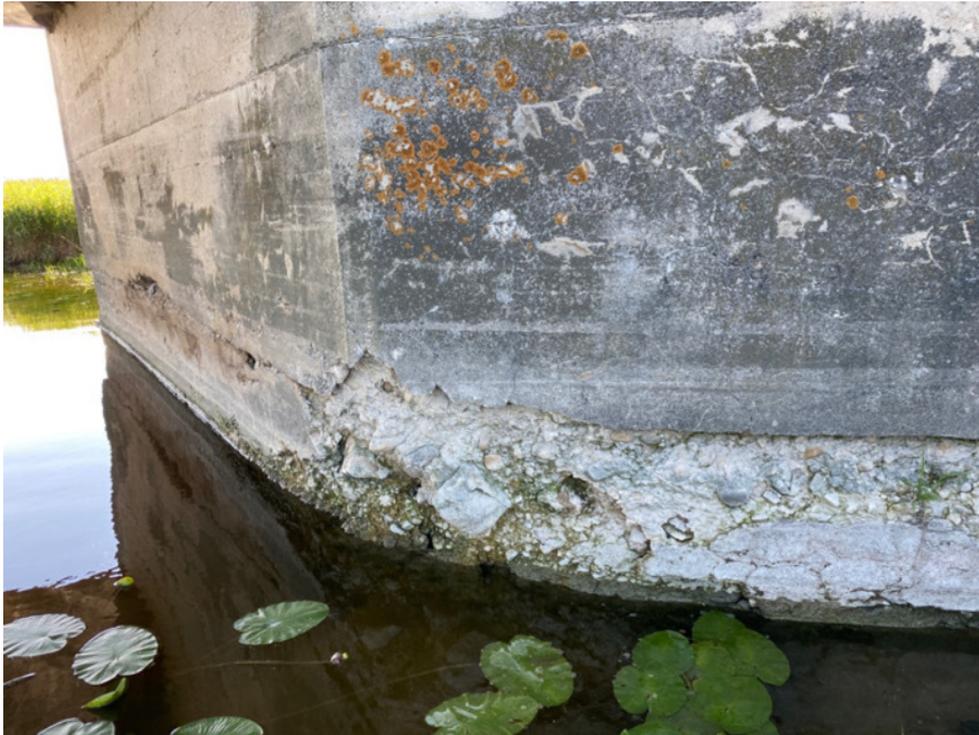
Wingwalls (South West)

| Severe erosion

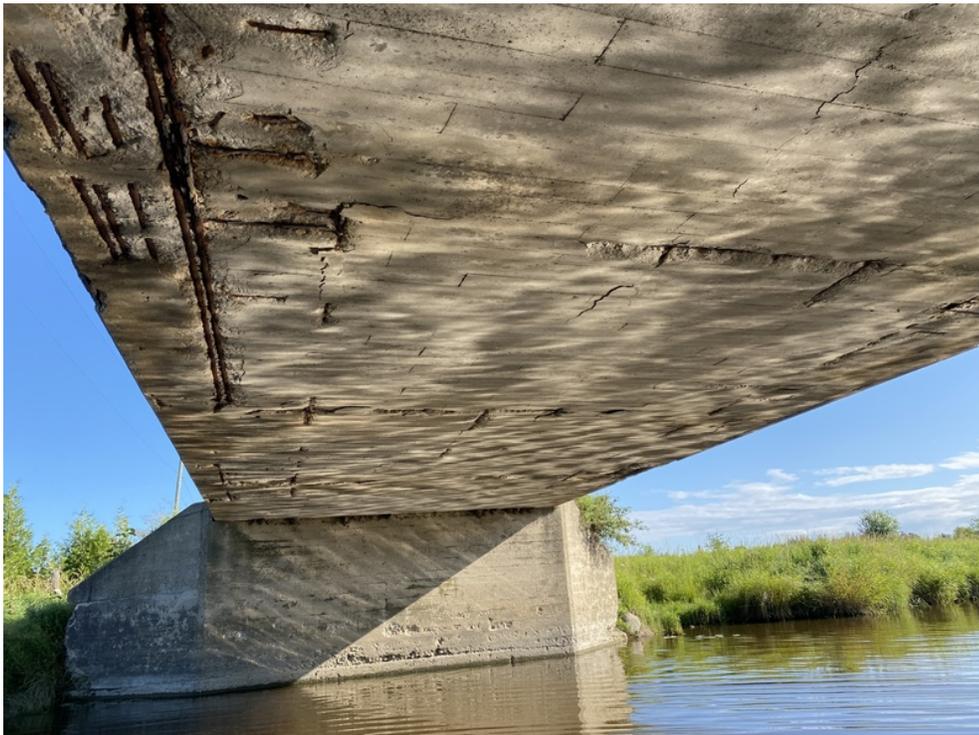
Soffit - Thin Slab - Ext (East)

| Exposed corroded rebar

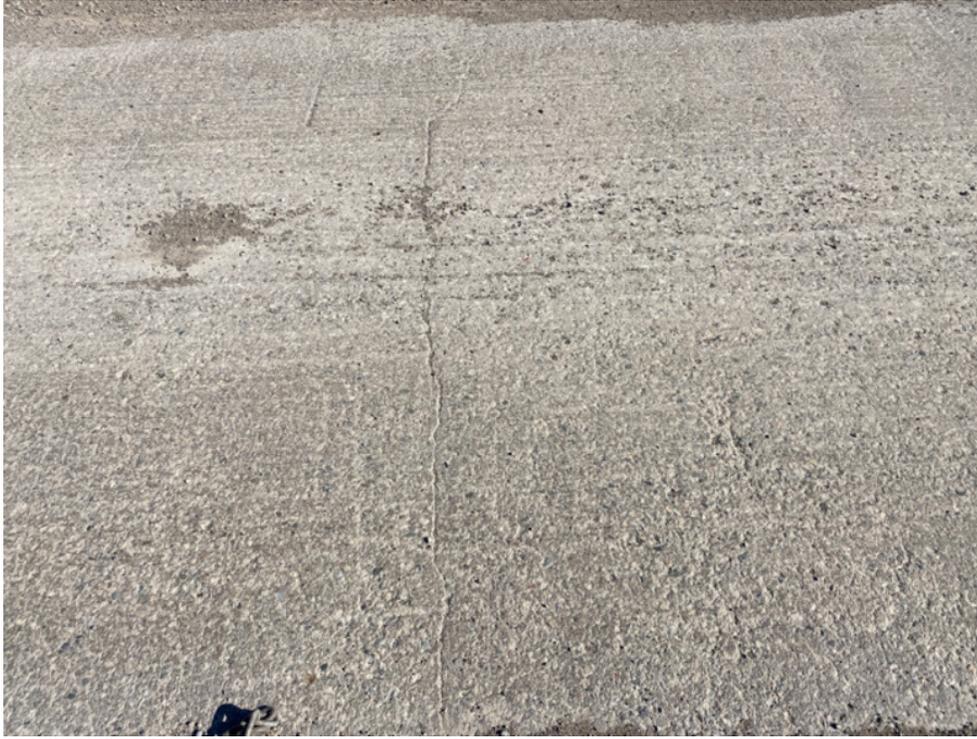
Deck Top (West)

| Wide crack

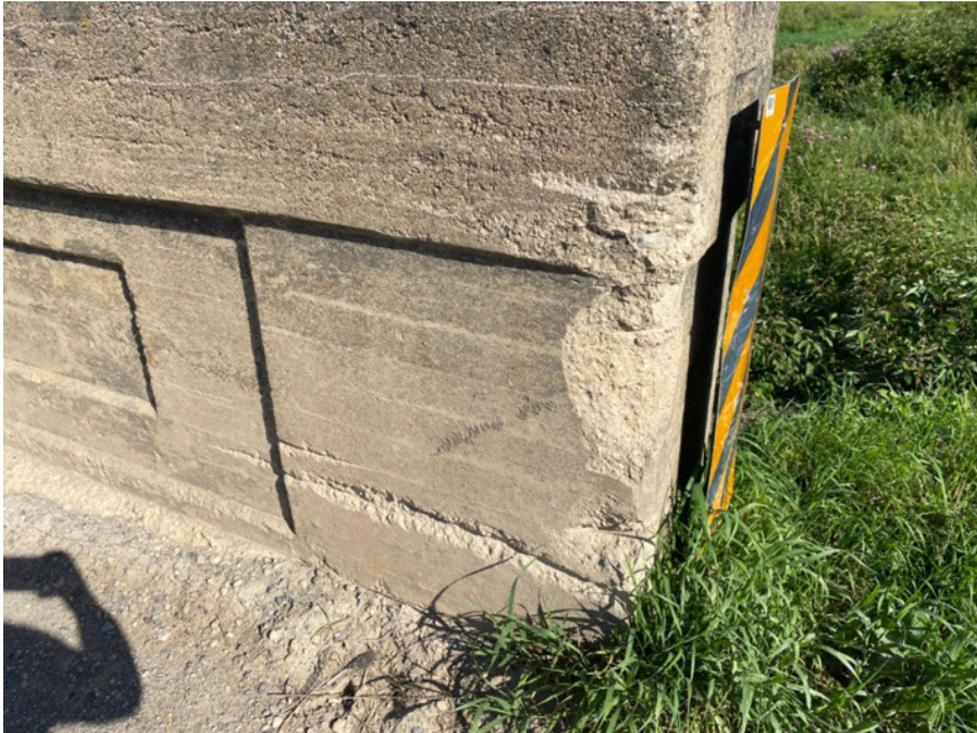
Girders - Ends (North East)

| Spalls

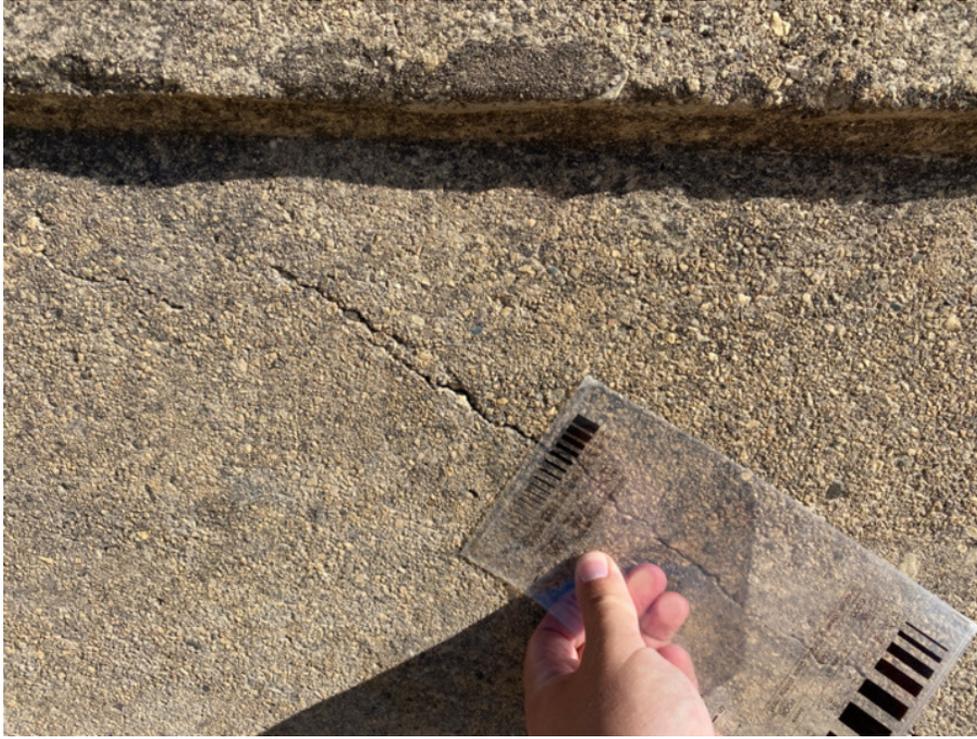
Girders - Middle (North)

| Wide diagonal crack

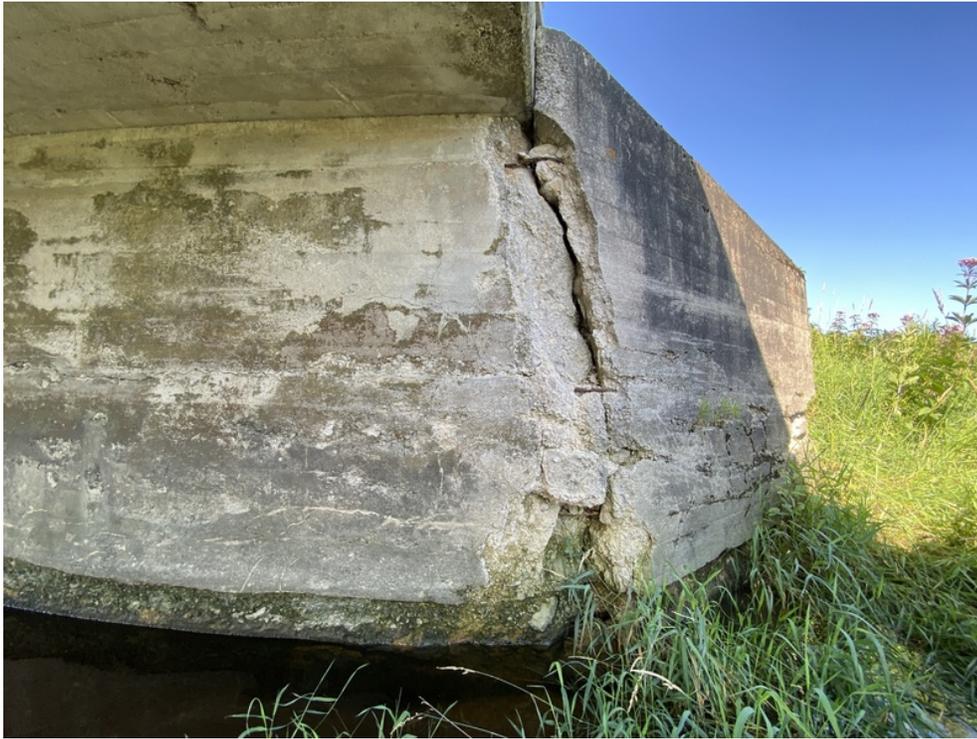
Wingwalls (North West)

| Severe disintegration

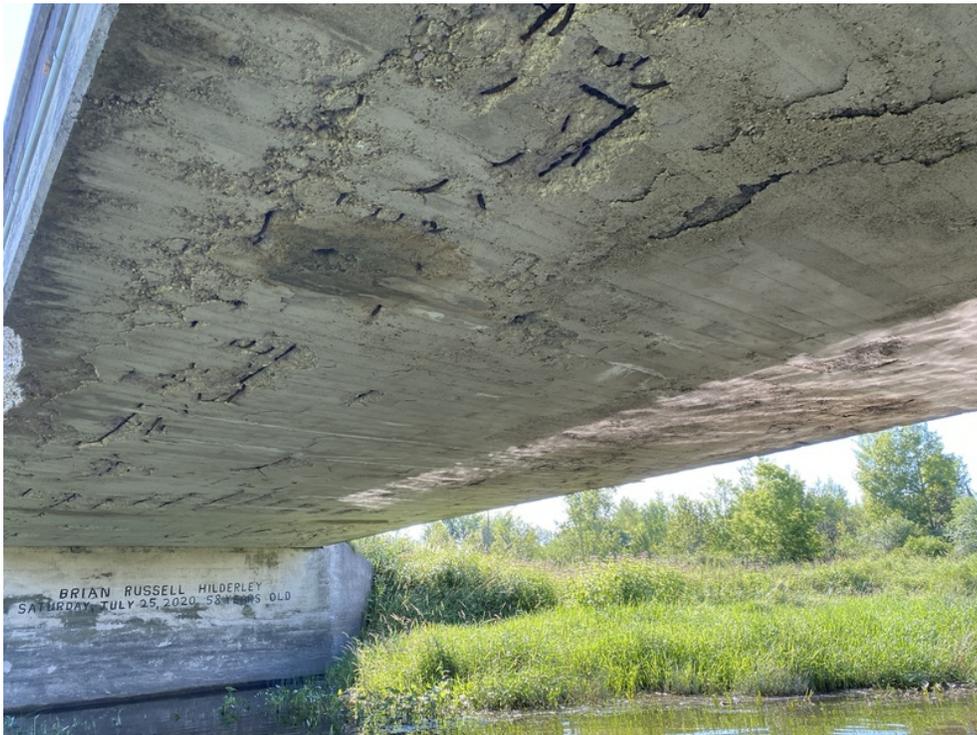
Soffit - Thin Slab - Int (North)

| Exposed corroded rebar (low cover)
