2023 OSIM Bridge Inspections Report

**Township of Amaranth
374028 6th Line
Amaranth, ON L9W 0M6**

**November 2023
300057065.0000**

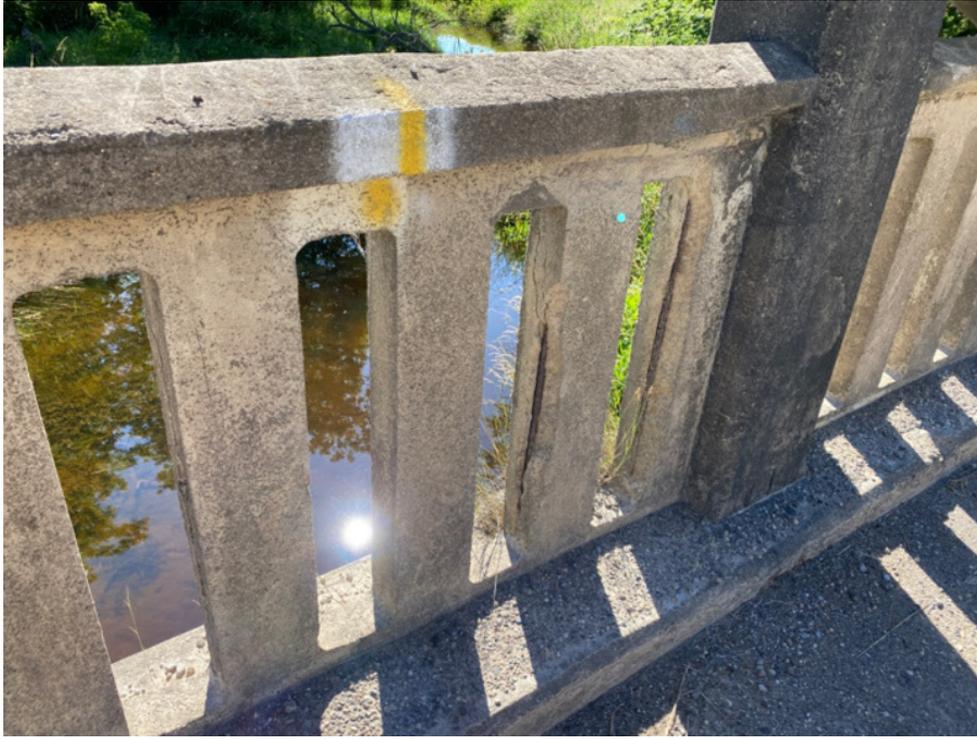
Railing System (East)

| Spalls with exposed corroded rebar

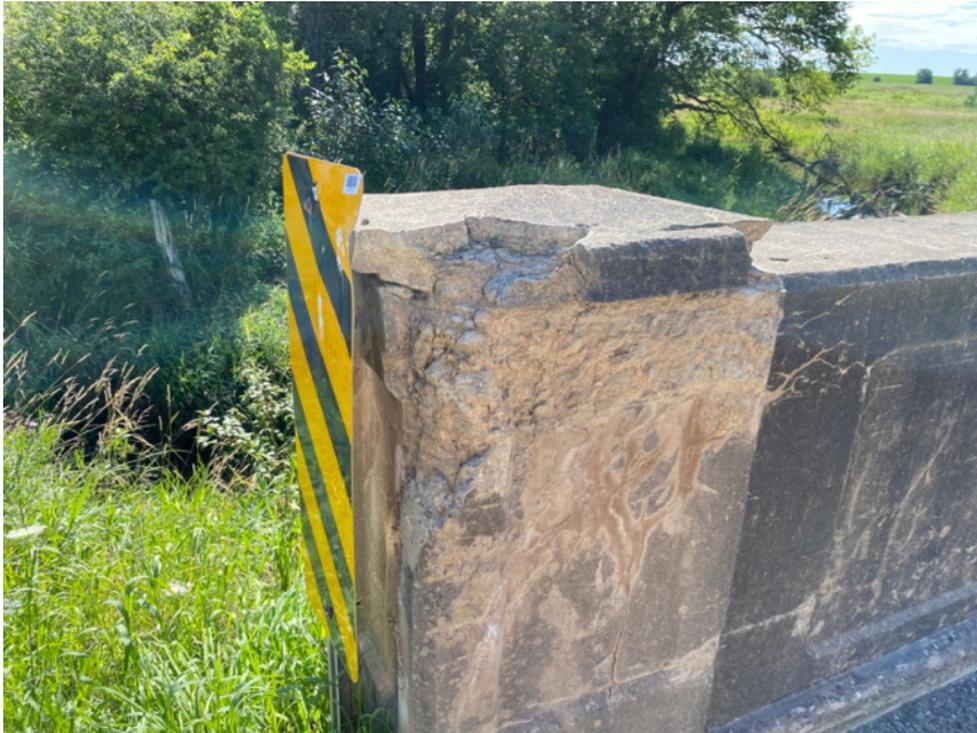
End Post (North East)

| Impact damage

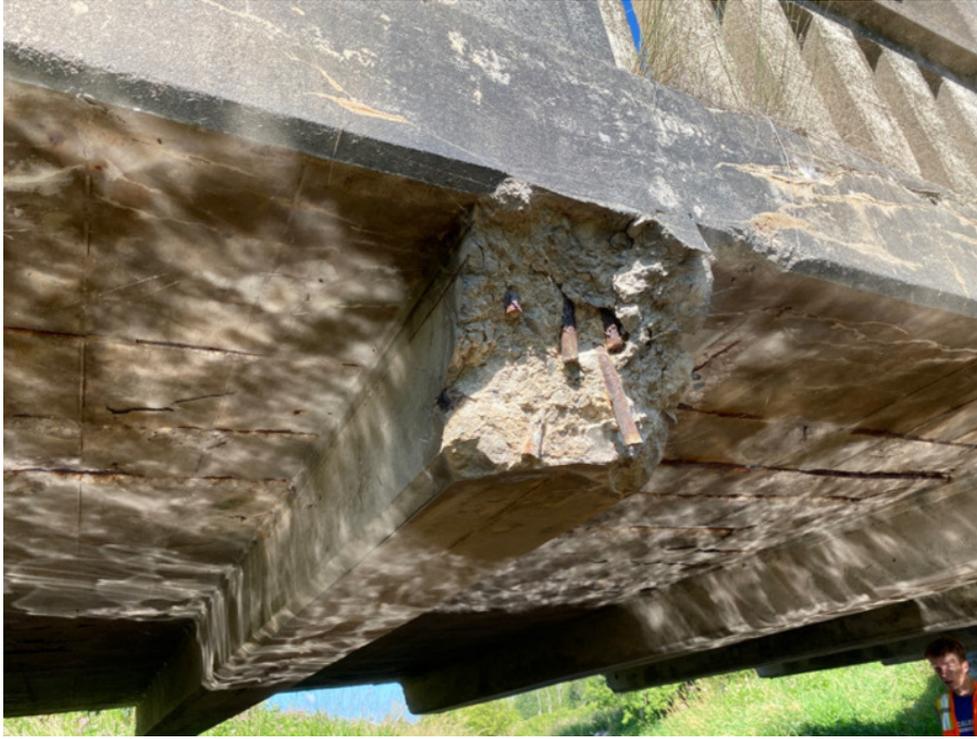
Floor Beams (Throughout)

| Spalled ends

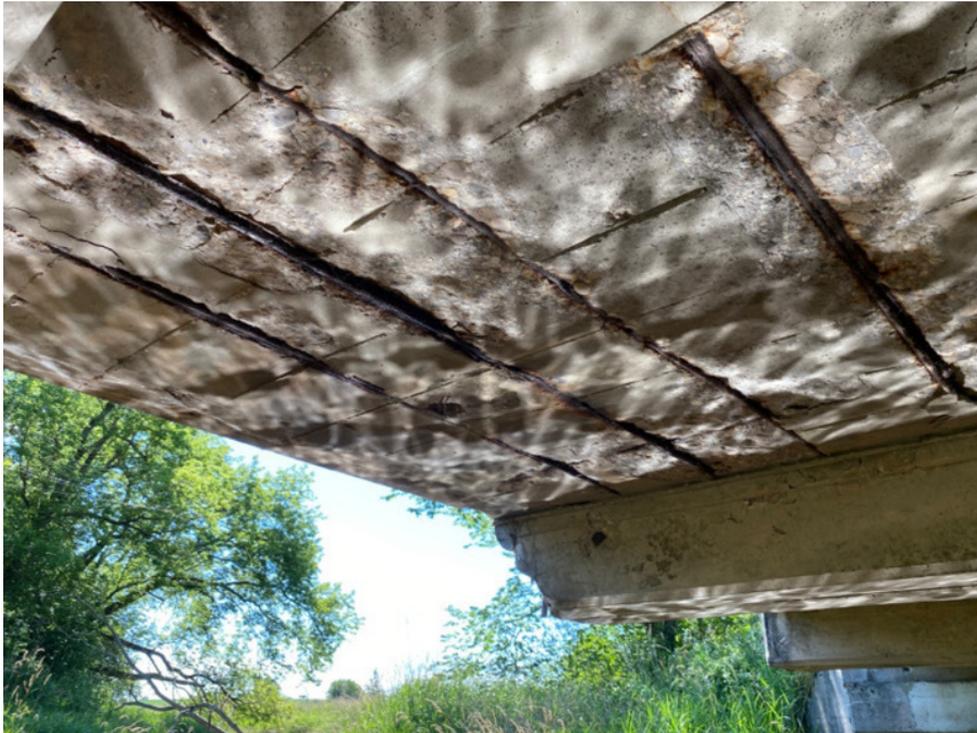
Soffit - Thin Slab - Int (Throughout)

| Spalls with exposed corroded rebar

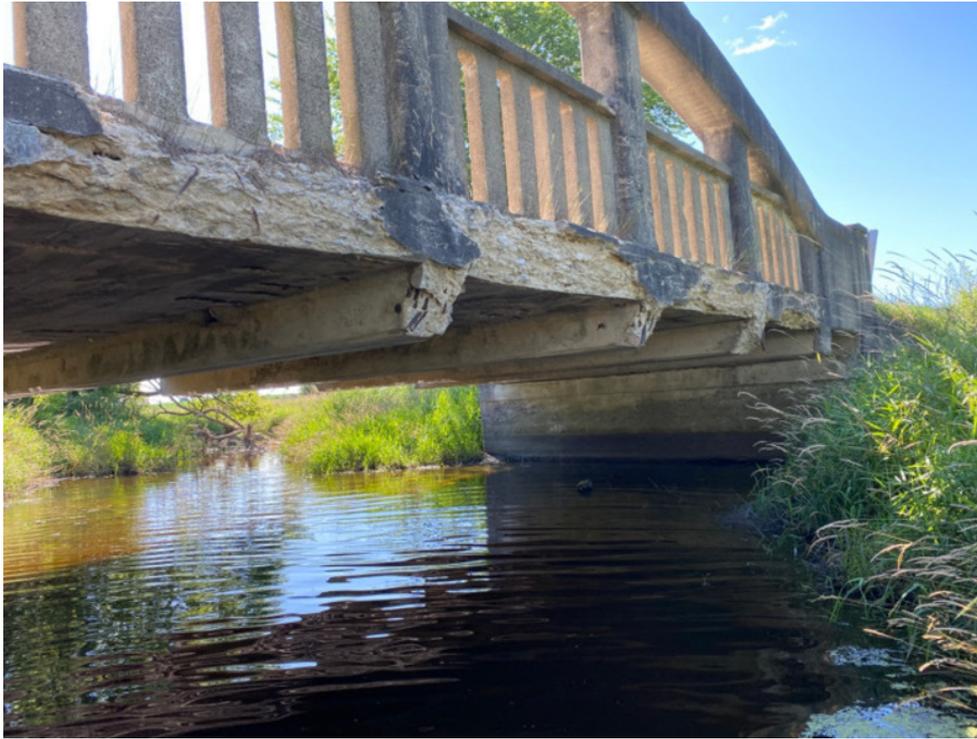
Bottom Chords (West)

| Severe disintegration

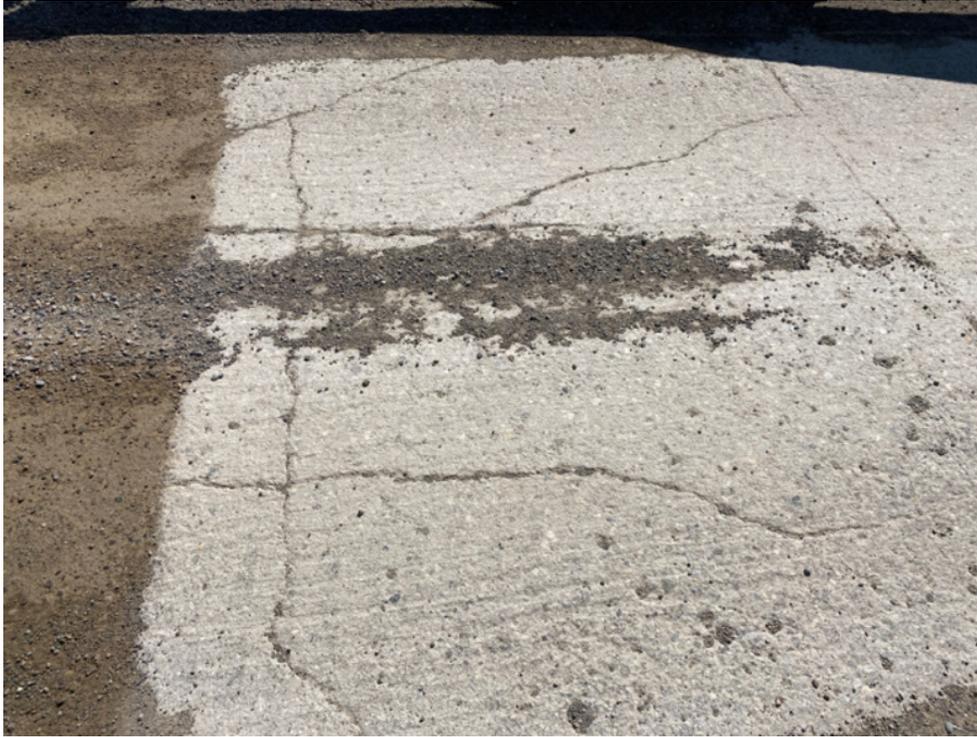
Deck Top (North)

| Wide cracks

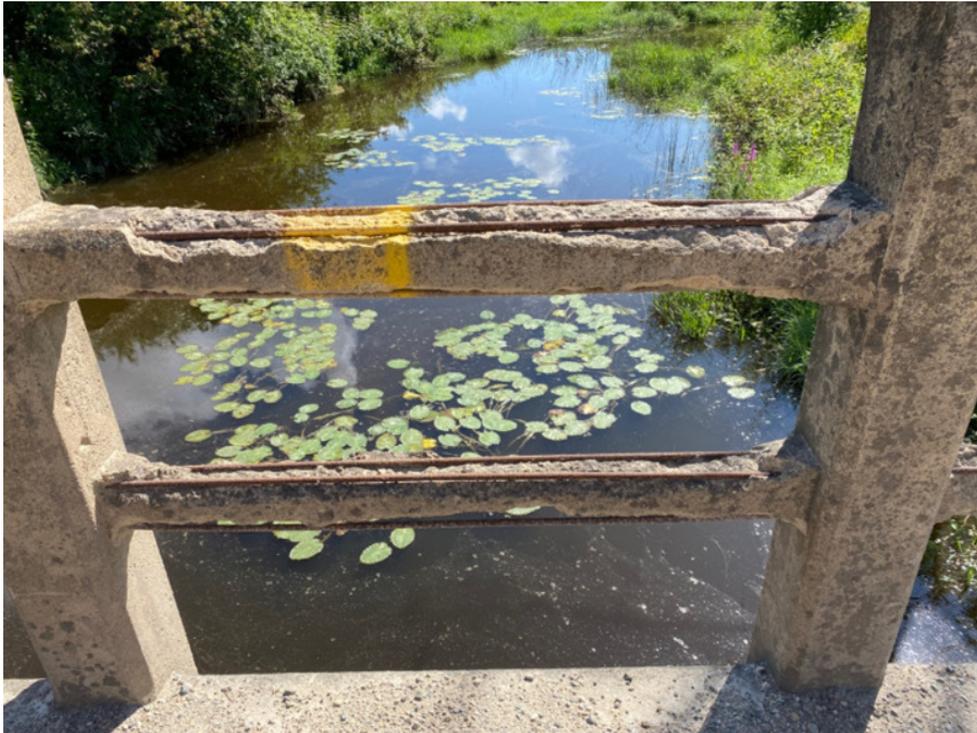
Railing System (Throughout)

| Spalls with exposed corroded rebar

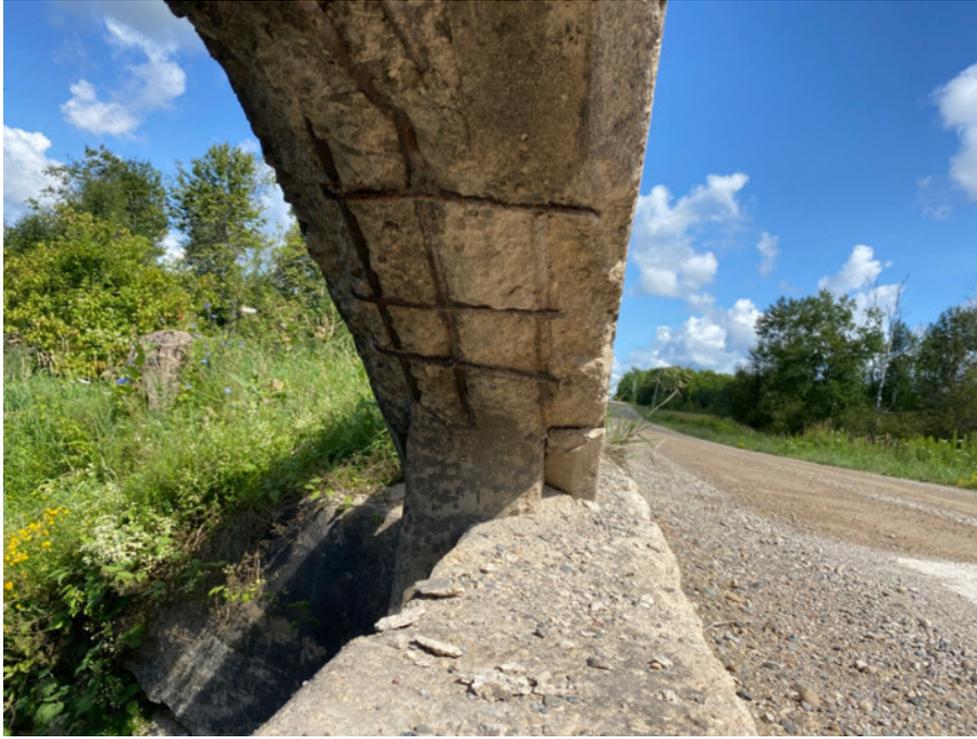
Top Chords (North West)

| Spall with exposed corroded rebar

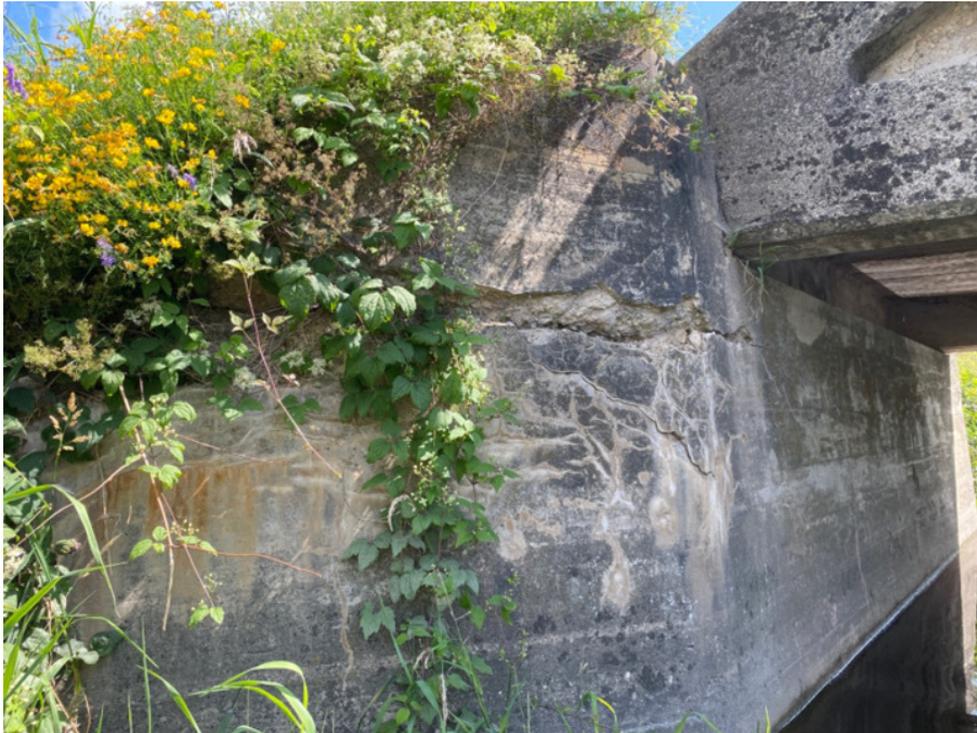
Wingwalls (North West)

| Severe disintegration

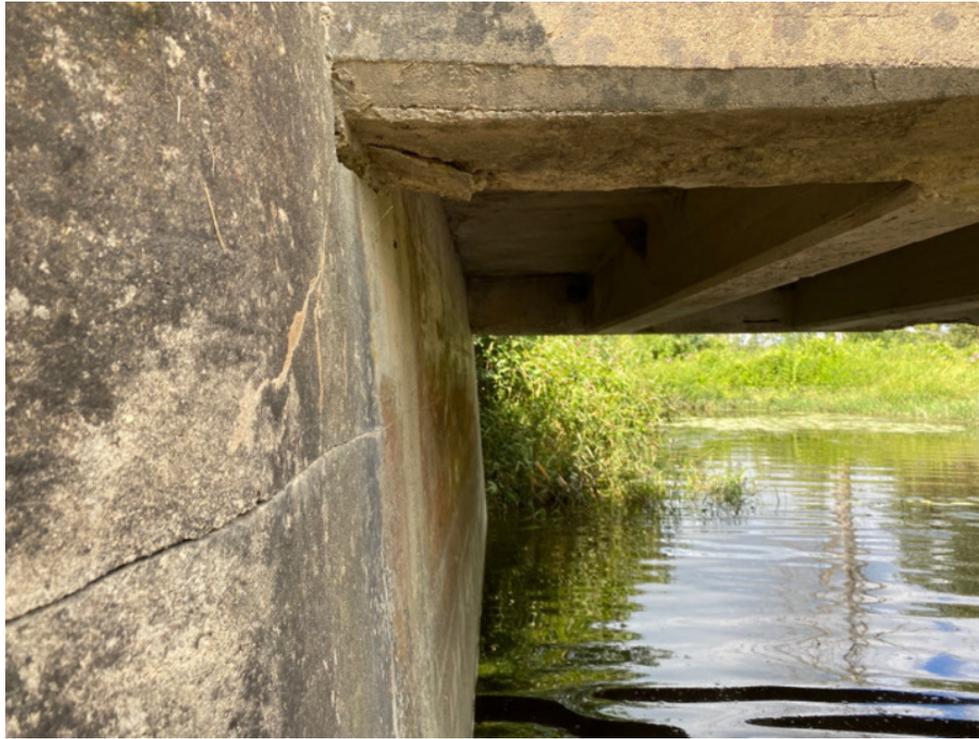
Abutment Walls (South)

Rotation

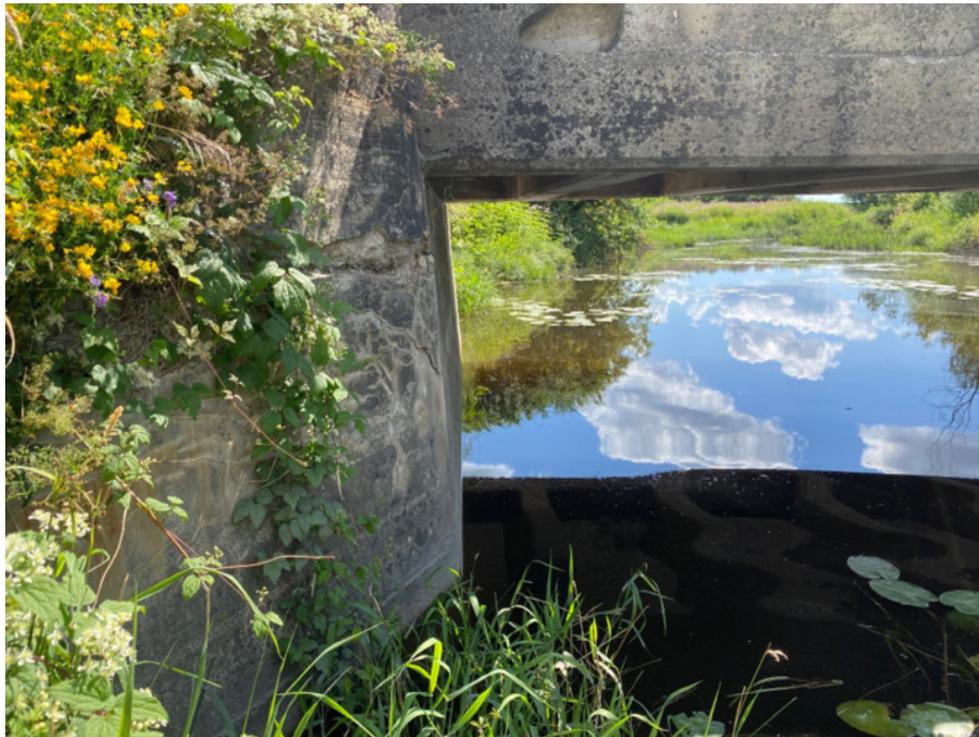
Abutment Walls (North)

Rotation

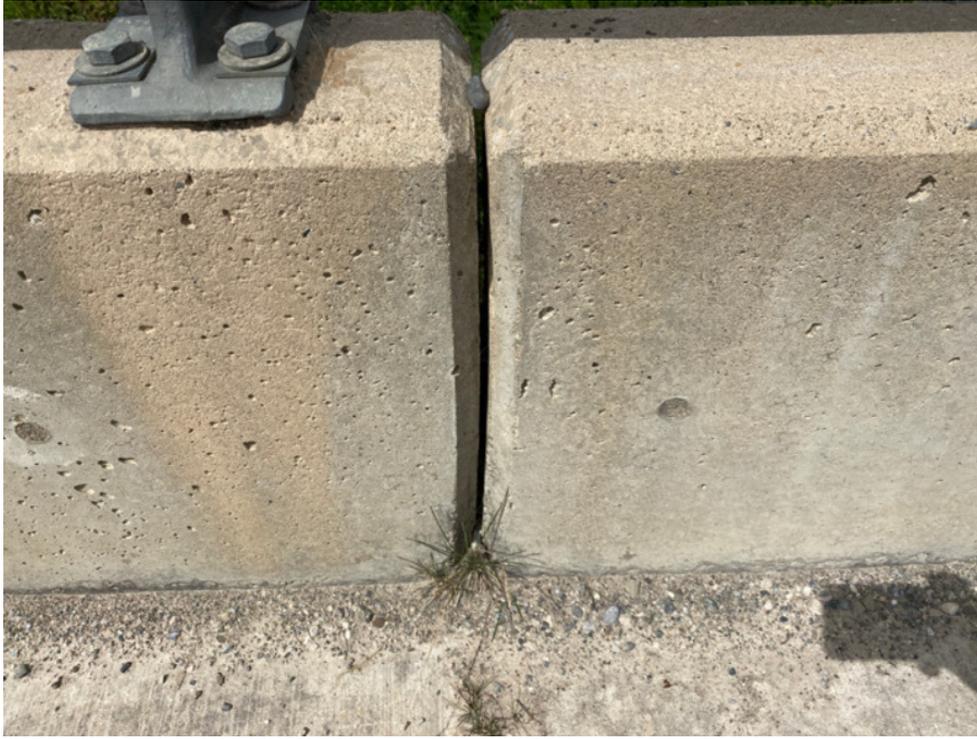
Barrier/Parapet Walls Interior (All quadrants)

| Deteriorated sealant

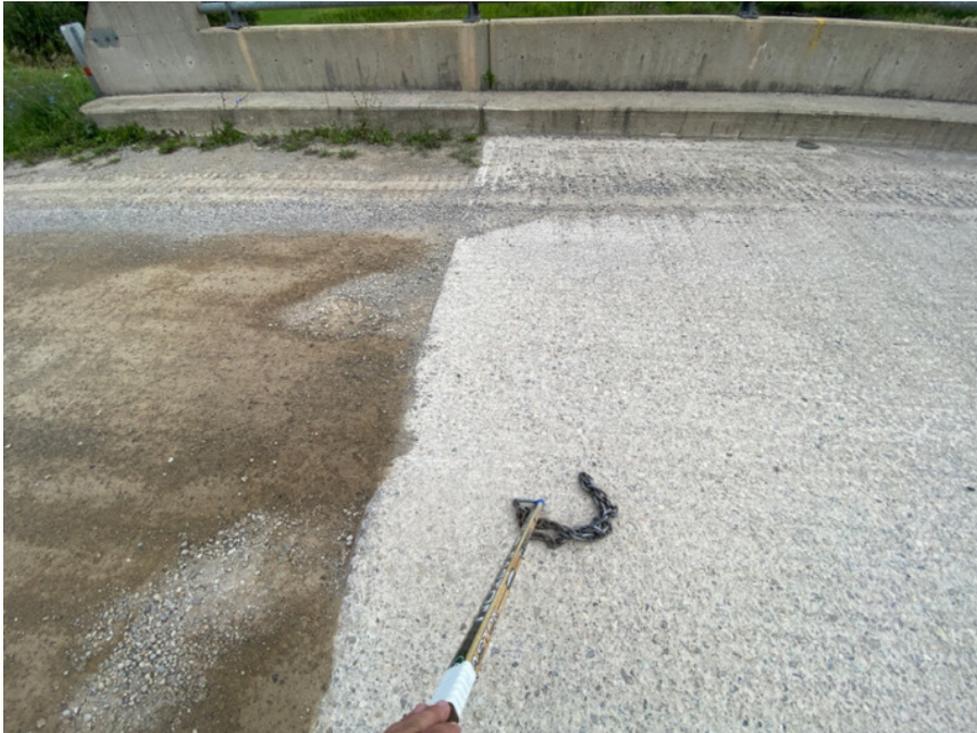
Deck Top (North)

| Delamination

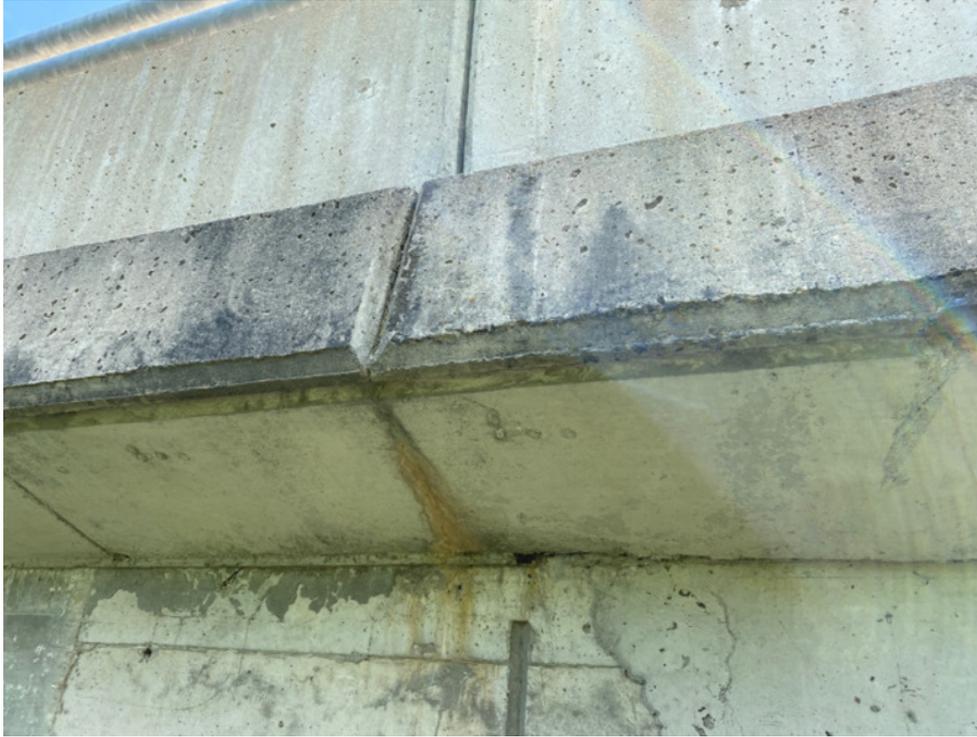
Soffit - Thin Slab - Ext (South West)

| Efflorescence staining

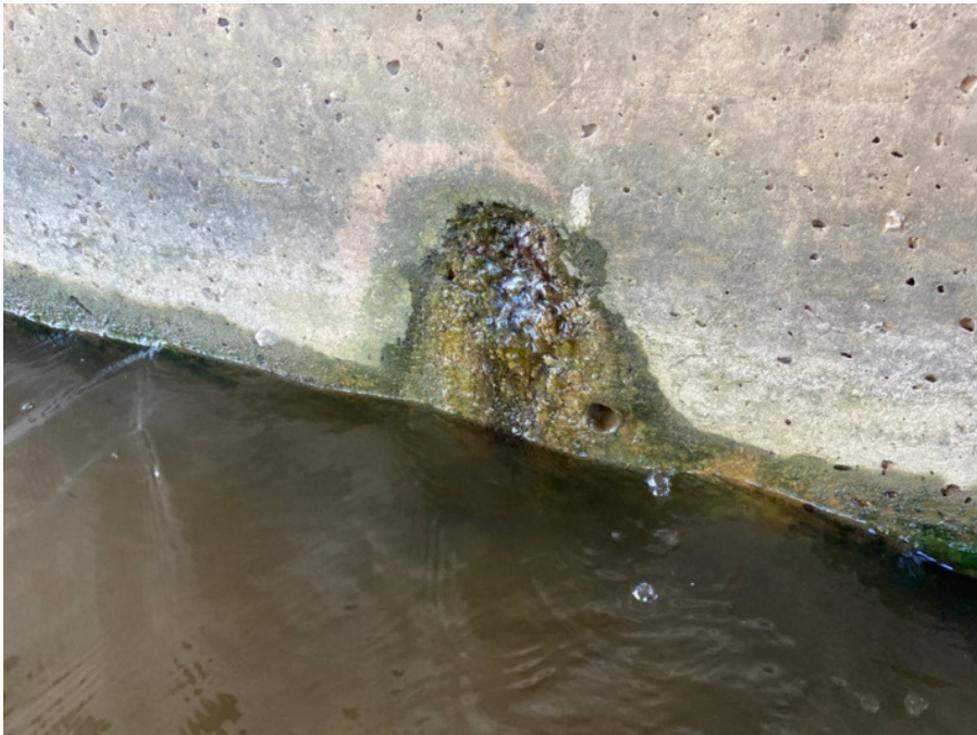
Abutment Walls (South)

| Moisture penetration

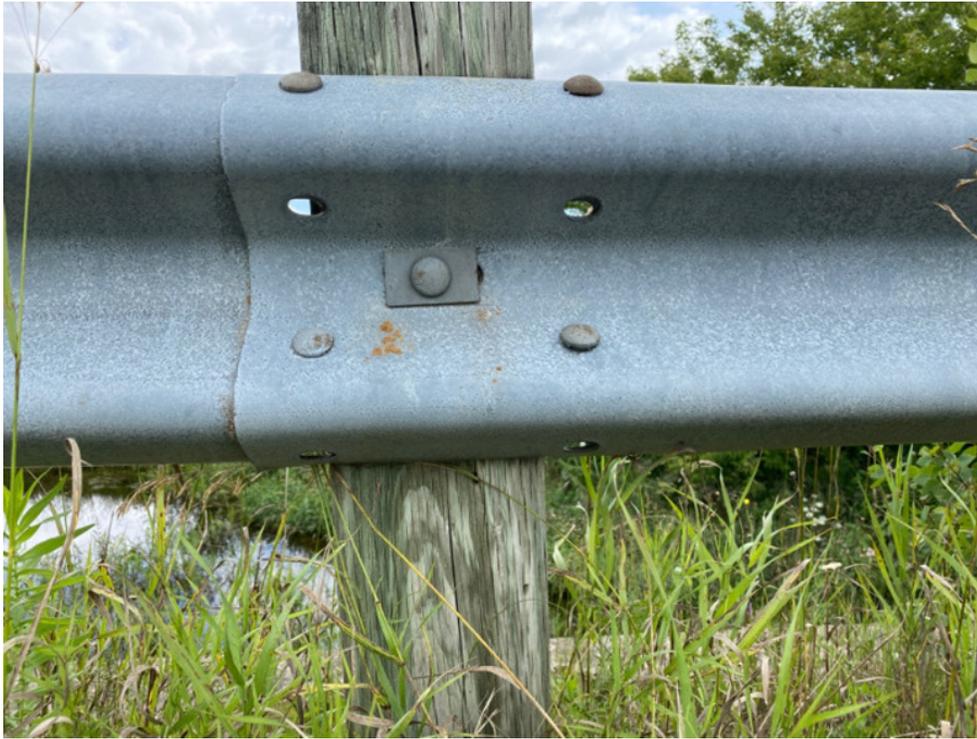
Approach Guide Rail (Throughout)

| Missing bolts

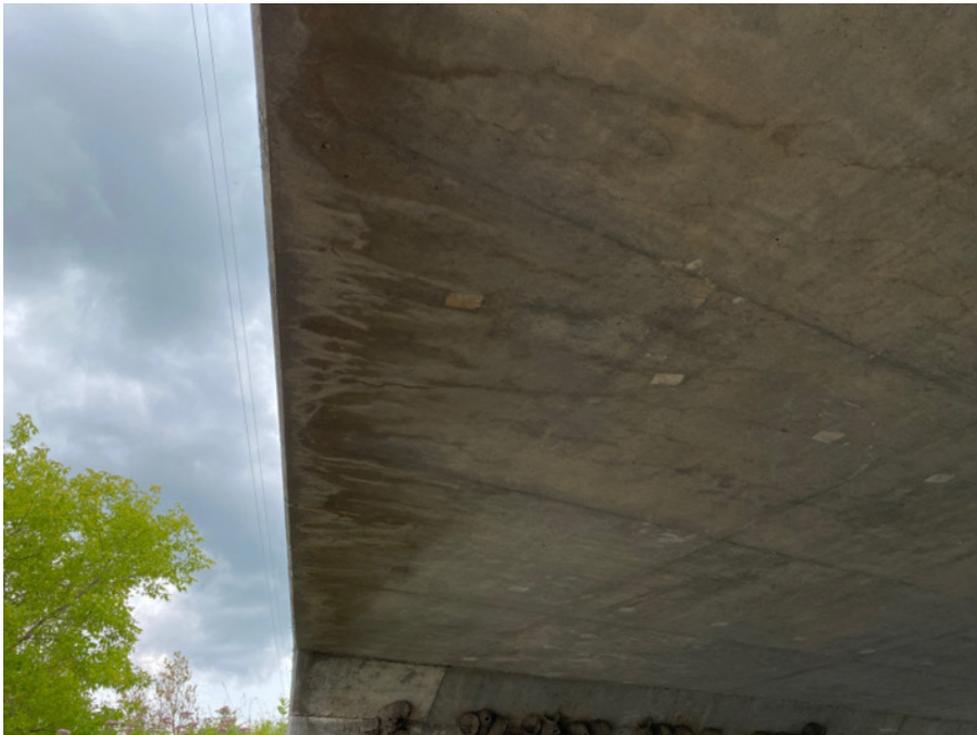
Barrels (South East)

| Moisture staining

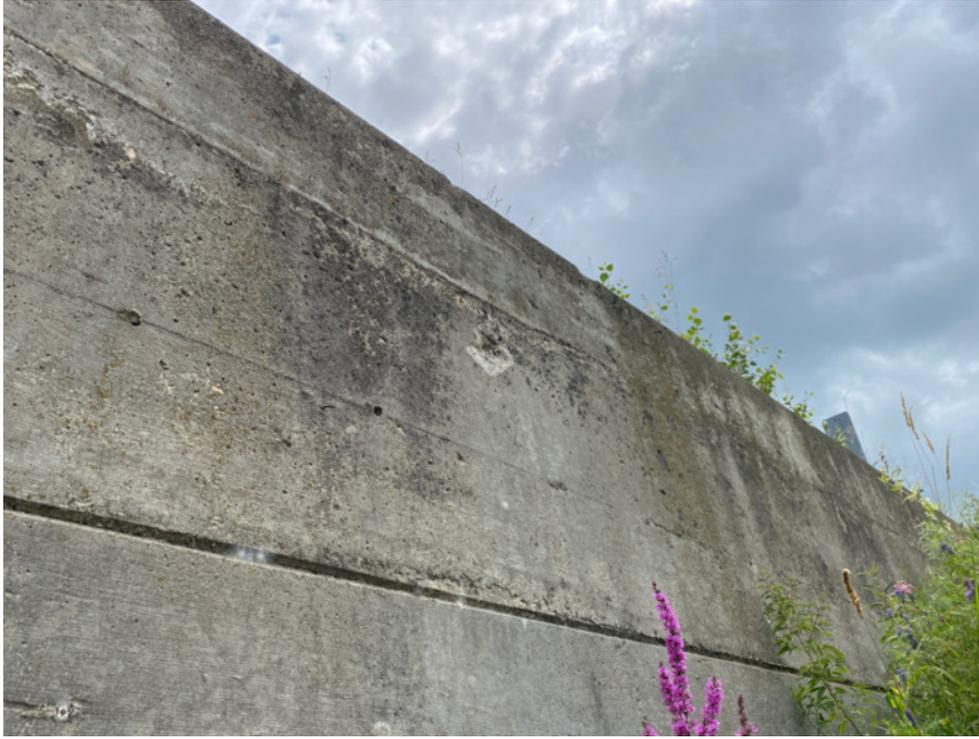
Wingwalls (South West)

| Small spall

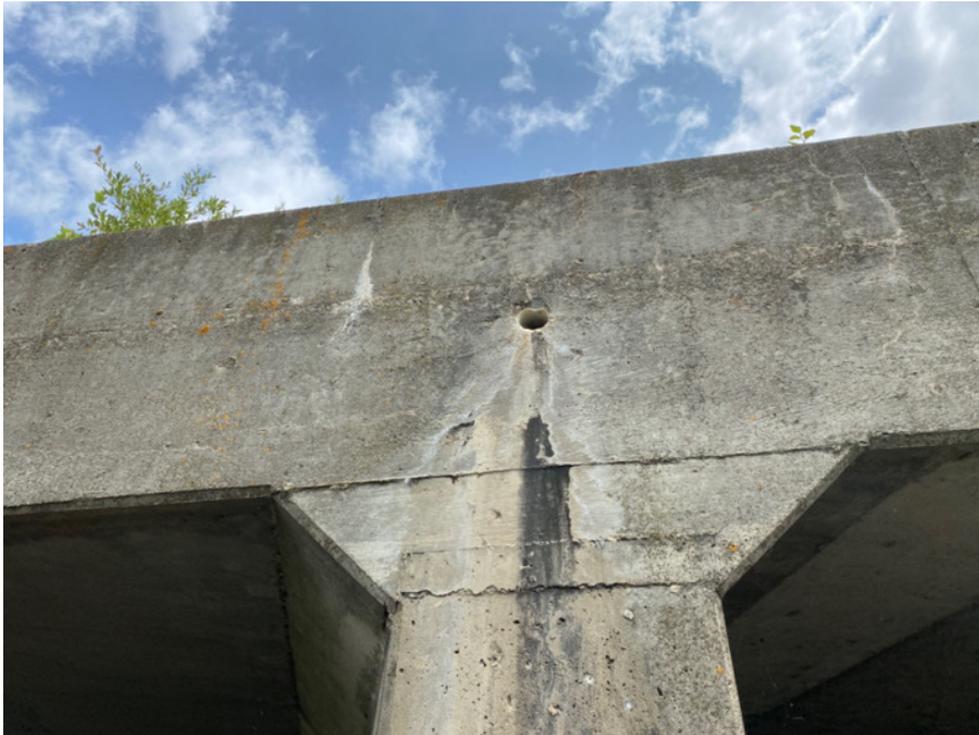
Outlet (West)

| Efflorescence

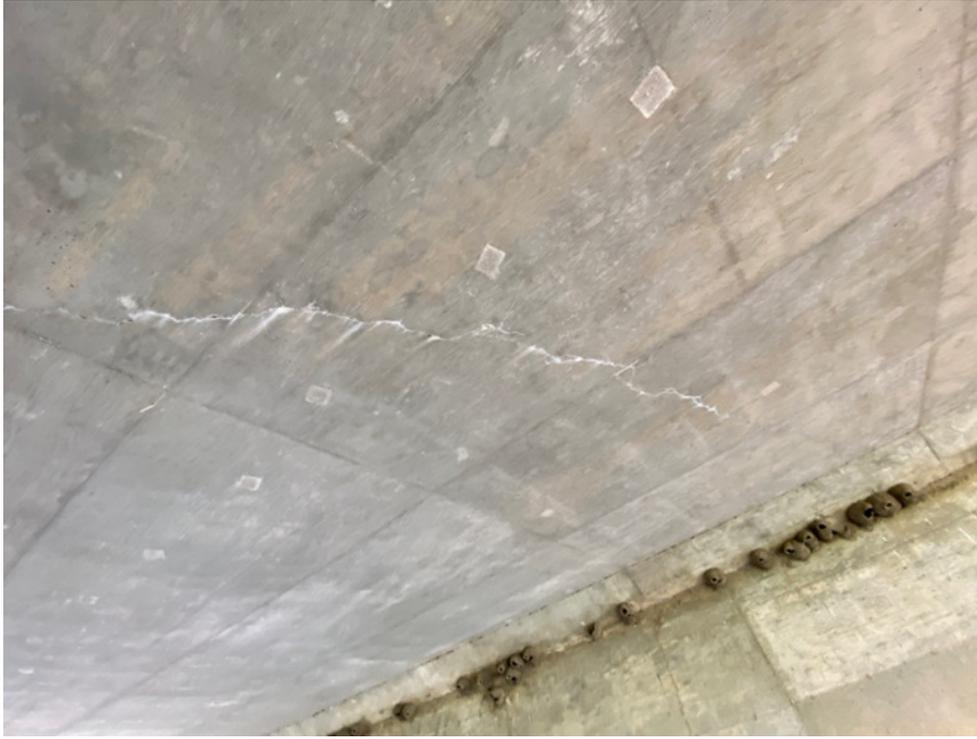
Barrels (North)

| Efflorescence

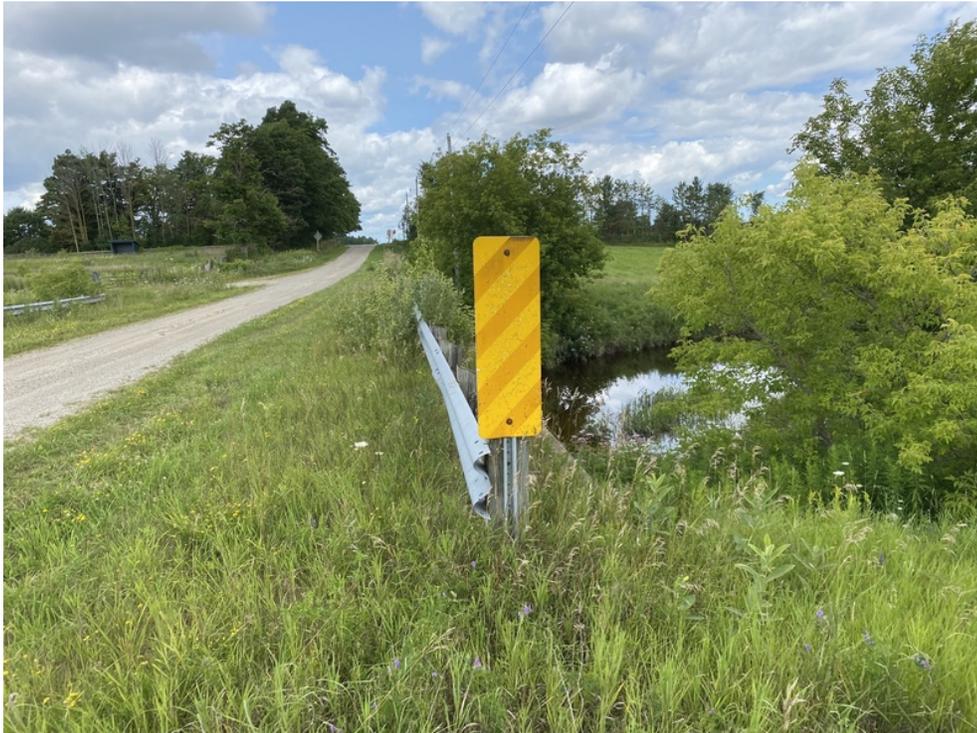
Signs (South East)

| Low reflectivity

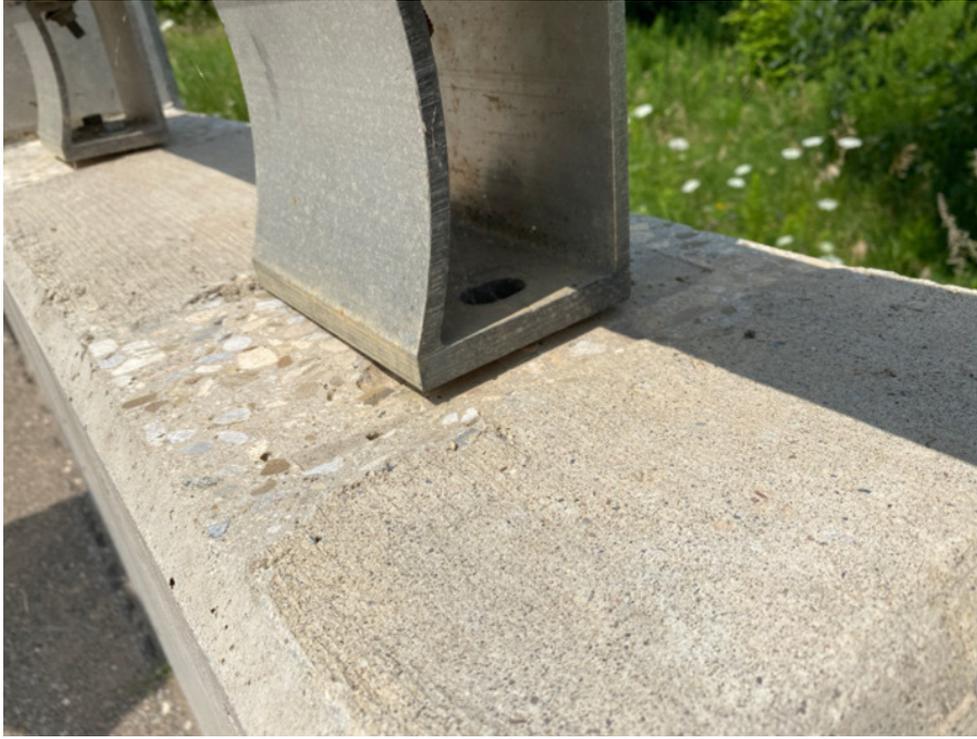
Hand Railings (North West)

| Missing bolt

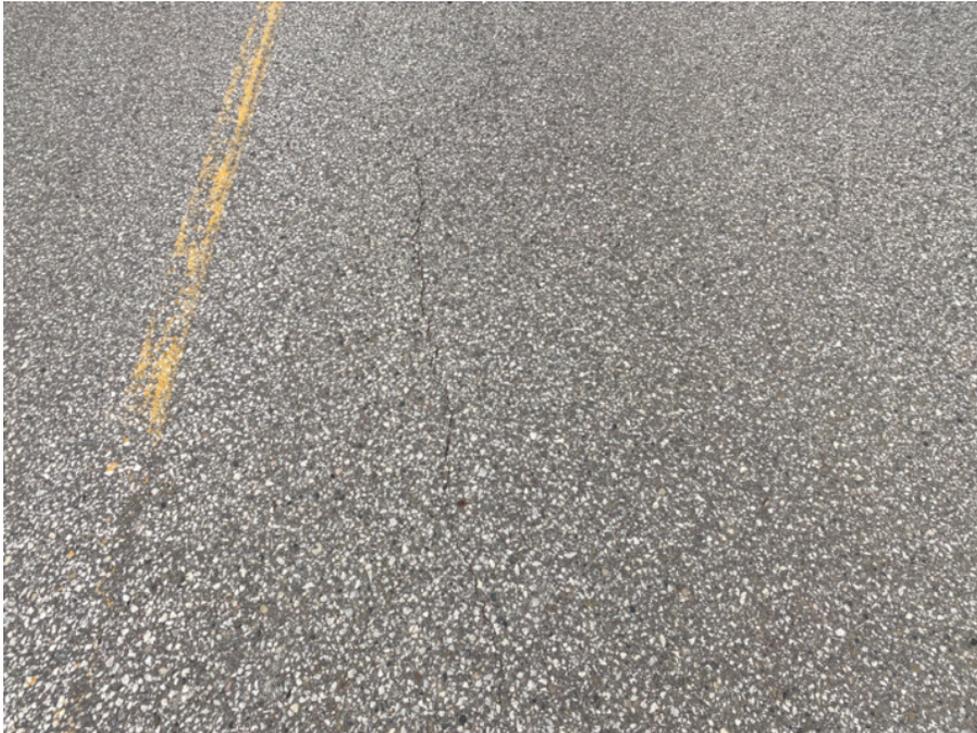
Approach Wearing Surface (South)

| Light longitudinal crack

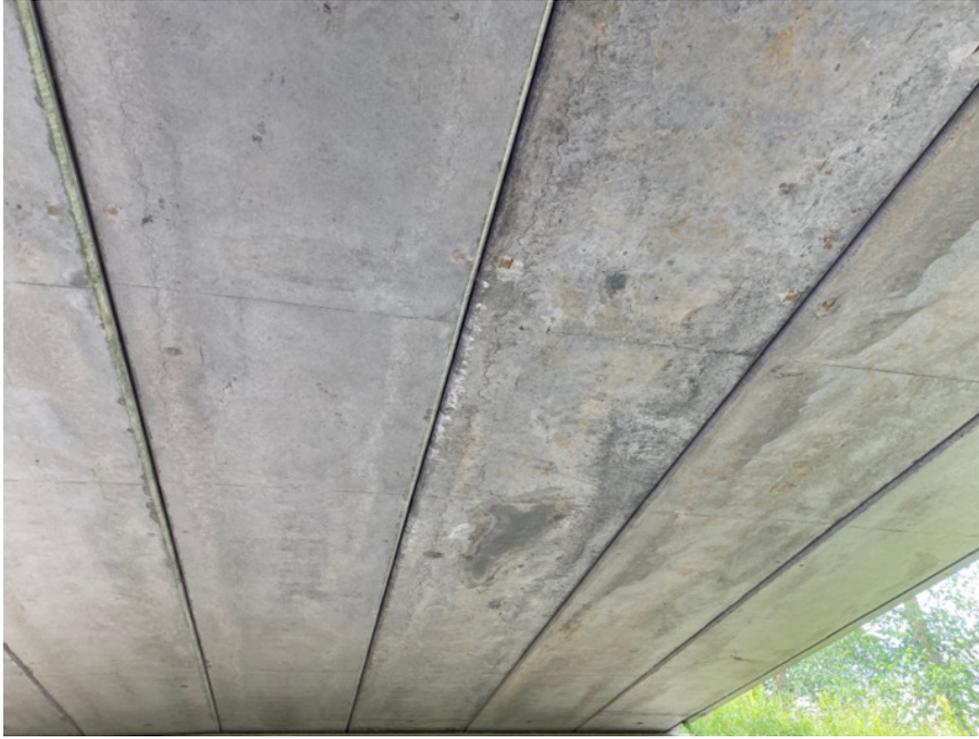
Girders - Middle (North)

| Moisture penetration with efflorescence

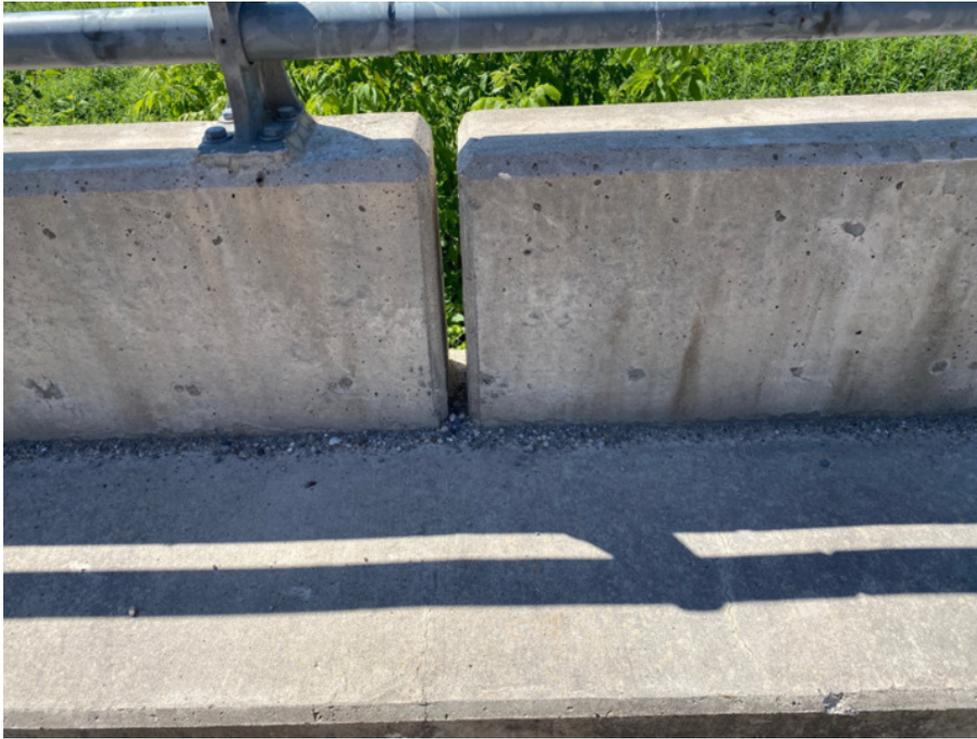
Barrier/Parapet Walls Interior (All Quadrants)

| Missing sealant

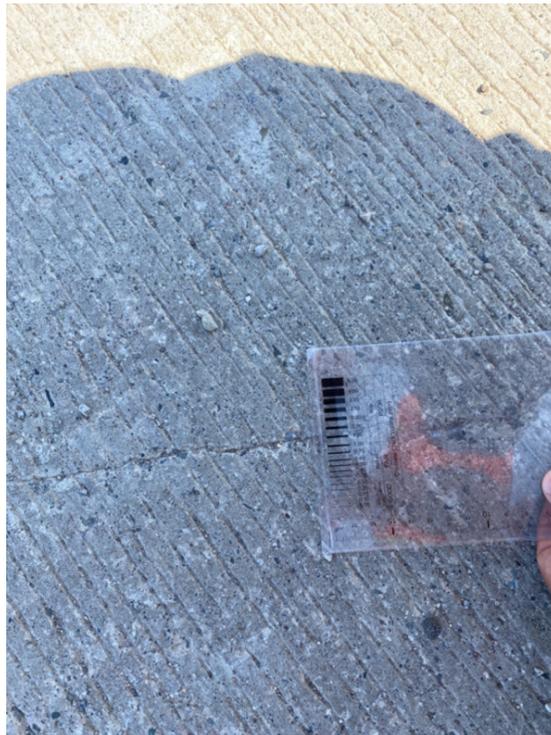
Deck Top (West)

| Wide crack

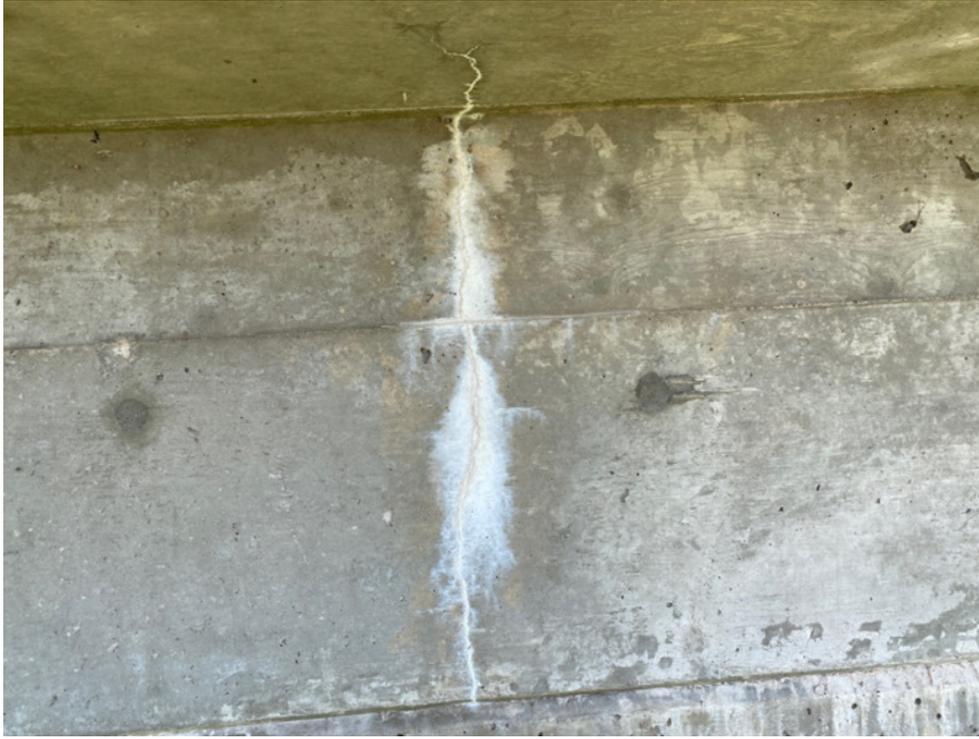
Wingwalls (South West)

| Efflorescence staining

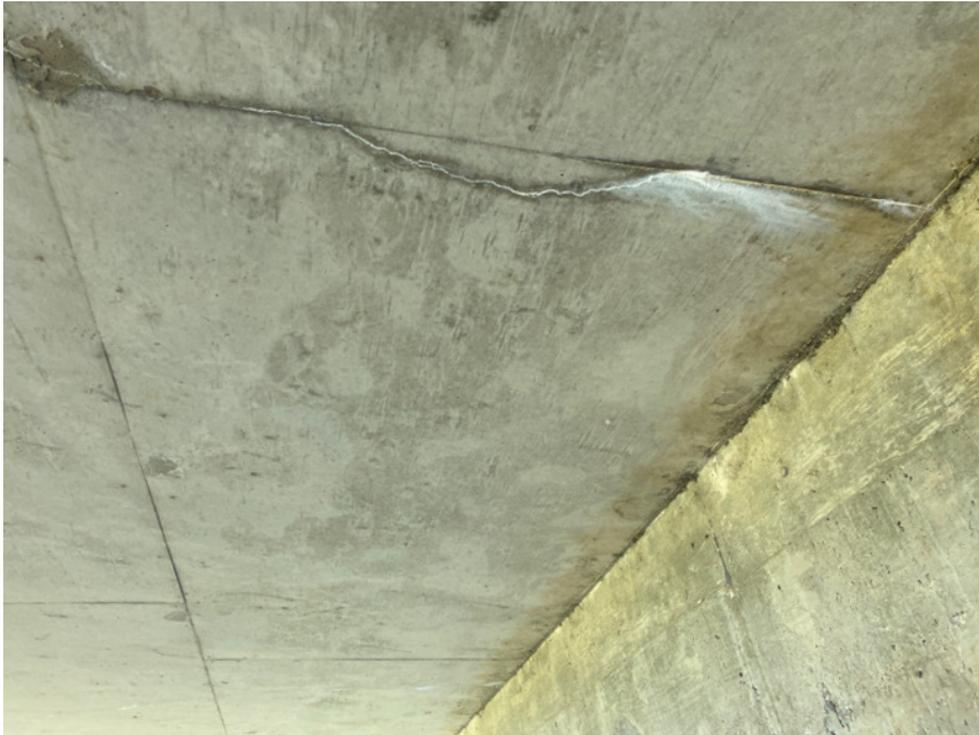
Soffit - Thin Slab - Int (East)

| Efflorescence staining

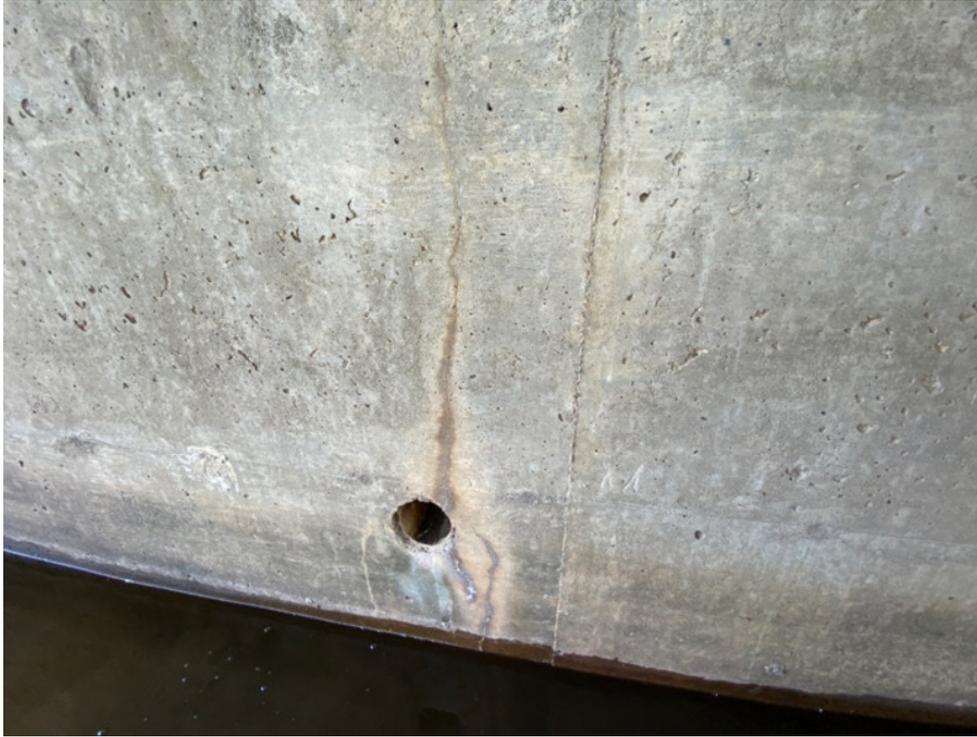
Abutment Walls (West)

Narrow stained crack

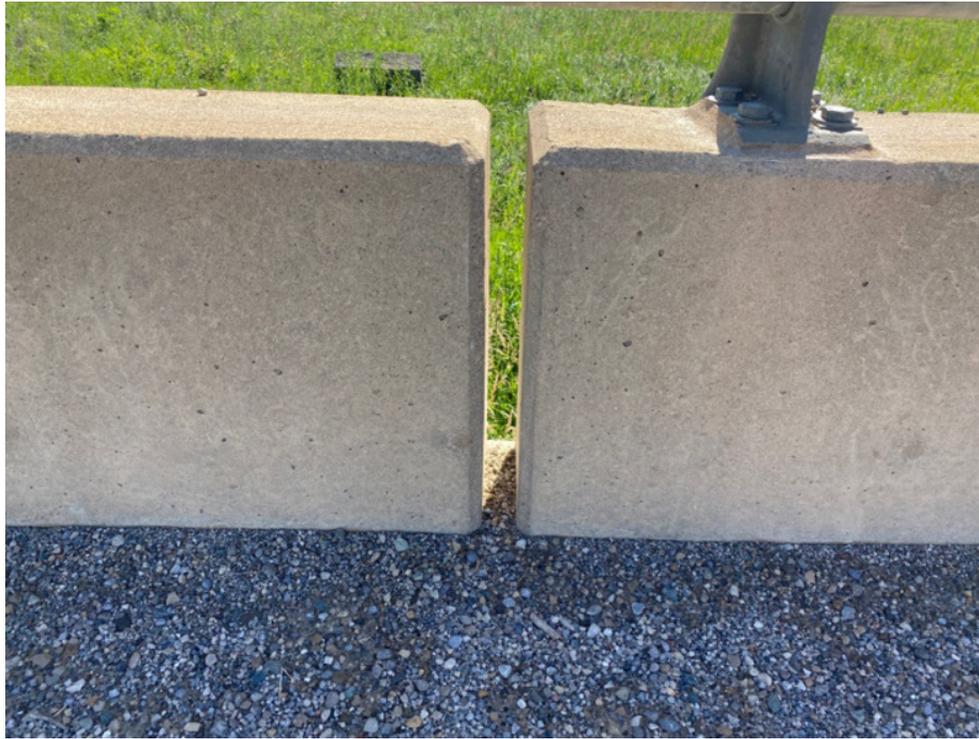
Barrier/Parapet Walls Interior (All Quadrants)

| Missing sealant

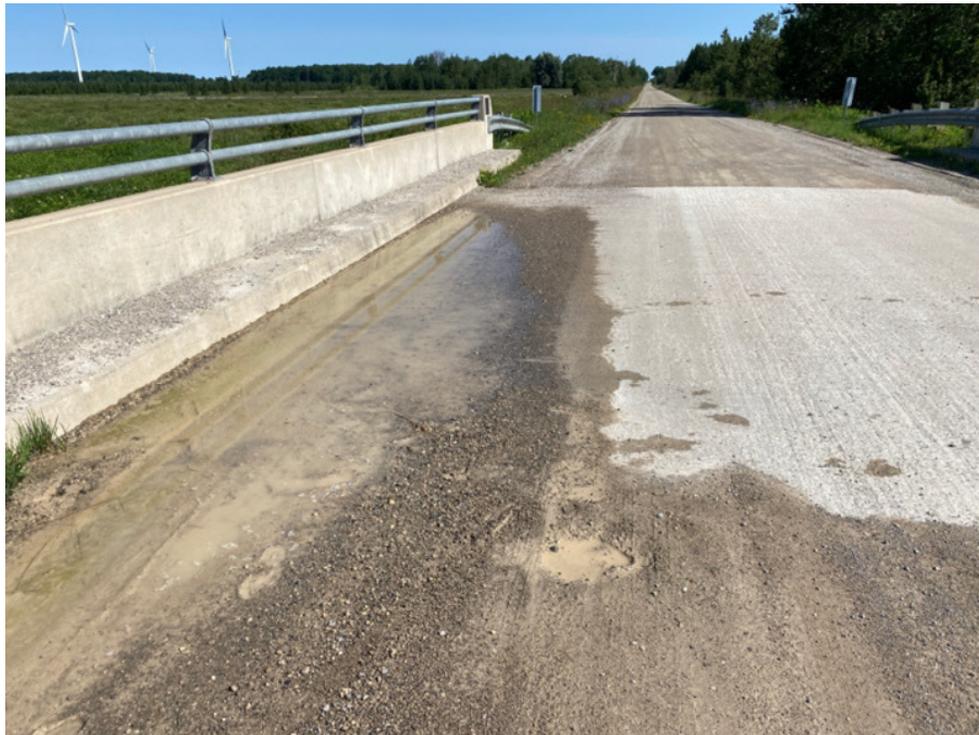
Deck Top (West)

| Water ponding

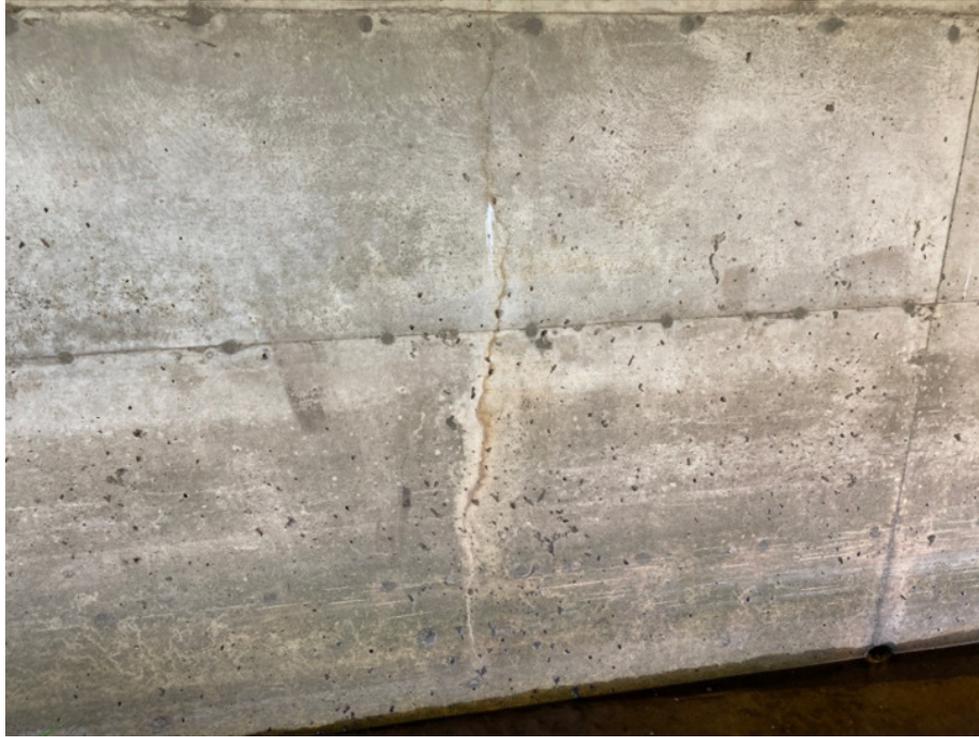
Abutment Walls (North)

| Efflorescence staining
