2023 OSIM Bridge Inspections Report

**Township of Amaranth
374028 6th Line
Amaranth, ON L9W 0M6**

**November 2023
300057065.0000**

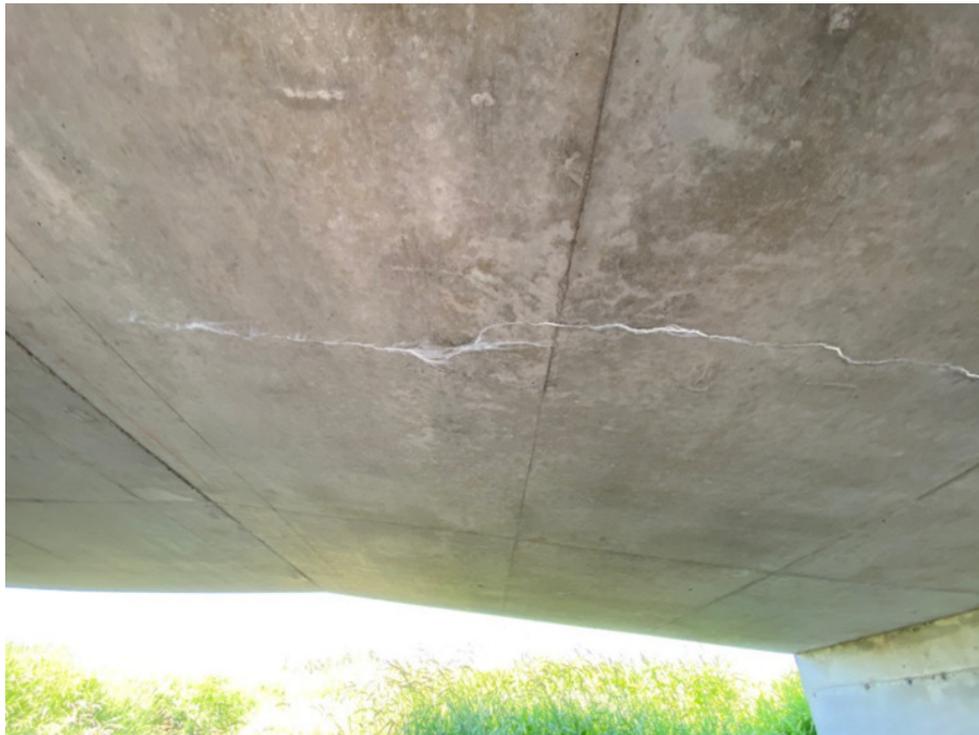
Soffit - Thin Slab - Int (West)

| Efflorescence staining

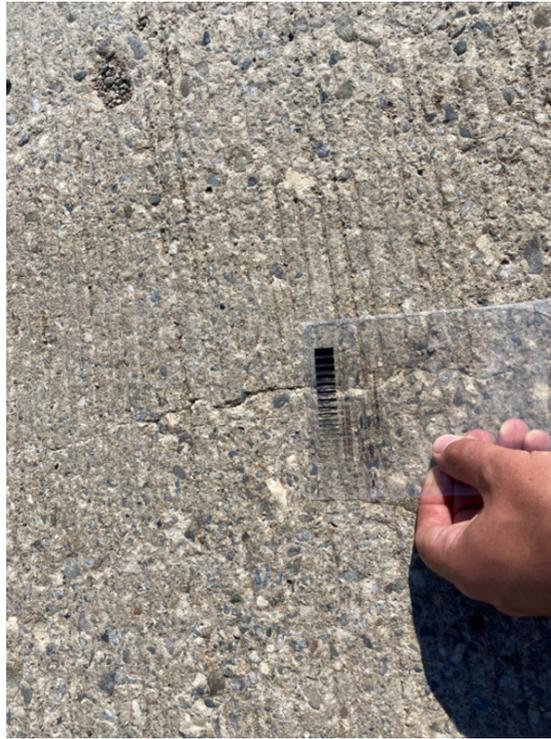
Deck Top (West)

| Wide crack

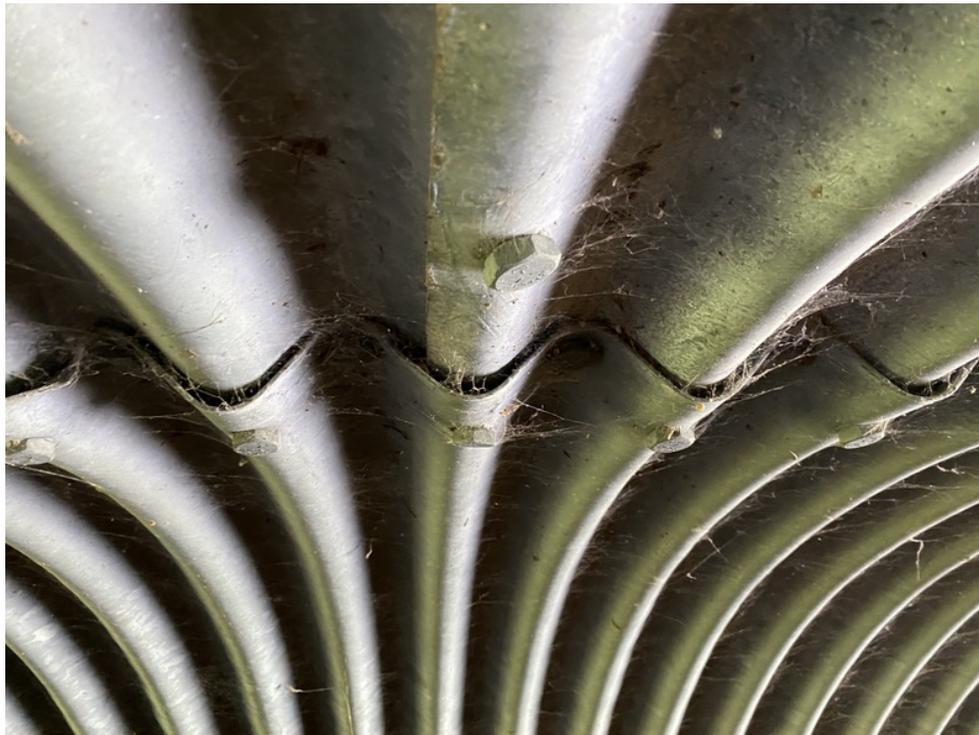
Barrels (South barrel)

| Cusping

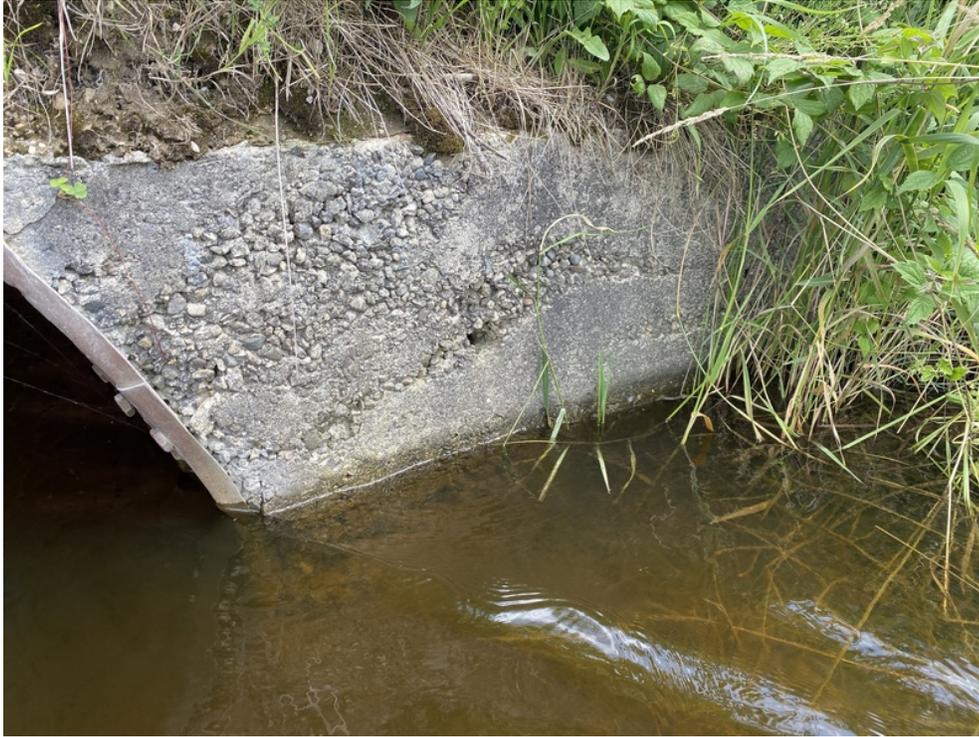
Outlet (West)

Moderate honeycombing
